Aviation Investigation Final Report

Location:	Jacksonville, Florida	Accident Number:	DCA19MA143
Date & Time:	May 3, 2019, 21:42 Local	Registration:	N732MA
Aircraft:	Boeing 737	Aircraft Damage:	Substantial
Defining Event:	Runway excursion	Injuries:	1 Minor, 142 None
Flight Conducted Under:	Part 121: Air carrier - Non-scheduled

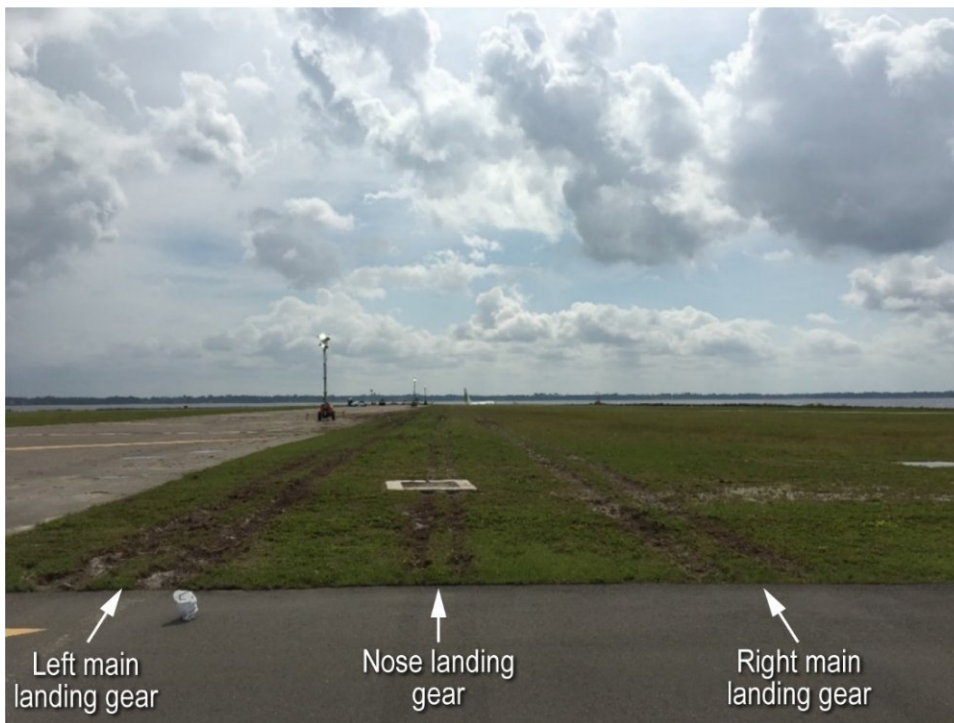
Light white landing gear track marks were visible on the pavement starting 1,592 ft from the displaced threshold (12 ft past the touchdown point of 1,580 ft computed by the onboard performance tool [OPT]) to the end of the pavement. The airplane's tracks showed variation in position relative to the right of centerline after touchdown and exited the paved surface about 55 ft to the right of centerline. The tracks continued in the grass area, deviating farther to the right of centerline and extending to the point at which the airplane struck the rock berm and entered the river, 90 ft right of centerline. Figure 1 shows the transition of track marks from the pavement to the grass and figure 2 shows the airplane at final rest in St Johns River.

Figure 1. Photograph of tire marks from the accident airplane's landing gear

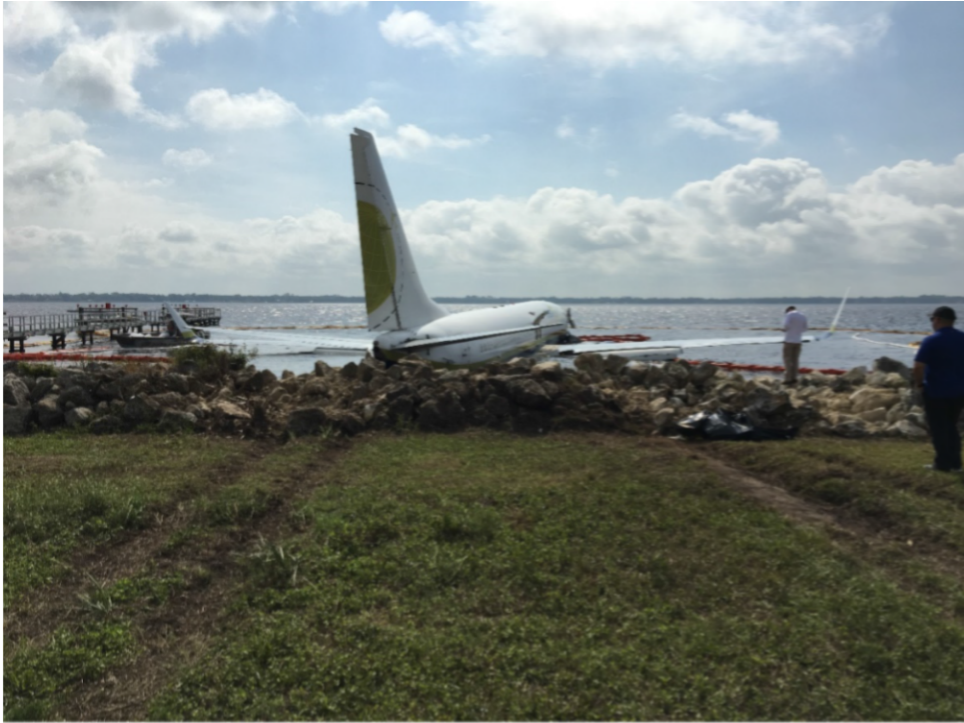
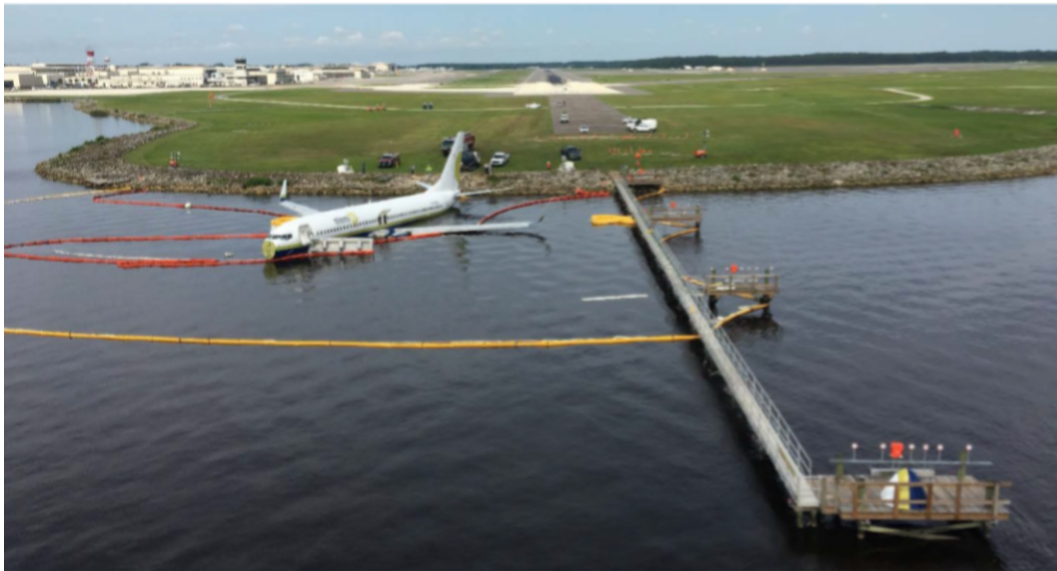
Figure 2. Photographs of accident airplane in St. Johns River

The airplane was mostly intact but sustained substantial damage. Portions of the engine cowlings, the radome, and both main landing gear separated during the accident sequence and were in the water adjacent to the airplane or on the rock embankment. Three life rafts were recovered in the water around the airplane. The L1 and R1 (forward) doors and the four overwing emergency exits were open. The L2 and R2 (aft) doors were closed. The L1 door
