# Aviation Investigation Final Report

<b>Location:</b>	Kent Island, Maryland	<b>Accident Number:</b>	ERA19FA163
<b>Date &amp; Time:</b>	May 4, 2019, 12:11 Local	<b>Registration:</b>	N572MD
<b>Aircraft:</b>	Guimbal Cabri	<b>Aircraft Damage:</b>	Destroyed
<b>Defining Event:</b>	Loss of visual reference	<b>Injuries:</b>	2 Fatal
<b>Flight Conducted Under:</b>	Part 91: General aviation - Personal

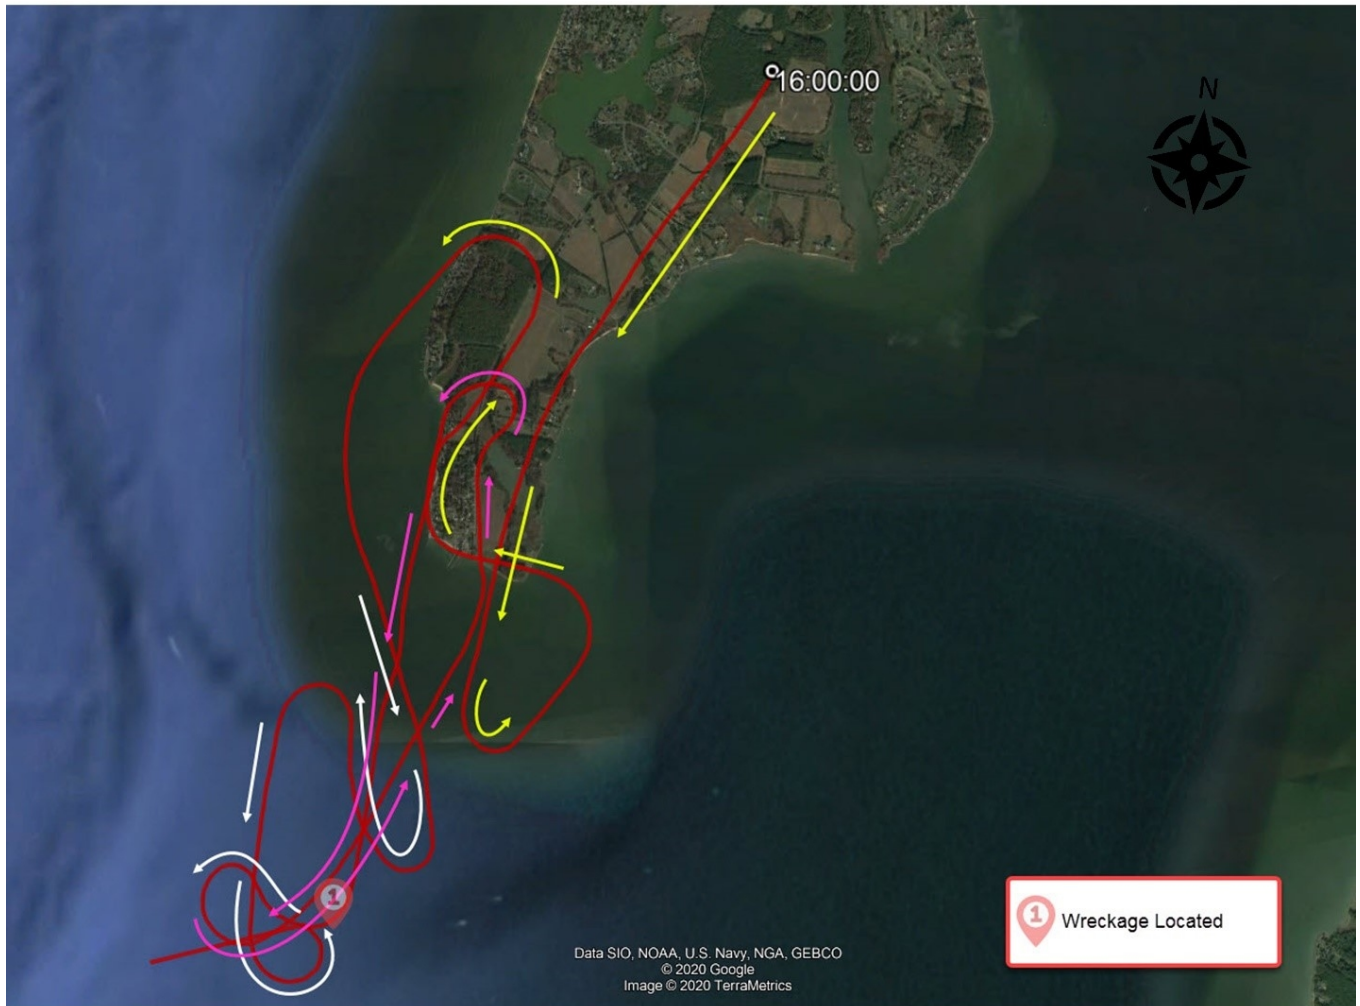
According to Federal Aviation Administration radar data, the helicopter flew over Kent Island and made several left and right turns over the southern tip of the island then flew about 2 miles south of the island. The helicopter maneuvered in that area beginning at 1200 until radar contact was lost at 1211. The radar track indicated that the helicopter was flying about 175 ft above the water for the final 10 minutes of the flight. Figure 1 depicts the helicopter's radar-observed flight path for the accident flight in red. The yellow arrows trace the helicopter's flight path as it initially transitioned from flying over land to water. The white arrows trace the helicopter's flight path as it continued to maneuver over the water, and the pink arrows trace the final portion of the flight until radar contact was lost. The number 1 point depicts where the wreckage of the helicopter was located in the water.

Figure 1 - The red line depicts the helicopter's radar-observed flight path for the 10 minutes before the accident. Note: The time displayed at the beginning of the radar plot is in universal coordinated time.

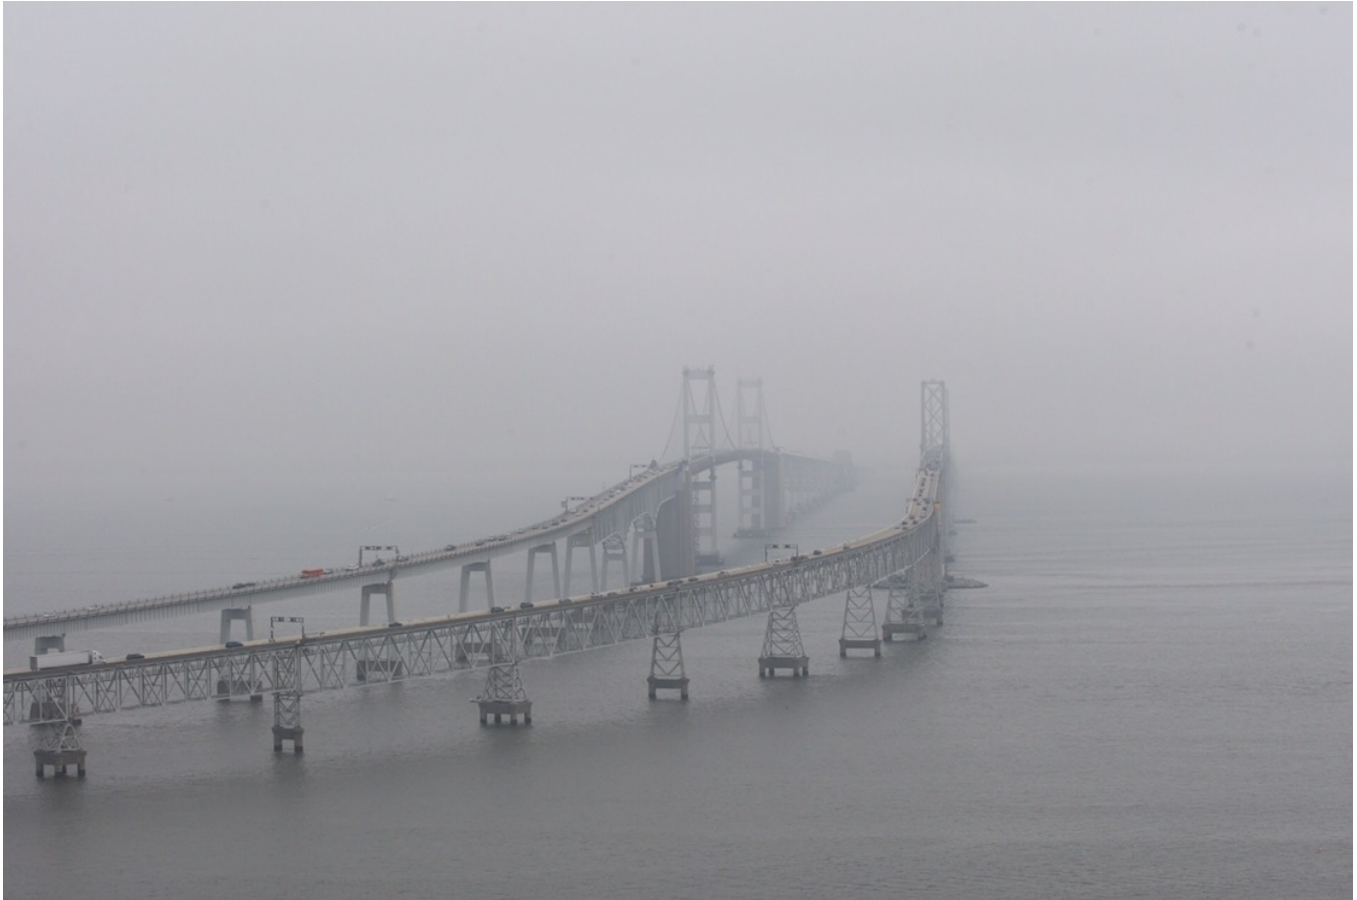
One photograph taken by the passenger while on the accident flight showed the visibility over the water was less than 3 miles. In another photograph, it was difficult to differentiate between the water and the sky.

Figure 2 - Photograph that passenger took on accident flight.
