# Aviation Investigation Final Report

| <b>Location:</b> | Santa Ynez, California | <b>Accident Number:</b> | WPR19FA146 |
| <b>Date &amp; Time:</b> | May 15, 2019, 13:39 Local | <b>Registration:</b> | N236AM |
| <b>Aircraft:</b> | Aviat A1 | <b>Aircraft Damage:</b> | Destroyed |

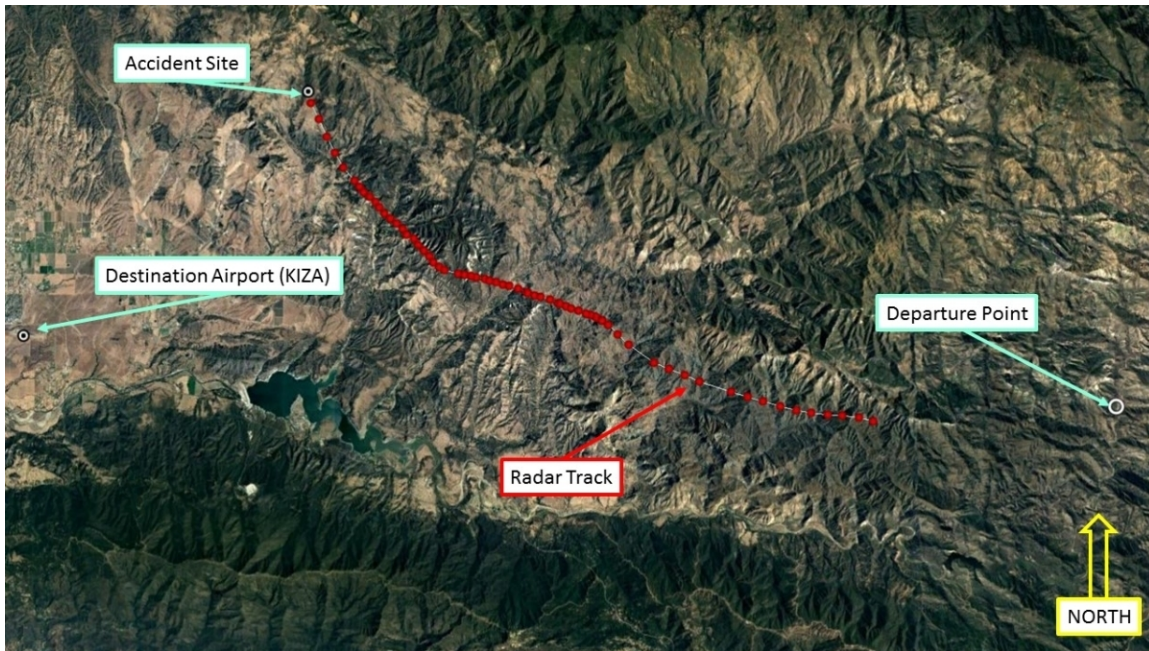
Recorded radar data showed a radar target consistent with the accident airplane about 6 miles west of the ranch on a west-northwesterly heading at 4,675 ft mean sea level (msl). The data showed the airplane continue a west-northwesterly heading for about 6 minutes varying between 4,375 and 4,775 ft msl. Subsequently, the airplane turned right to a northwesterly heading. About 20 seconds later, the airplane started descending. The airplane continued a northwesterly heading while descending for about 2 minutes until radar contact was lost. The last recorded radar target was about 0.2 mile south of the accident site at 2,725 ft msl. Figure 1 shows the airplane’s radar track laid over an aerial view of the mountainous terrain and the departure, destination, and accident site locations.

**Figure 1.** The airplane’s radar track laid over an aerial photograph of the mountainous terrain and the departure, destination, and accident site locations.

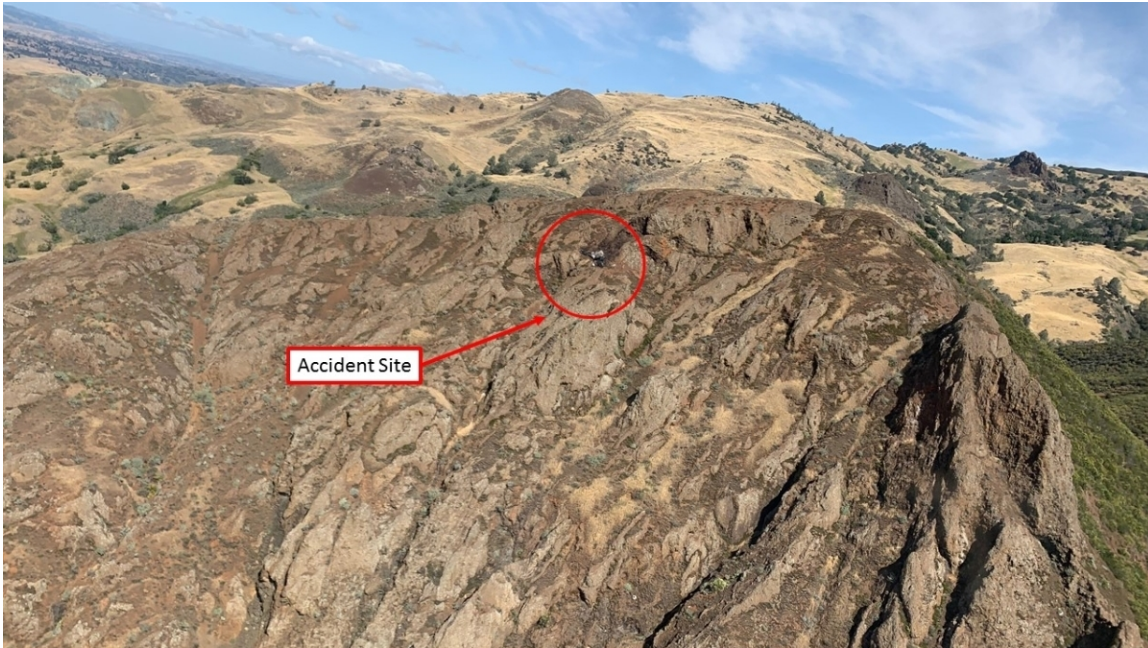
Examination of the accident site revealed that the airplane had impacted mountainous terrain at an elevation of about 2,700 ft msl and an approximate magnetic heading of 284° (see figure 2 for a photograph showing an aerial view of the accident site). The main wreckage came to rest upright about 30 ft below the initial impact point and was mostly consumed by fire. All the airplane's major structural components were present at the accident site.

**Figure 2.** Aerial view of the accident site.

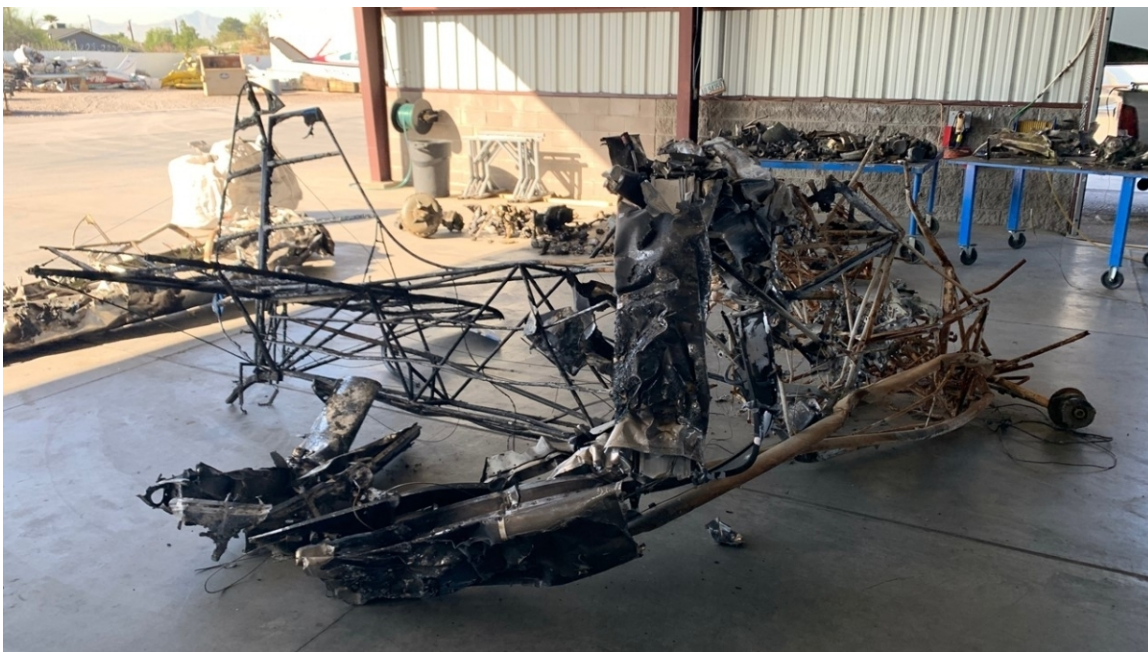
The wreckage exhibited severe thermal fire damage (see figure 3 for a photograph of the wreckage). All the fabric covering was burned and/or melted away from the wing and fuselage structure, except for the outboard left horizontal stabilizer. The right wing remained attached to the airframe, but the left wing was separated from the airframe. Both the left and right wings were severely fire damaged and bent and buckled throughout their spans.

**Figure 3.** Photograph of the recovered wreckage.
