# Aviation Investigation Final Report

<b>Location:</b>	Alpine, Utah	<b>Accident Number:</b>	WPR19FA148
<b>Date &amp; Time:</b>	May 17, 2019, 10:34 Local	<b>Registration:</b>	N744TW
<b>Aircraft:</b>	Robinson R44	<b>Aircraft Damage:</b>	Substantial
<b>Defining Event:</b>	VFR encounter with IMC	<b>Injuries:</b>	2 Fatal
<b>Flight Conducted Under:</b>	Part 91: General aviation - Personal

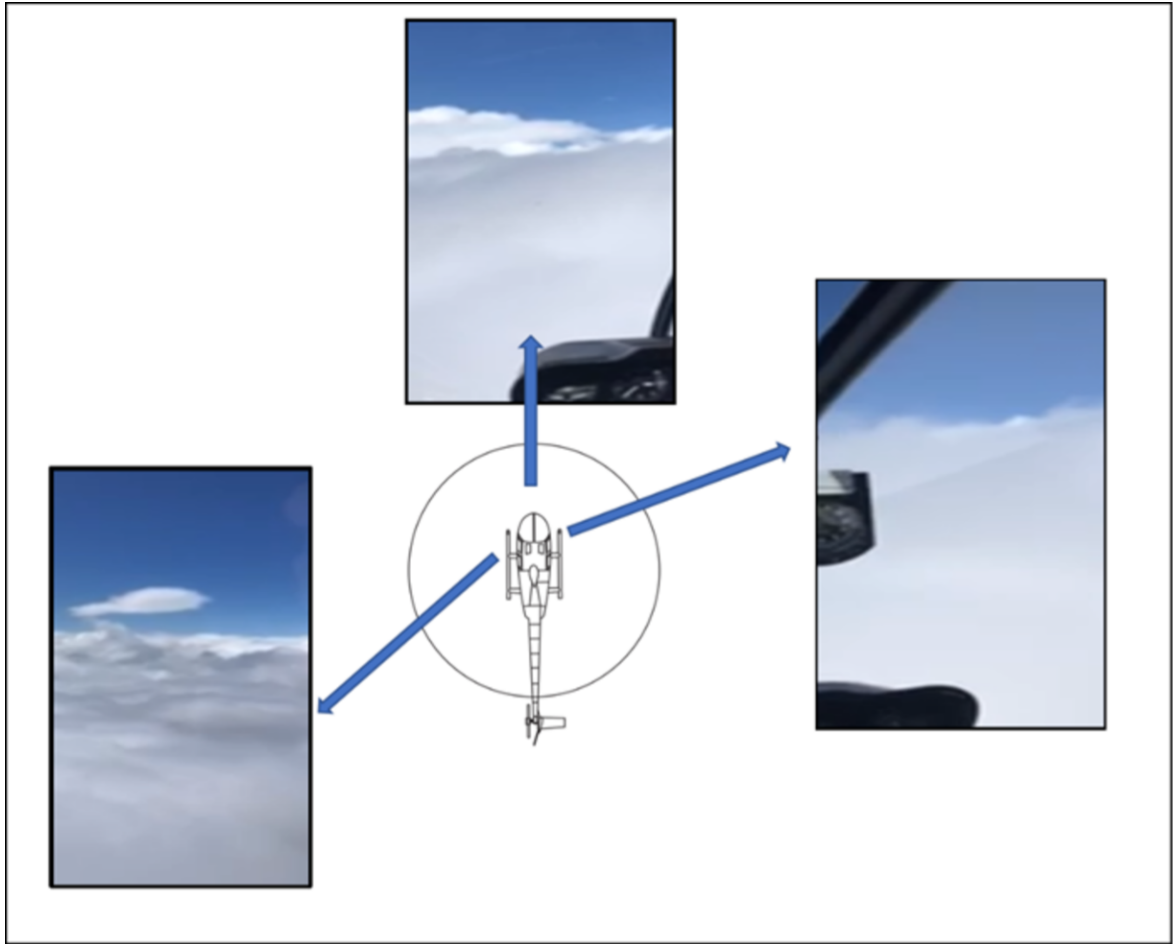
The pilot's mother stated that the pilot kept the helicopter at his home in Myton, Utah, and that he and his wife had planned to fly to South Valley Regional Airport (U42), West Jordan, Utah, to pick up a second passenger before proceeding to Phoenix, Arizona. She saw the helicopter depart at 0930 and stated that it was raining lightly at that time. At 1022, she received a text message from the passenger stating that they were "17 minutes out." At 1025, she received a text stating that "the flight was smooth." At 1027, she received a short video showing the helicopter above a thick cloud layer with no discernable horizon. Some of the cloud tops appeared above the helicopter, as seen in Figure 1.

Figure 1. Images recorded by a passenger.

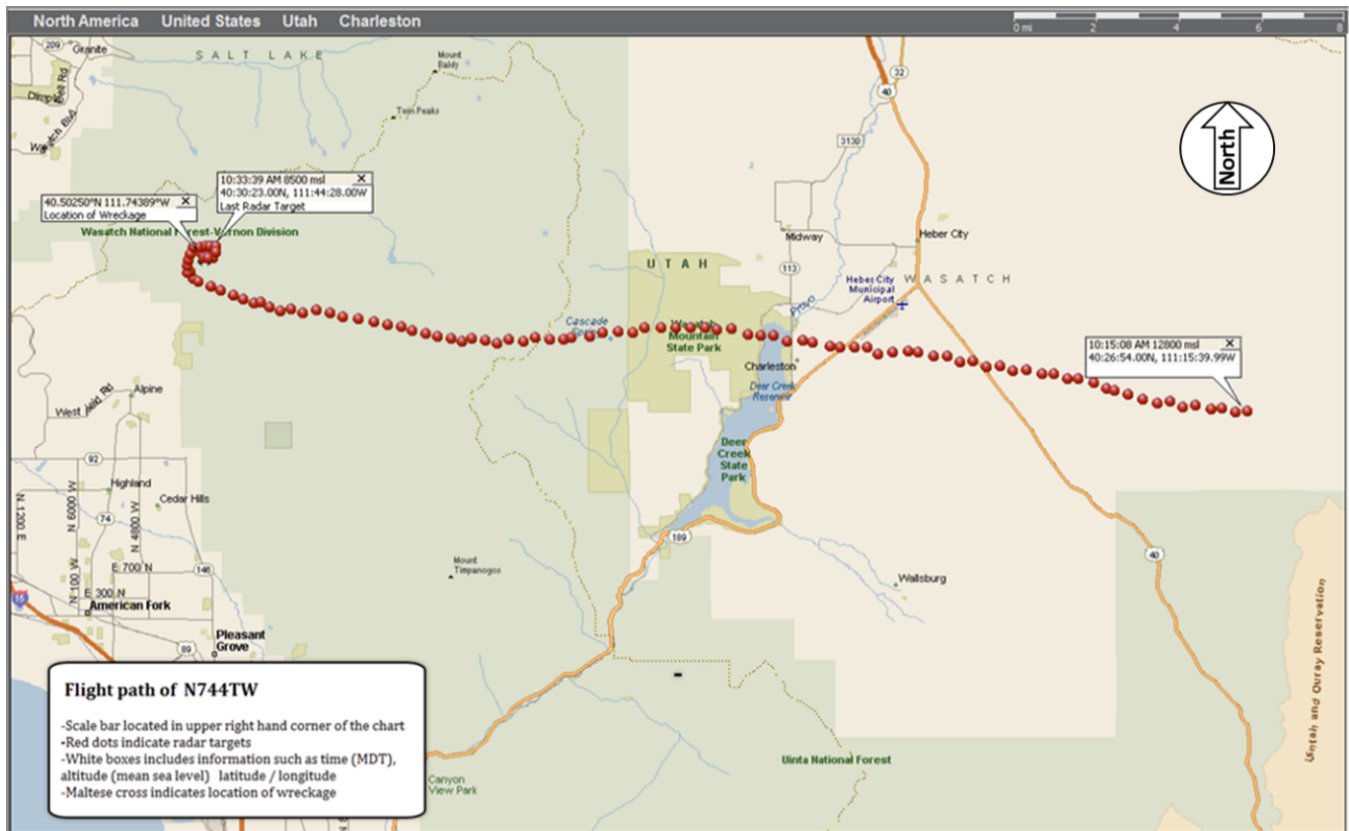
Radar data provided by the Federal Aviation Administration (FAA) revealed a target correlated to the accident helicopter first appear on radar at 0956 at an altitude of 10,400 ft mean sea level (msl), on a heading of 309° about 44 miles west of the pilot's residence. The helicopter continued generally on a west-northwest course, as shown in Figure 2. The airspeed initially varied from 37 to 88 knots ground speed but stabilized to about 85 knots for most of the flight. The helicopter climbed to 13,000 ft msl at 1007 and remained between 12,700 and 13,000 ft msl until about 1030, when it descended below 12,500 ft msl. At 1031, the helicopter began a right descending right turn that continued until radar contact was lost at 1033 at an altitude of 9,200 ft msl and groundspeed of 108 knots, about 1,650 ft from

Figure 2. Recorded radar targets showing the likely route of flight.

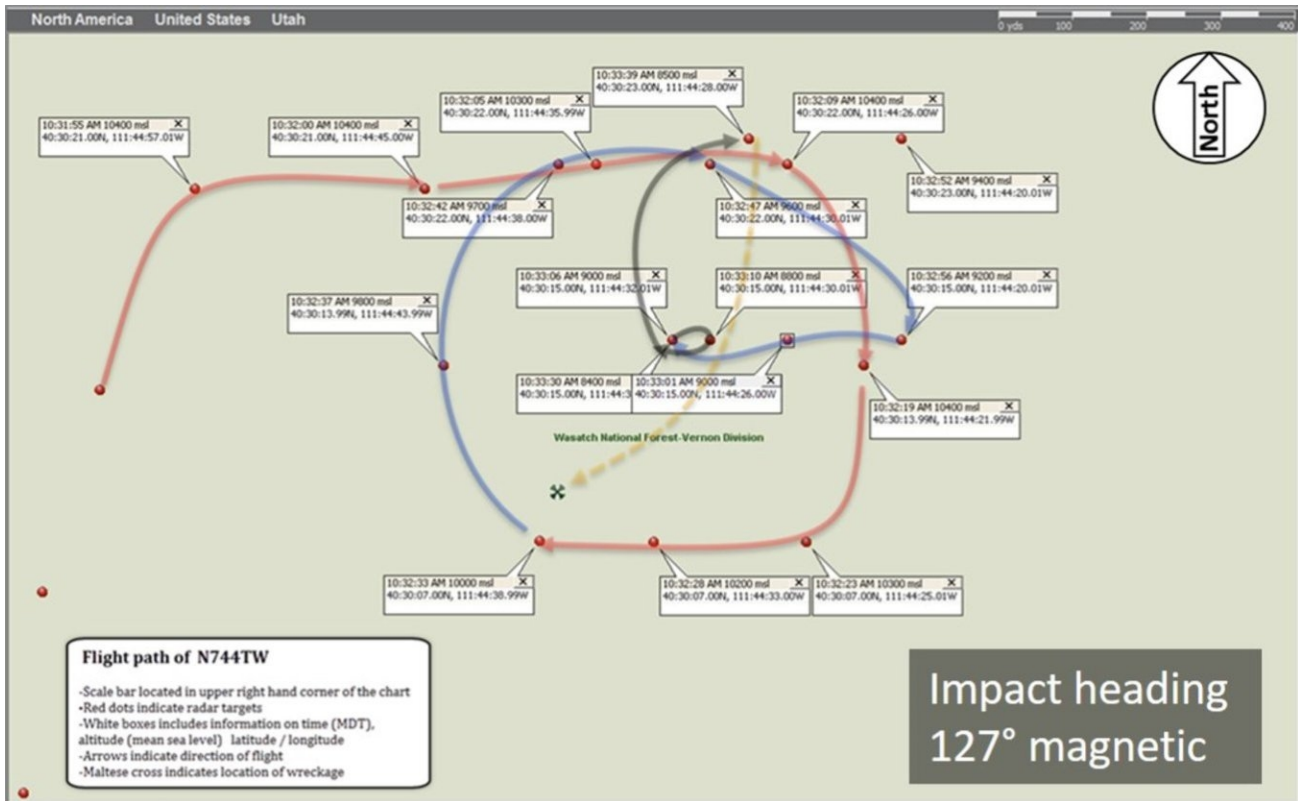
the accident site. The data revealed that the helicopter completed about 2 1/2 360° turns before radar contact was lost. (see Figure 3.)

Figure 3. Radar targets showing the turning descent. Path lines show estimated track.

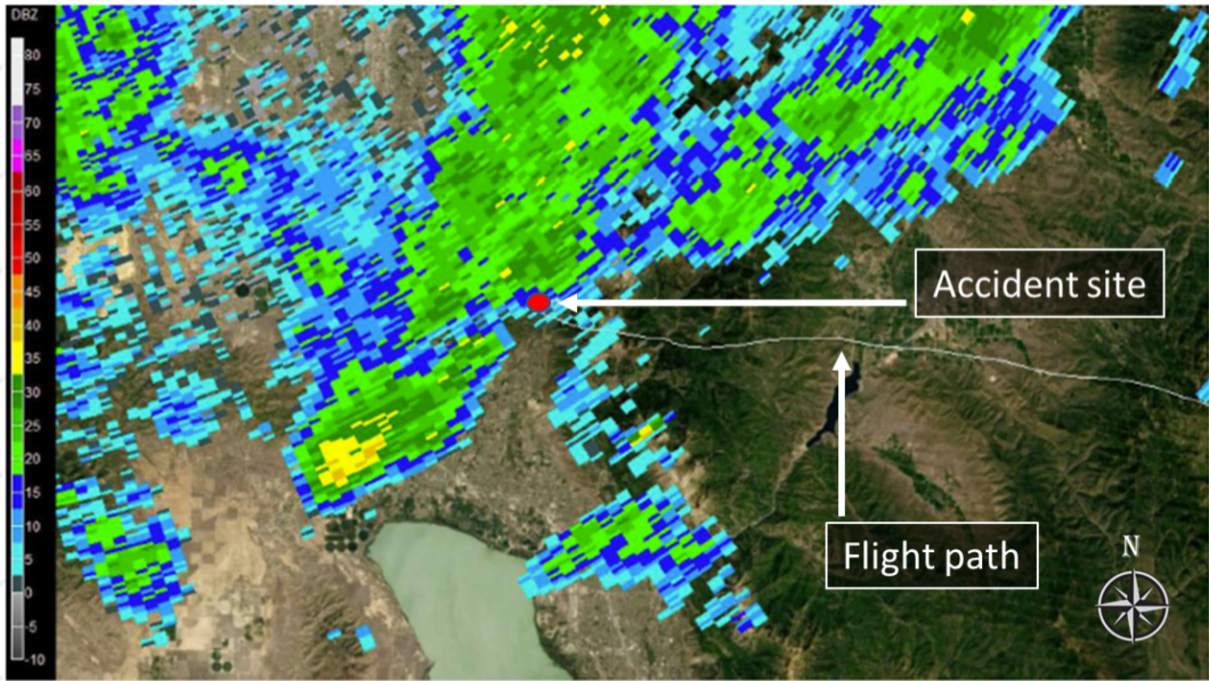
AIRMET Sierra was issued at 0845 for moderate icing between the freezing level and 18,000 ft msl and mountain obscuration by clouds, precipitation, or mist, and was active for the accident location at the accident time. Weather radar imagery above the accident location between about 8,600 ft and 14,200 ft msl identified reflectivity consistent with light rain in an area that included the accident site. (see Figure 4.)

Figure 4. Weather radar imagery

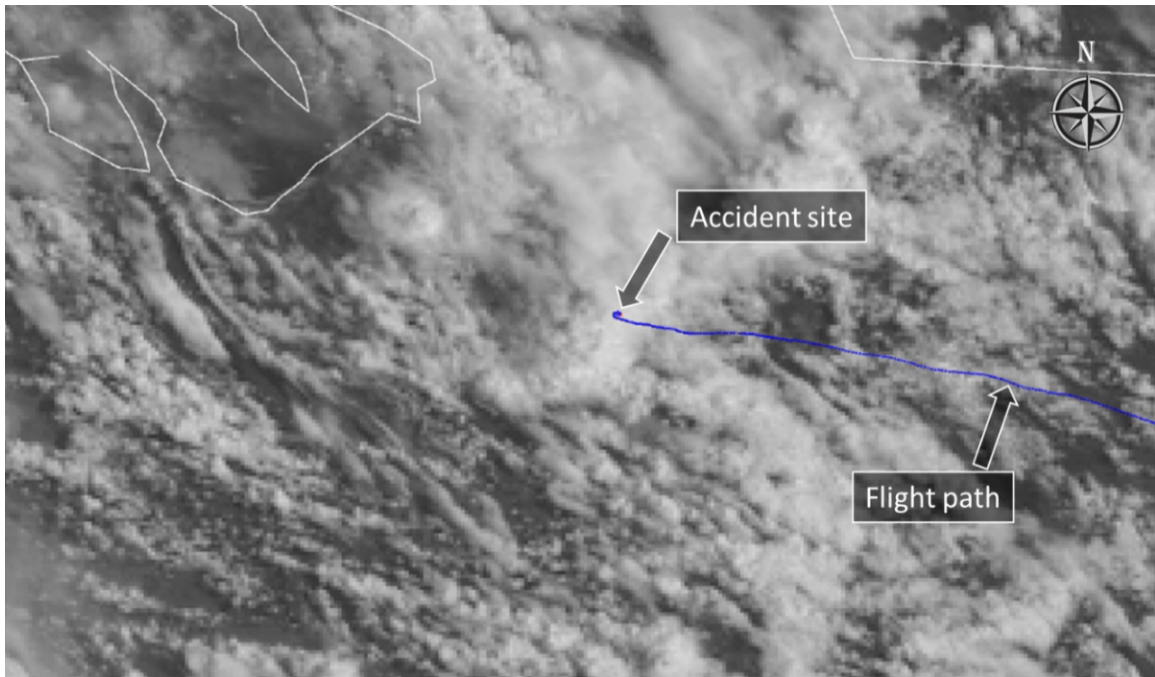
Satellite imagery identified cloudy conditions over the accident site, with analysis indicating cloud tops of about 13,000 ft msl along the route of flight and a cloud top height of about 19,500 ft msl during the final portions of the flight, as shown in Figure 5.

Figure 5. Satellite imagery showing clouds.
