Aviation Investigation Final Report

Location:	Alpine, Utah	Accident Number:	WPR19FA148
Date & Time:	May 17, 2019, 10:34 Local	Registration:	N744TW
Aircraft:	Robinson R44	Aircraft Damage:	Substantial
Defining Event:	VFR encounter with IMC	Injuries:	2 Fatal
Flight Conducted Under:	Part 91: General aviation - Personal

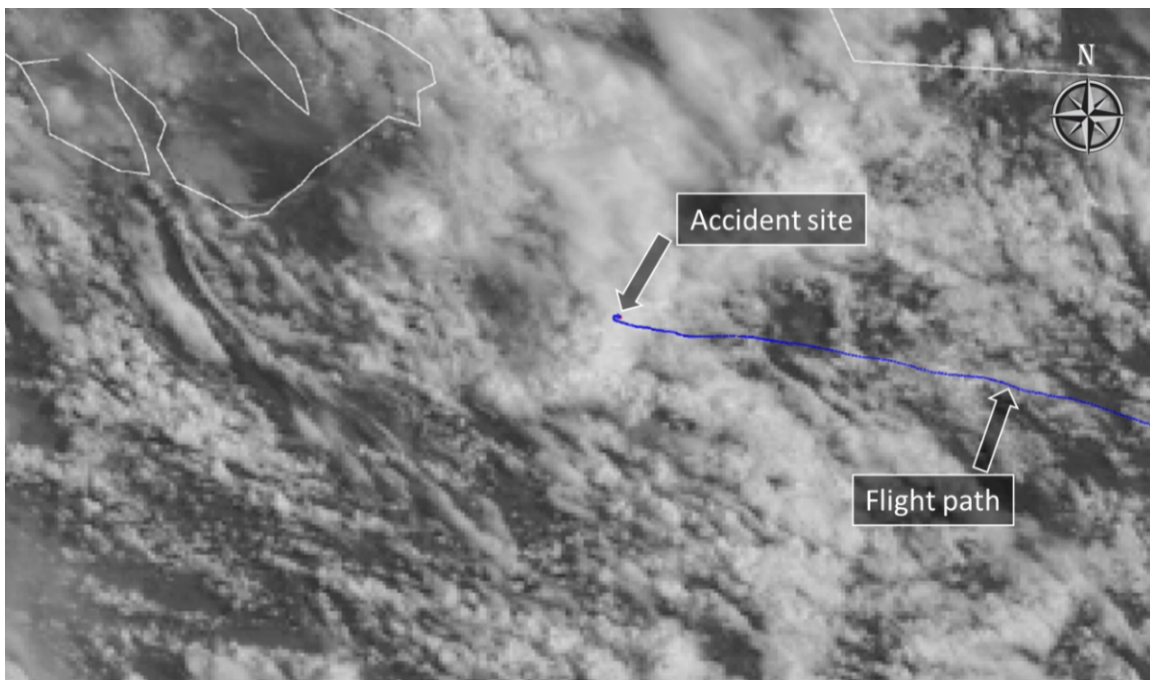
Figure 5. Satellite imagery showing clouds.

Satellite imagery identified cloudy conditions over the accident site, with analysis indicating cloud tops of about 13,000 ft msl along the route of flight and a cloud top height of about 19,500 ft msl during the final portions of the flight, as shown in Figure 5.
