Aviation Investigation Final Report

Location:	Metlakatla, Alaska	Accident Number:	ANC19FA019
Date & Time:	May 20, 2019, 15:56 Local	Registration:	N67667
Aircraft:	De Havilland DHC 2	Aircraft Damage:	Substantial
Defining Event:	Loss of control on ground	Injuries:	2 Fatal
Flight Conducted Under:	Part 135: Air taxi & commuter - Scheduled

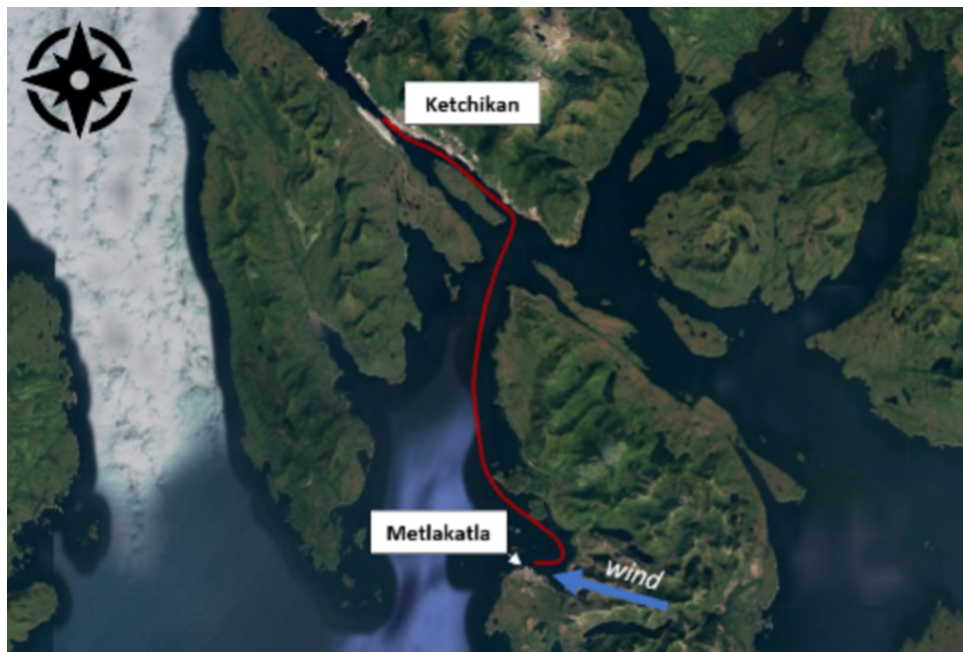
A review of GPS track data revealed that the airplane departed 5KE about 1543 and traveled southeast over an area known as the Tongass Narrows, then south to Metlakatla Harbor at an altitude of about 800 ft. The airplane made a right turn to a 240° (magnetic) heading in the southern portion of the harbor then the data ended. (See figure 1.)

Figure 1. Flight track (red) and wind observation.

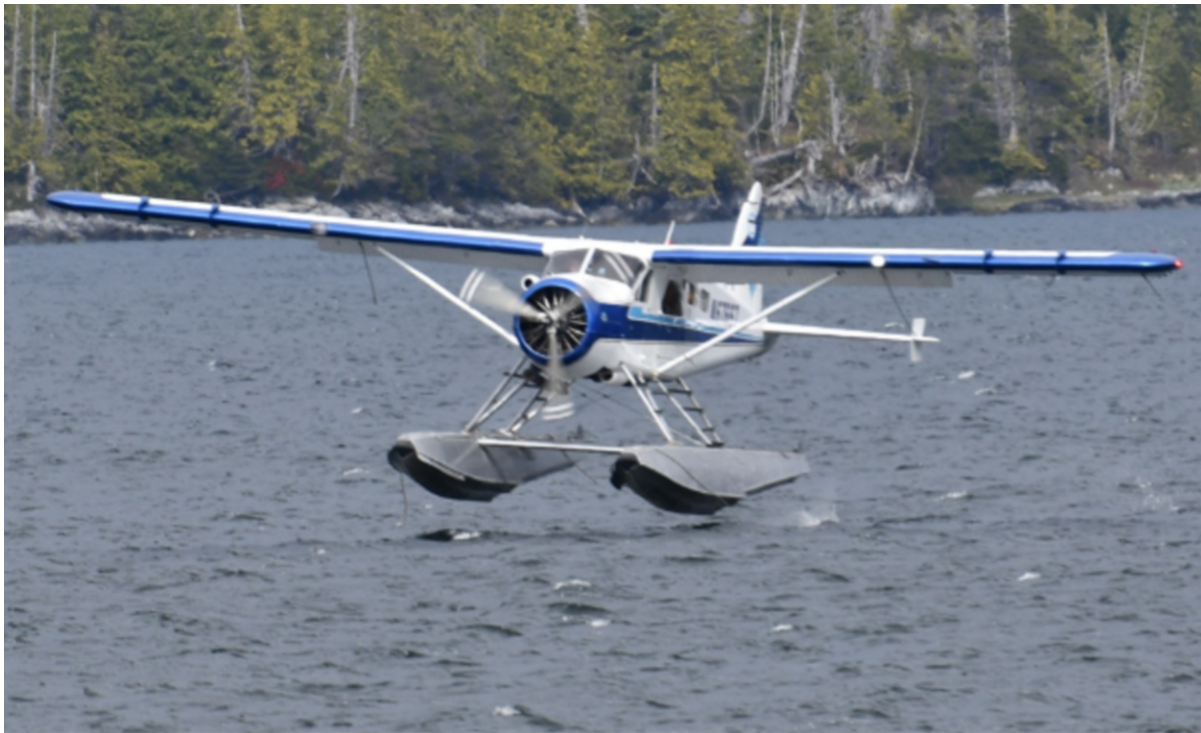
There were three witnesses to the airplane's approach and landing. One of the witnesses, who was taking photographs near the pier, reported that the wind appeared to be pushing the airplane right during touchdown and that the airplane was drifting right as the floats contacted the water. After the airplane skipped once or twice, the left wing "dipped" down, then the right wing "dipped down and dug into the water," which resulted in the airplane nosing over and the right wing separating.

Figure 2. The airplane during the landing sequence after a brief touchdown on the left float. (Source: Nicholas King.)

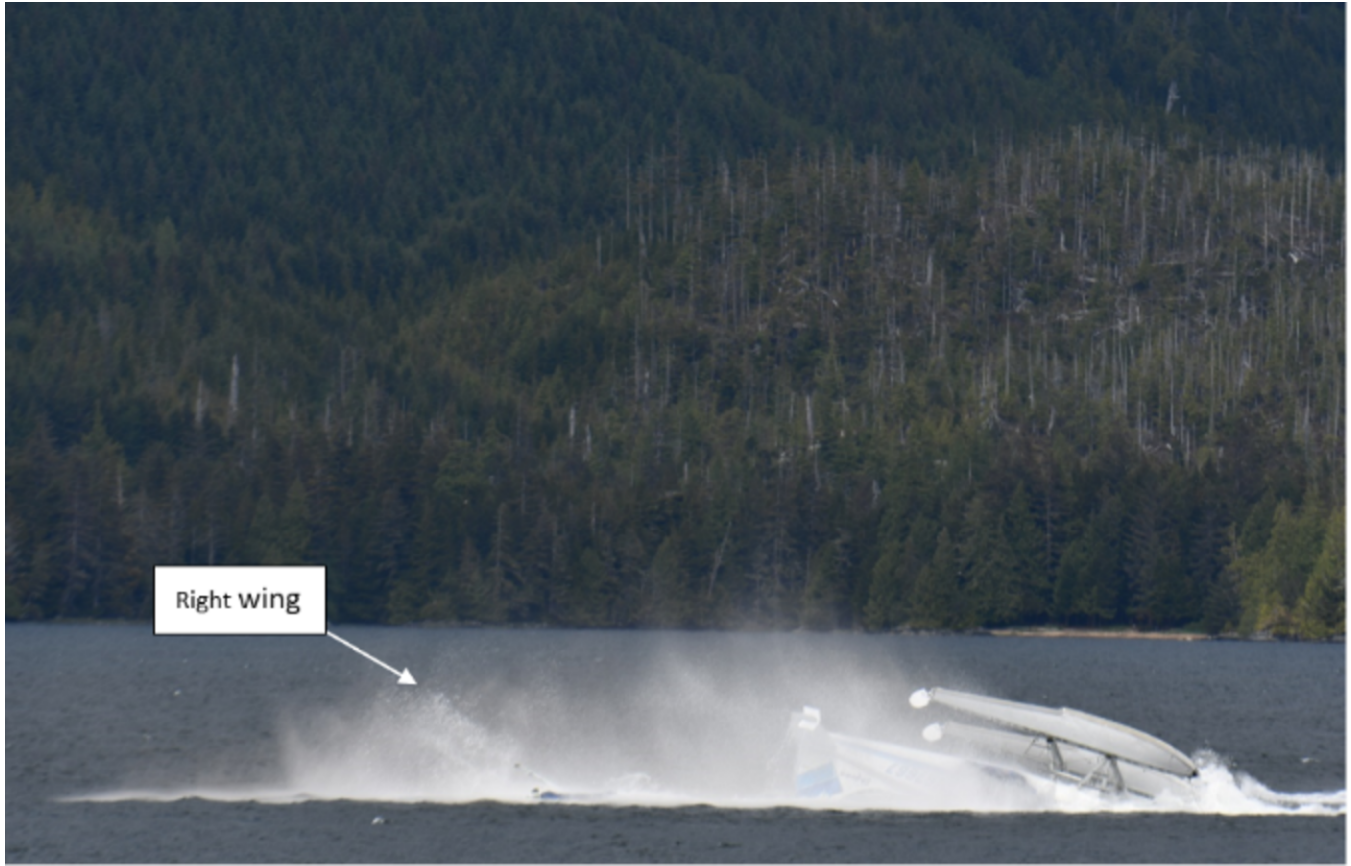
Another witness, who was in a boat, stated that the airplane hit the water hard and he saw the right float "dig into the water" before the airplane turned over as it pivoted around. The third witness stated that the airplane appeared to be "teetering back and forth" and a gust of wind appeared to push the tail upward as the right wing dropped down and the airplane nosed over. She stated that the wind was from the southeast with gusts of 13 mph and the water was less than choppy. The inverted airplane partially sank with the front fuselage and cockpit under water. (See figures 2 and 3.)

Figure 3. The airplane inverted after the accident. (Source: Nicholas King.)

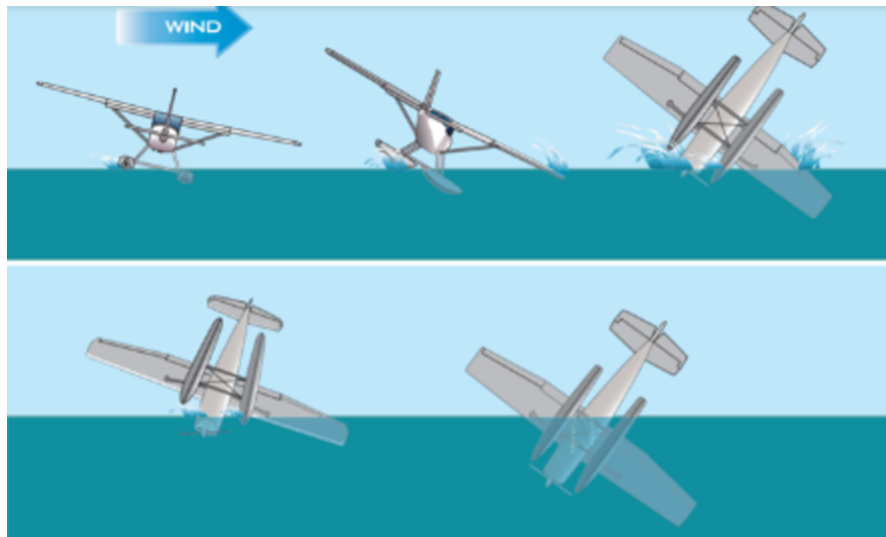
If the seaplane touches down while drifting sideways, the sudden resistance as the floats contact the water creates a skidding force that tends to push the downwind float deeper into the water. The combination of the skidding force, wind, and weathervaning as the seaplane slows down can lead to a loss of directional control and a waterloop. If the downwind float submerges and the wingtip contacts the water when the seaplane is moving at a significant speed, the seaplane could flip over. See figure 6.3. (Figure 6.)

Figure 6. Figure 6-3 in the FAA Seaplane Handbook illustrating the hazard of landing while drifting sideways in a crosswind at significant speed.
