Aviation Investigation Final Report

Location:	Metlakatla, Alaska	Accident Number:	ANC19FA019
Date & Time:	May 20, 2019, 15:56 Local	Registration:	N67667
Aircraft:	De Havilland DHC 2	Aircraft Damage:	Substantial
Defining Event:	Loss of control on ground	Injuries:	2 Fatal
Flight Conducted Under:	Part 135: Air taxi & commuter - Scheduled

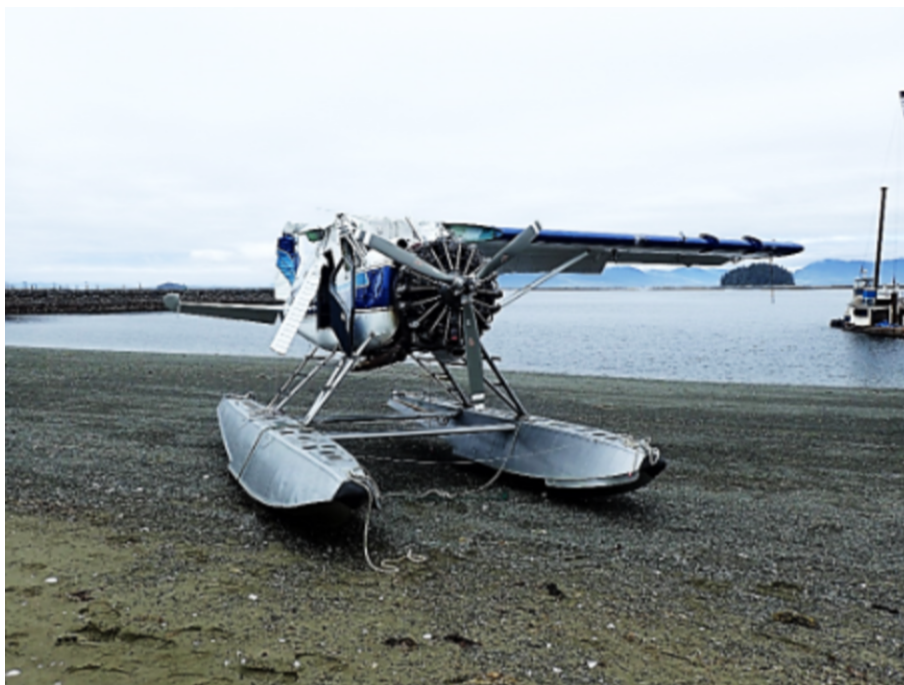
The airplane came to rest inverted on an easterly heading with the right wing separated and floating about 15 ft to the west. First responders stated that the passenger’s front right seat was removed to facilitate rescue and subsequently sank in the bay. A postaccident examination of the airframe revealed that all other major components were attached. The floats, float struts, spreader bars, and control cables were intact. The right and left sea rudders were each fractured at the lower welds and exhibited minor bending deformation. (See figure 5.)

Figure 5. The airplane after recovery from the harbor.

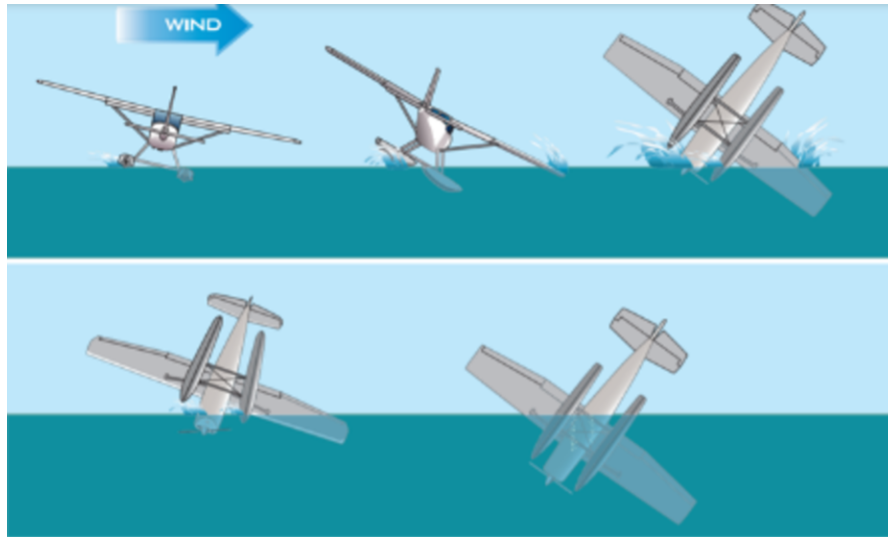
If the seaplane touches down while drifting sideways, the sudden resistance as the floats contact the water creates a skidding force that tends to push the downwind float deeper into the water. The combination of the skidding force, wind, and weathervaning as the seaplane slows down can lead to a loss of directional control and a waterloop. If the downwind float submerges and the wingtip contacts the water when the seaplane is moving at a significant speed, the seaplane could flip over. See figure 6.3. (Figure 6.)

Figure 6. Figure 6-3 in the FAA Seaplane Handbook illustrating the hazard of landing while drifting sideways in a crosswind at significant speed.
