Aviation Investigation Final Report

Location:	Whittier, Alaska	Accident Number:	WPR19FA152
Date & Time:	May 21, 2019, 13:00 Local	Registration:	N5457X
Aircraft:	Cessna A185	Aircraft Damage:	Substantial
Defining Event:	Landing gear not configured	Injuries:	1 Fatal, 1 Serious, 1 Minor
Flight Conducted Under:	Part 91: General aviation - Personal

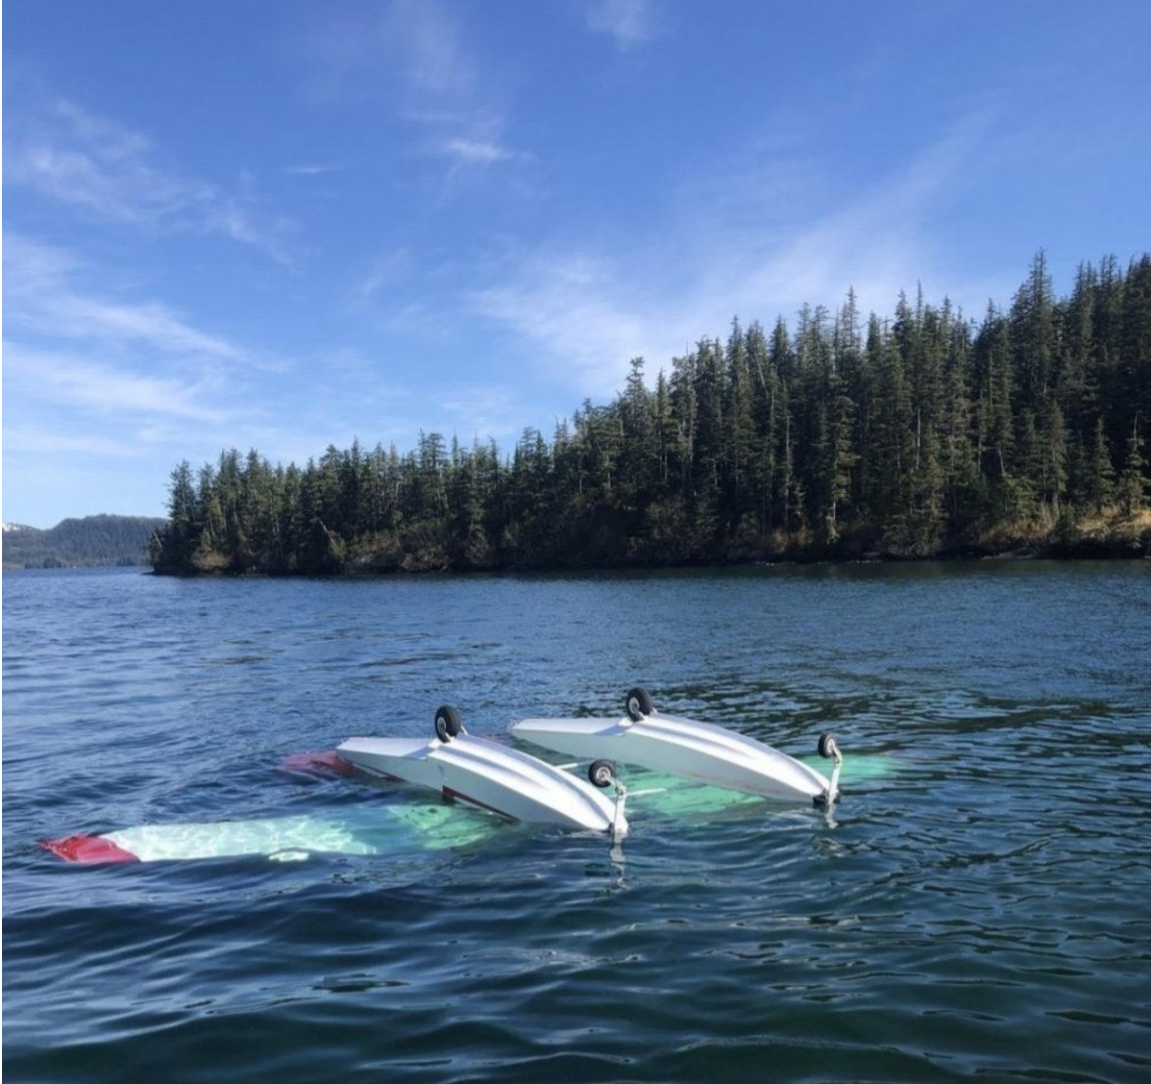
Shortly after landing on water, the amphibious airplane nosed over and came to rest inverted. The passenger in the front right seat drowned following the accident, likely as a result of being incapacitated by head injuries sustained during the impact. The landing gear were found extended and the landing gear selector was found in the "down" position.

The pilot's failure to configure the landing gear for a water landing, which resulted in a nose-over. Contributing to the accident was the pilot's distraction due to his talking passengers.

Review of photos taken a few hours after the accident revealed that the airplane came to rest inverted with the entire fuselage submerged, with only the floats remaining above water. The four wheels of the landing gear appeared in the extended, runway landing position. (see Figure 1.) Subsequent examination of the cockpit revealed that the gear control lever was in the “DOWN” position. (see Figure 2.)

Figure 1. Airplane at the accident site with landing gear extended.

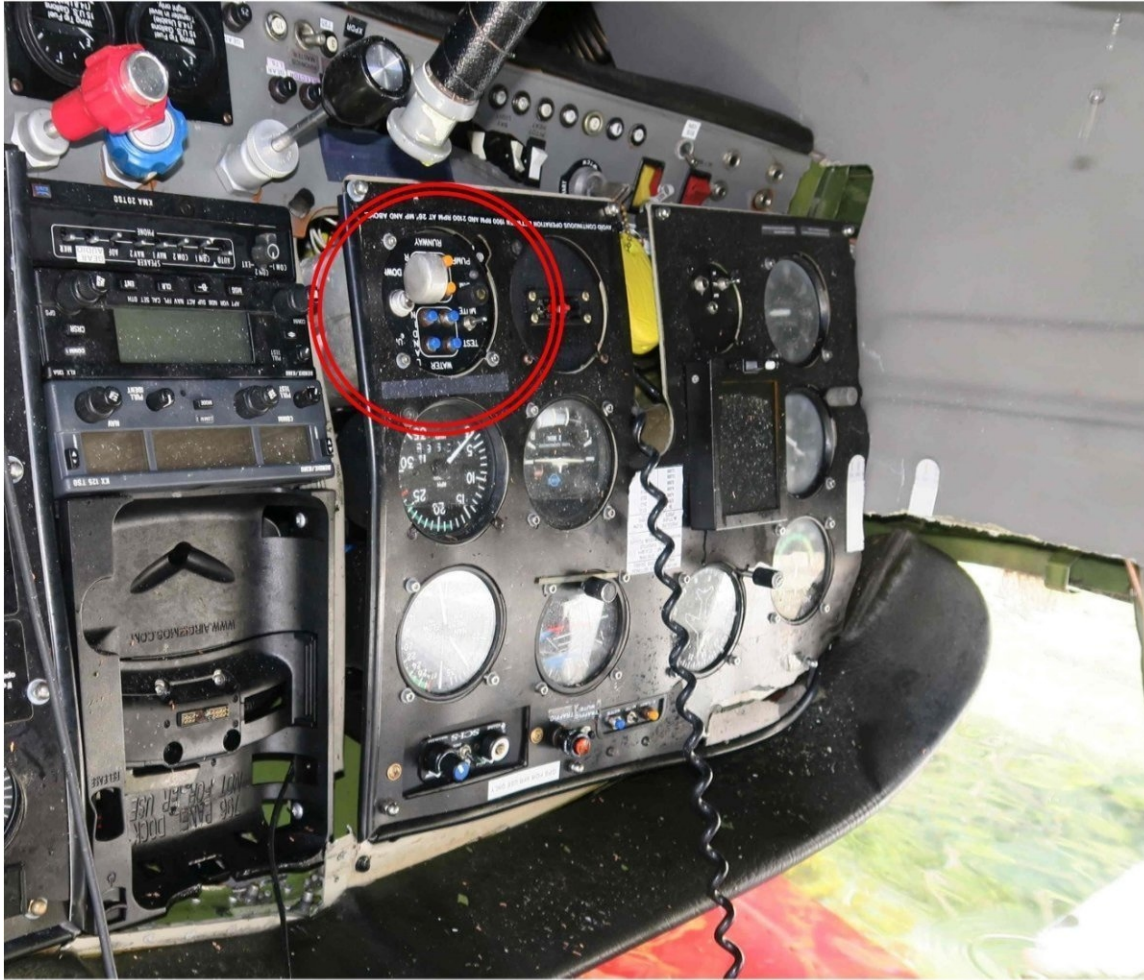
Figure 2. Landing gear control in “DOWN” position (Airplane upside down in water).
