Aviation Investigation Final Report

Location:	Yankeetown, Florida	Accident Number:	CEN19LA147
Date & Time:	May 17, 2019, 15:15 Local	Registration:	N4861P
Aircraft:	Cessna P210	Aircraft Damage:	Substantial
Defining Event:	Electrical system malf/failure	Injuries:	1 Minor
Flight Conducted Under:	Part 91: General aviation - Personal

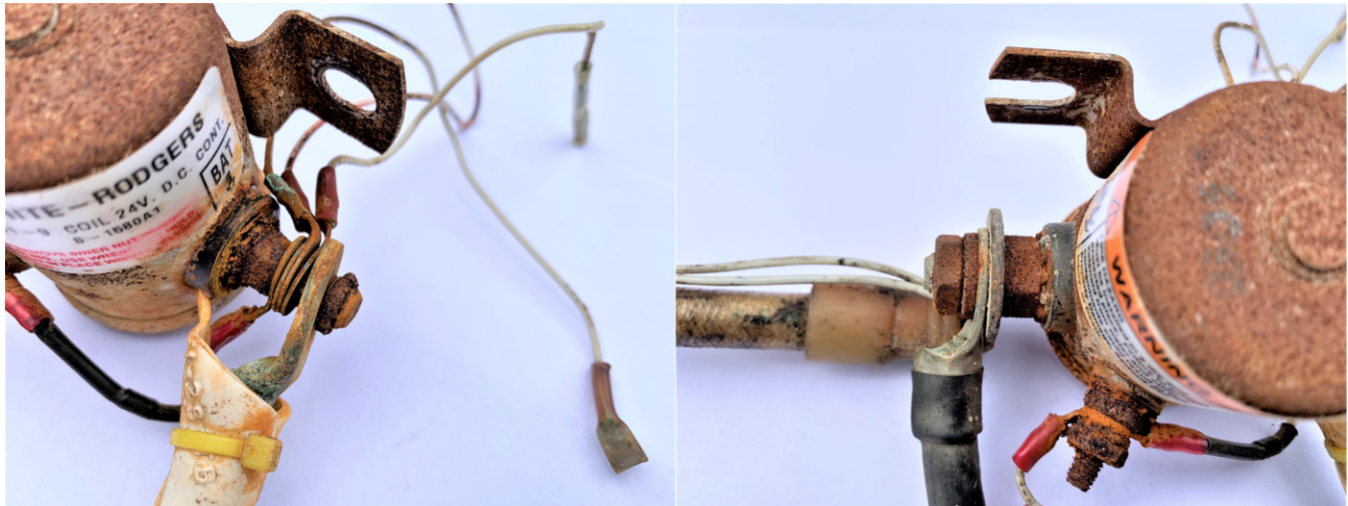
Examination of the airplane's electrical system revealed the battery's positive power cable was loose where it attached to the battery contactor terminal. Additionally, the component stack-up did not include any washers and had a smaller nut when compared to the other cable terminal. The nut had backed off about 2 threads, which resulted in a loose cable connection. The total loss of electrical power during flight was likely due to the loose cable connection on the battery contactor. The engine magnetos produce ignition spark independent of the airplane electrical system; the loss of electrical power did not affect normal engine operation. The reason for the total loss of engine power could not be determined based on available evidence.

Examination of the airplane's electrical system revealed the battery's positive power cable was loose where it attached to the battery contactor (p/n S-1580A1) terminal. The nut used to

secure the battery’s positive power cable was significantly smaller than the nut used on the terminal that secured two cables; one cable to the battery switch and the other cable to the starter motor contactor. Additionally, the loose positive battery cable component stack-up did not include any washers. The nut had backed off about 2 threads, which resulted in a loose cable connection (see the figure below).

Figure. Battery contactor terminal for the positive battery cable was loose (left). The battery contactor terminal for the battery switch and starter motor contactor cables was tight (right).
