# Aviation Investigation Final Report

<b>Location:</b>	Jerome, Idaho	<b>Accident Number:</b>	WPR19LA157
<b>Date &amp; Time:</b>	May 14, 2019, 09:19 Local	<b>Registration:</b>	N965CV
<b>Aircraft:</b>	Vought F4U-7	<b>Aircraft Damage:</b>	Substantial
<b>Defining Event:</b>	Miscellaneous/other	<b>Injuries:</b>	1 Minor
<b>Flight Conducted Under:</b>	Part 91: General aviation - Personal

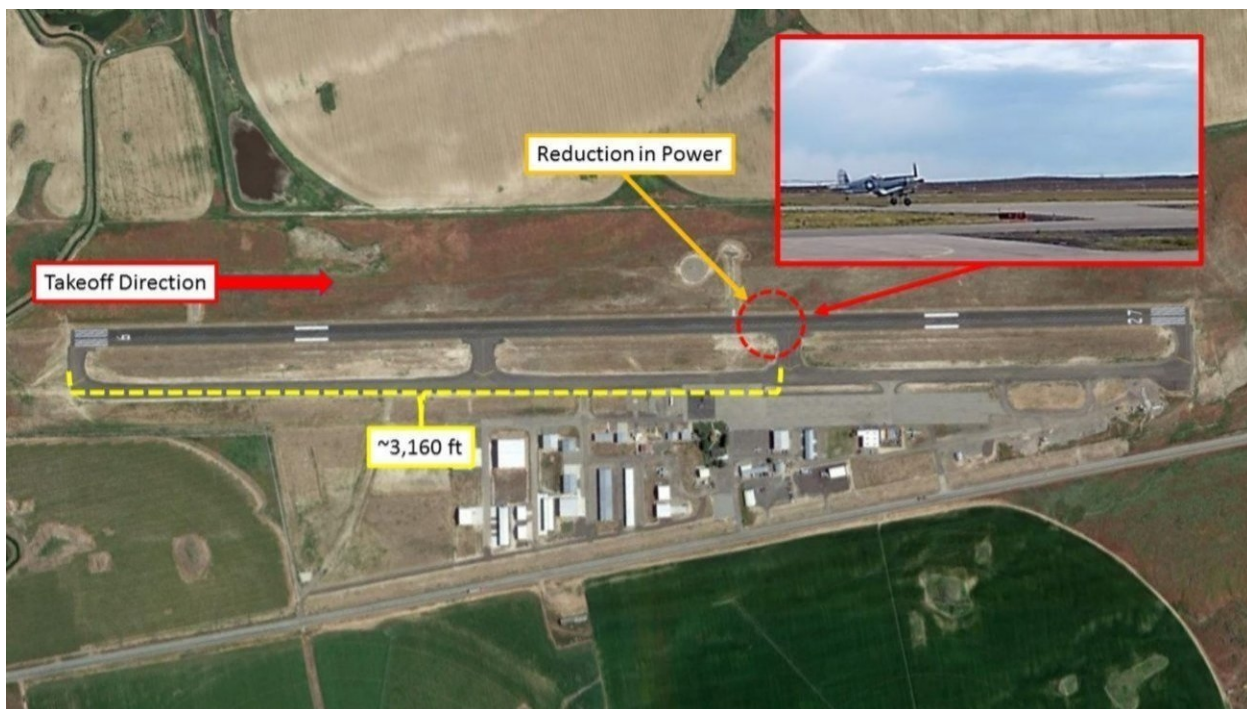
A video of the takeoff and accident sequence was captured by a witness located on the airport property. The video showed the airplane in a slight tail-low attitude during the takeoff roll. Shortly after the airplane passed the windsock and airport weather reporting station, a reduction in engine power was heard (refer to the following figure). Shortly thereafter, a streak of smoke originated from the left main

landing gear. About 3 seconds later, as the tail of the airplane transitioned onto the ground, another streak of smoke originated from the left main landing gear. The airplane was observed exiting the right side of the runway and became airborne briefly before it impacted the ground and cartwheeled.

Figure 1: Diagram showing the area where a reduction of power was heard along with a screen shot from the captured video.
