# Aviation Investigation Final Report

<b>Location:</b>	Hemet, California	<b>Accident Number:</b>	WPR19FA161
<b>Date &amp; Time:</b>	June 8, 2019, 09:38 Local	<b>Registration:</b>	N123GN
<b>Aircraft:</b>	Lockwood AIRCAM	<b>Aircraft Damage:</b>	Substantial
<b>Defining Event:</b>	Aircraft structural failure	<b>Injuries:</b>	1 Fatal
<b>Flight Conducted Under:</b>	Part 91: General aviation - Flight test

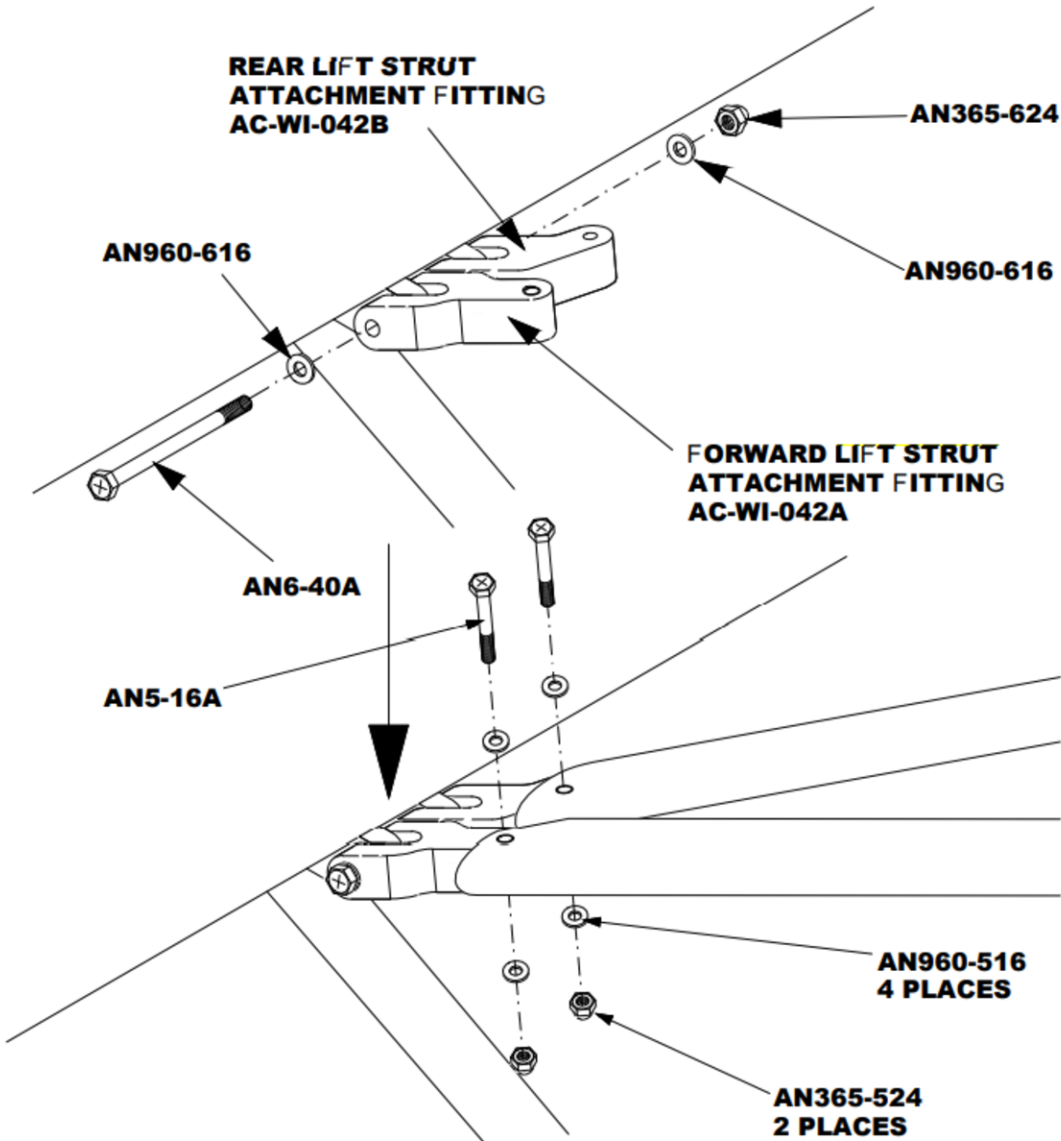
Figure 1: Lift Strut to Center Fuselage Construction Drawing

According the Aircam Construction manual, Section 12, “Airframe Assembly & Rigging,” (See figure 1) the wings are secured to the fuselage by forward and rear lift struts that are bolted to attachment fittings on the center fuselage. During construction, the builder must lift the wing and fit the forward strut over the attachment fitting and then insert an AN5-16A bolt through the strut and attachments and secure them with AN960-516 washers and AN365-524 nuts torqued to 30 inch-lbs.

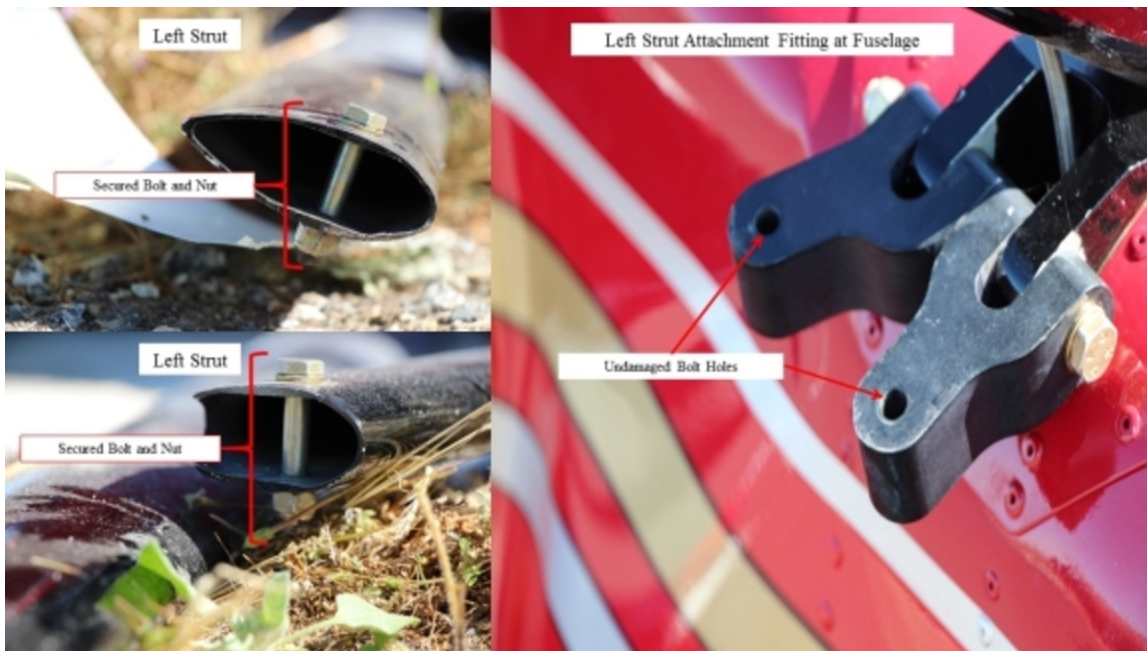
The forward and rear left-wing lift struts remained connected to the wing but were not attached to the fuselage attachment fittings. Further examination revealed that the bolts were present and secured to the lift struts with washers and nuts but had not been connected to the fuselage through the attachment fittings (See figure 2). The fittings on the fuselage were intact, and their corresponding bolt holes were undamaged. The forward and rear right-wing strut were properly attached to the fuselage attachment fittings and the hardware was secure.

**Figure 2:** The left picture shows the left-wing strut attachment fitting ends, and the right picture shows the fuselage attachment fittings as found at the accident site.

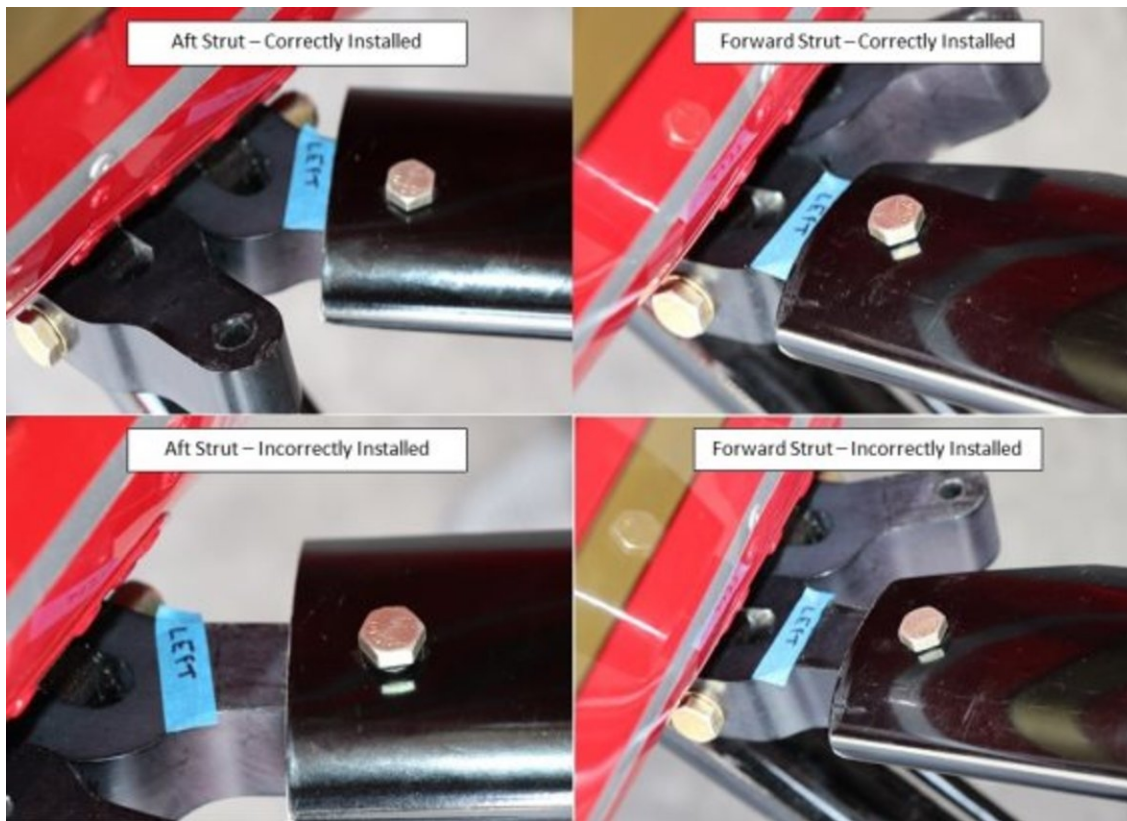
Examination of the airplane revealed that the AN5-16A bolts had been secured to each strut with the appropriate washers and nuts. However, the lift strut attachment fittings were not damaged. During a subsequent test, the struts felt secure after they were reinstalled to the lift strut attachment fittings, as they were during the accident flight, without the bolts running through the lift strut attachment fittings. The struts were then reinstalled with the bolts running through both the lift struts and attachment fittings in accordance with the manufacturer's rigging manual and felt secure when the investigators tried to pull

it from the fitting. The attachment fitting was taped during the examination to show the differences between the appearance of the assembly when the struts are correctly and incorrectly installed to the fitting (See figure 3).

**Figure 3:** Photograph showing the left forward and aft wing strut installation with both bolts incorrectly and correctly installed in the attachment fitting bolt holes.
