# Aviation Investigation Final Report

<b>Location:</b>	Butler, Missouri	<b>Accident Number:</b>	CEN19FA161
<b>Date &amp; Time:</b>	June 10, 2019, 10:20 Local	<b>Registration:</b>	N622MM
<b>Aircraft:</b>	Cessna 425	<b>Aircraft Damage:</b>	Destroyed
<b>Defining Event:</b>	Powerplant sys/comp malf/fail	<b>Injuries:</b>	1 Fatal
<b>Flight Conducted Under:</b>	Part 91: General aviation - Personal

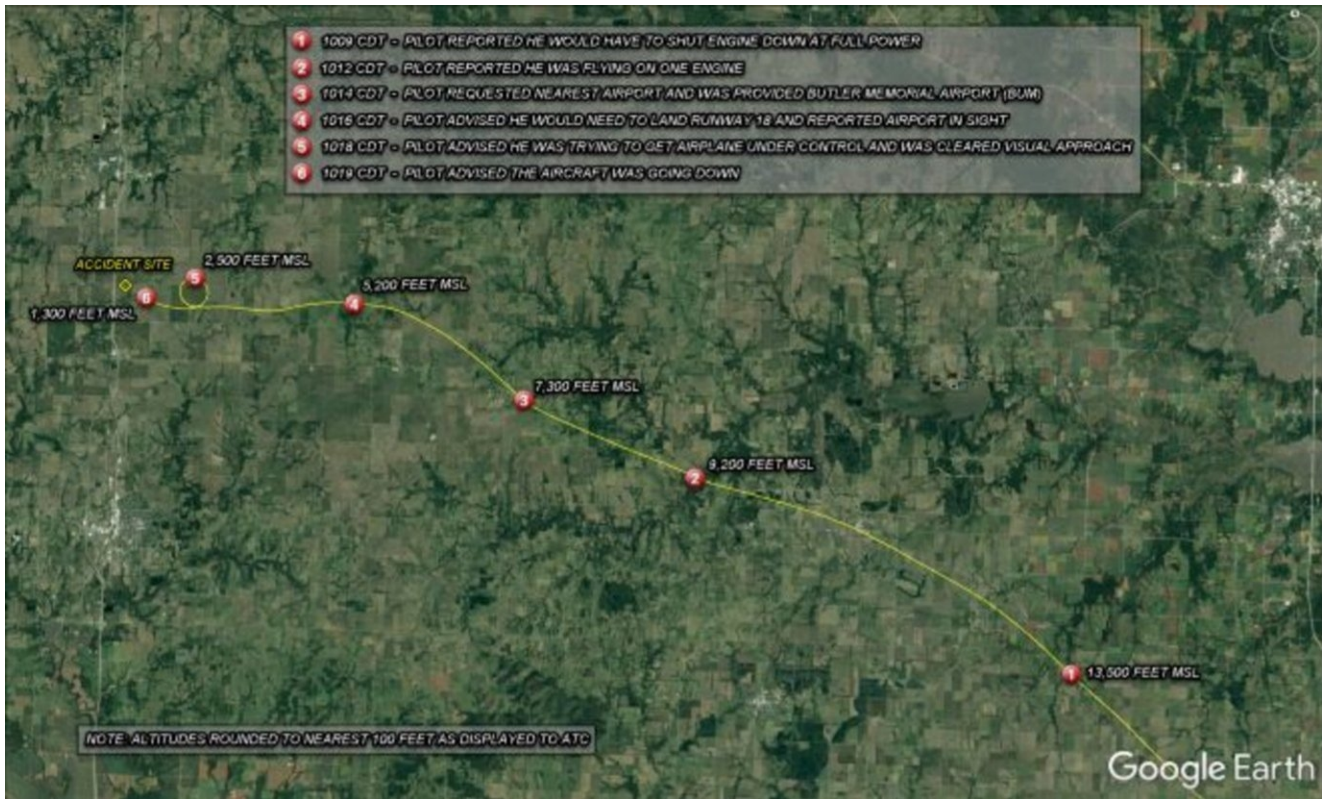
Figure 1. Flight Path

Between 1018:53 and 1019:08, the pilot advised the controller that the airplane was “gonna go down” on the highway. No further transmissions were received from the pilot. Radar data showed that the airplane made a 360° right turn when the airplane was at an altitude of about 2,500 ft mean sea level, as shown in figures 1 and 2. The last radar data point was recorded when the airplane was at 1,300 ft mean sea level.

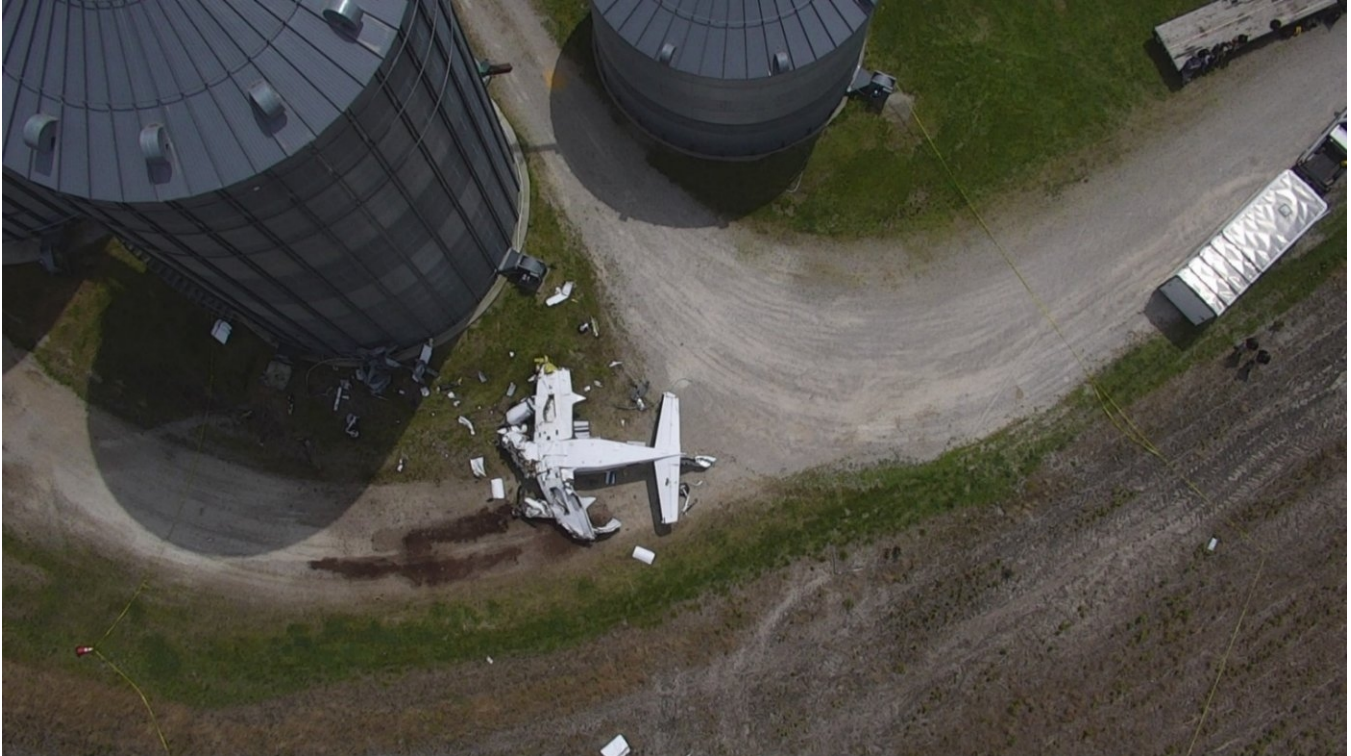
Figure 3. Aerial View of Accident Site

The airplane initially impacted a gravel road with the right wing tip in a nose-down, right-wing-low attitude. The right engine/nacelle impacted the ground between the gravel road and a 100-ft-tall grain silo. The left wing struck a steel staircase on the exterior of the silo. The left and right main landing gear also contacted the silo. Rubber tire transfer marks were observed about 20 and 30 ft up the silo steel structure. A small fragment of airplane aluminum was found attached to the silo about 30 ft up. One of the left propeller blades contacted the silo about 15 ft up and left a black, white, and red paint smear on the silo surface. The nose of the airplane struck an air cycle machine at the base of the silo before as the airplane impacted the ground. The airplane then cartwheeled onto the left engine and came to rest inverted about 30 ft from the initial impact point, as shown in figure 3.
