# Aviation Investigation Final Report

<b>Location:</b>	New York, New York	<b>Accident Number:</b>	ERA19FA191
<b>Date &amp; Time:</b>	June 10, 2019, 13:40 Local	<b>Registration:</b>	N200BK
<b>Aircraft:</b>	Agusta A109	<b>Aircraft Damage:</b>	Destroyed
<b>Defining Event:</b>	Loss of visual reference	<b>Injuries:</b>	1 Fatal
<b>Flight Conducted Under:</b>	Part 91: General aviation - Executive/Corporate

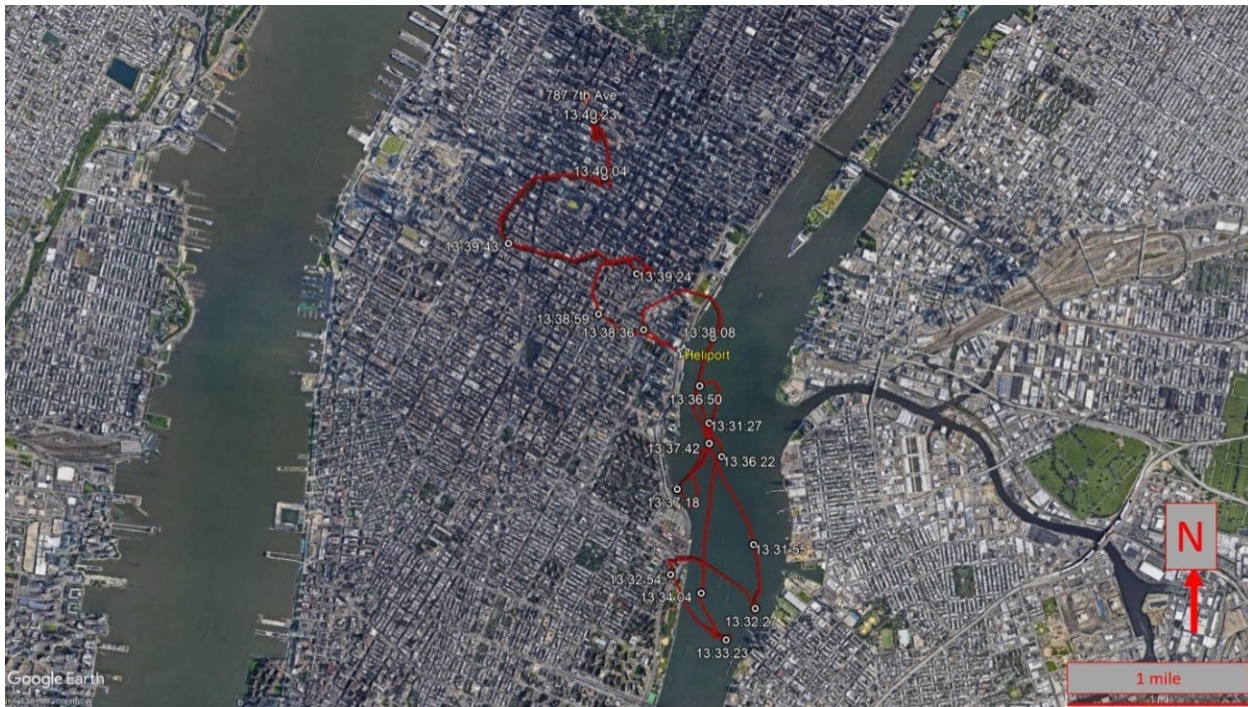
Figure 1 - Helicopter Ground Track

A review of automatic dependent surveillance - broadcast (ADS-B) data from the Federal Aviation Administration (FAA) revealed that the helicopter departed and initially flew south over the East River before changing course northward. About 5 to 7 minutes after departure, the pilot contacted the FBO and requested to return to the heliport. He was advised to land on pad No. 4. The pilot then radioed that he “did not know where he was.” The helicopter flew erratically over the East River, changed course and altitude several times before making a 270° turn, which approached 6N5 from the west. About 500 ft west of 6N5, at an altitude of 600 to 700 ft mean sea level (msl), the helicopter reversed course and flew erratically over Manhattan before impacting the roof of a 54-story building at 787 7<sup>th</sup> Avenue. The last recorded position of the helicopter was about 0.1 nautical mile southeast of the building at an altitude of about 1,570 ft msl. The overall height of the building above the street was about 790 ft msl, with the roof section where the helicopter came to rest (below the exterior walls and catwalks surrounding the perimeter of the roof), about 765 ft msl.
