Aviation Investigation Final Report

Location:	Addison, Texas	Accident Number:	CEN19MA190
Date & Time:	June 30, 2019, 09:11 Local	Registration:	N534FF
Aircraft:	Textron Aviation B-300	Aircraft Damage:	Destroyed
Defining Event:	Loss of control in flight	Injuries:	10 Fatal
Flight Conducted Under:	Part 91: General aviation - Personal

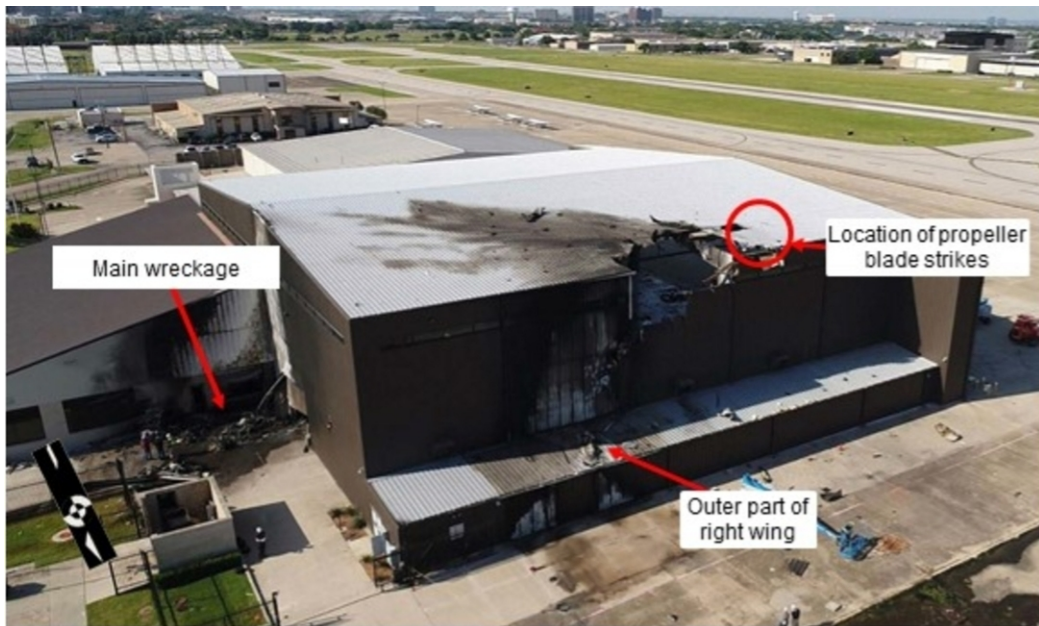
Figure 2. Photograph of an aerial view of the accident site

Propeller blade strikes (see figures 2 and 3) were observed at the airplane's initial point of impact including a strike to a hangar roof truss, which was coated white. Evidence indicates that the strikes were made by the left propeller. The distances between the propeller blade strikes were measured to determine propeller speed at impact (see figure 3). The left propeller's speed at impact was estimated at 1,259 to 1,300 rpm.
