# Aviation Investigation Final Report

<b>Location:</b>	Addison, Texas	<b>Accident Number:</b>	CEN19MA190
<b>Date &amp; Time:</b>	June 30, 2019, 09:11 Local	<b>Registration:</b>	N534FF
<b>Aircraft:</b>	Textron Aviation B-300	<b>Aircraft Damage:</b>	Destroyed
<b>Defining Event:</b>	Loss of control in flight	<b>Injuries:</b>	10 Fatal
<b>Flight Conducted Under:</b>	Part 91: General aviation - Personal

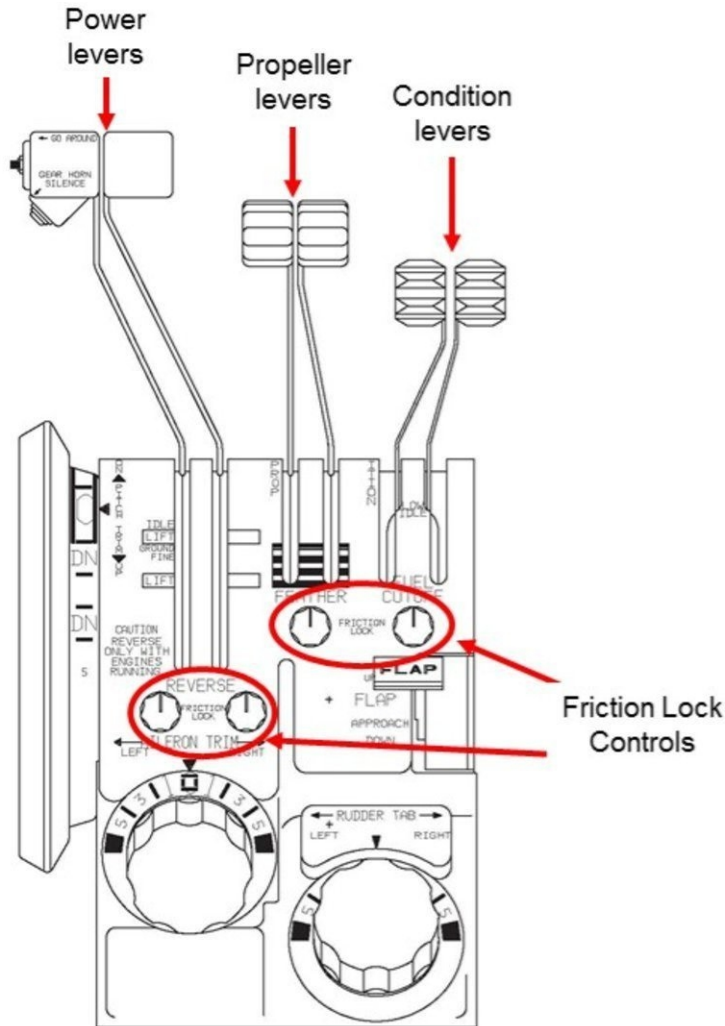
**Figure 1.** Diagram of B-300 Engine and Propeller Controls

The engine and propeller control levers on the accident airplane model are located between the two cockpit seats. The power quadrant includes two power levers (which controls engine power from idle through takeoff) and two propeller levers (which control propeller speed and feathering) to the right of the power levers. Two engine condition levers are to the right of the propeller levers and have three positions: FUEL CUTOFF, LOW IDLE, and HIGH IDLE; the idle settings limit idle speed at 62% N1 (39,000 gas generator rpm) minimum for low idle and 70% N1 minimum for high idle. The left condition lever controls the left engine, and the right condition lever controls the right engine (see figure 1).

Friction lock control knobs are located on the power quadrant. Each power lever has its own friction lock control knob at the base of the quadrant to adjust the power levers' tension. One friction knob controls the tension of both propeller levers. Turning the knobs counterclockwise increases tension and turning them clockwise reduces tension (see Additional Information for more information on friction adjustment). The force required to move the power lever or the propeller control lever aft with the friction setting fully disengaged is 0.6 lbs and 2 lbs, respectively.

The aileron trim knob was found attached to the power quadrant, and the rudder trim knob and a section of connecting rod were found in the wreckage. No trim position indications could be determined for either knob. Damage to the control lever friction components precluded determining the friction setting during the accident flight.
