Aviation Investigation Final Report

Location:	Mosby, Montana	Accident Number:	WPR19LA194
Date & Time:	July 13, 2019, 14:30 Local	Registration:	N3078G
Aircraft:	Bell 47G 3B 1	Aircraft Damage:	Substantial
Defining Event:	Loss of control in flight	Injuries:	2 Serious, 1 Minor
Flight Conducted Under:	Part 91: General aviation - Aerial observation

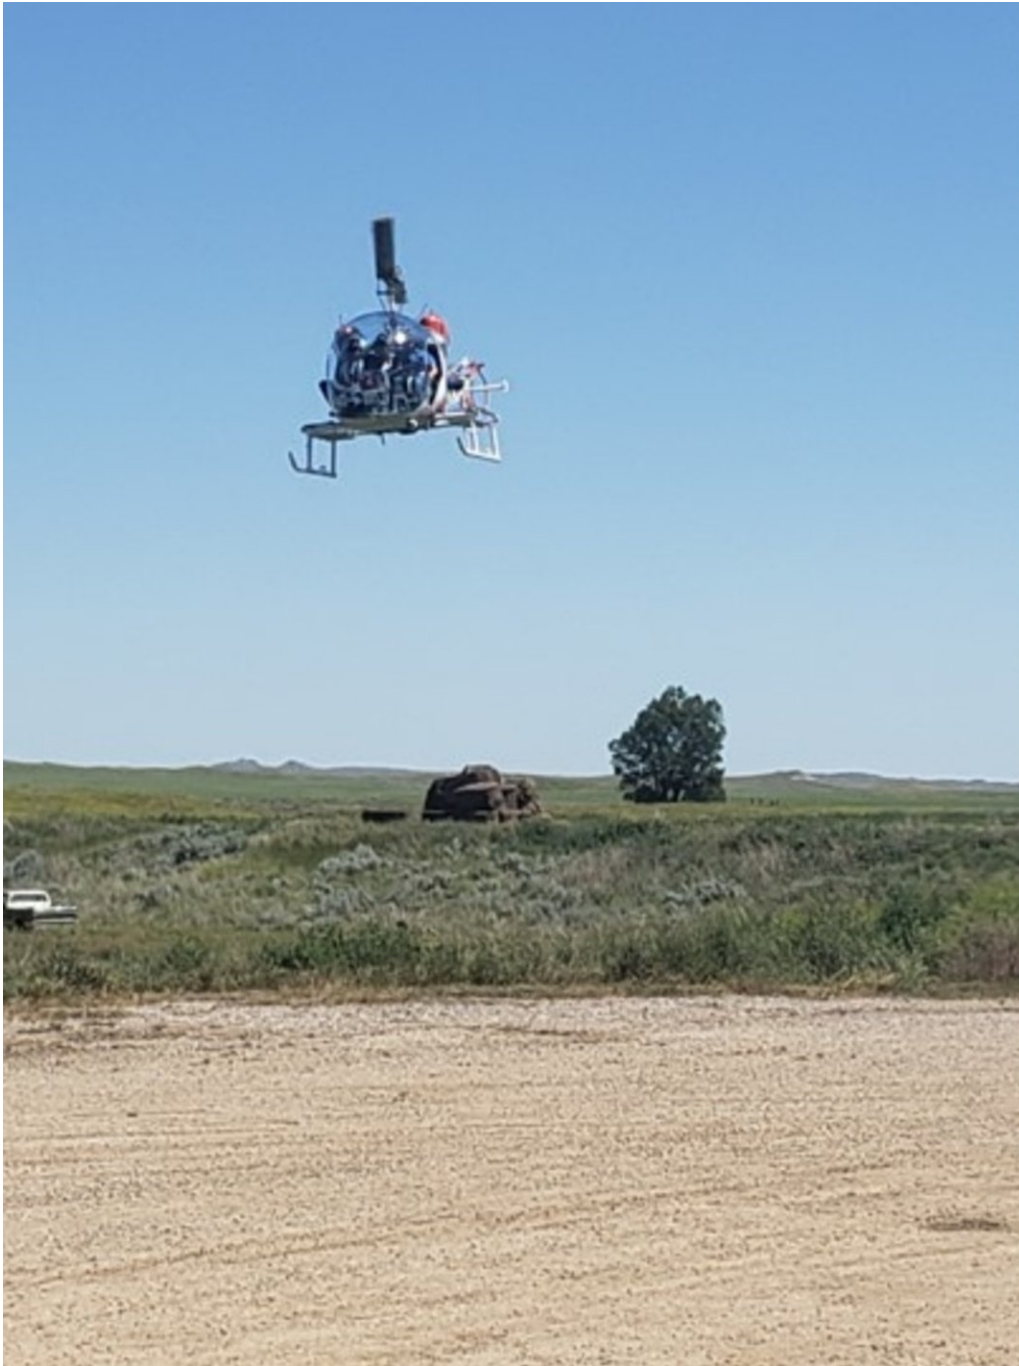
During the approach, the helicopter was operating in a high-power demand condition due to high density altitude, high gross weight, and while near the out-of-ground effect boundary and at a slow airspeed. These conditions reduced the amount of yaw control effectiveness available to counter an uncommanded right yaw. Additionally, the pilot's selected approach path placed the helicopter on the leeward side of a building and likely exposed the helicopter to disturbed air that disrupted the airflow entering the main rotor and tail rotor and initiated the uncommanded right yaw/loss of tail rotor effectiveness.

One passenger stated that the helicopter pitched from side to side and then the tail came around twice. He stated that the pilot tried to climb and as the helicopter was going up, it was still spinning. The other passenger recalled that they were approaching the building and the helicopter swung to the right and started to ascend above the building. A witness located near the building reported that the helicopter approached from the east and looked normal until it was about 30 to 40 ft above the ground. He said that the helicopter turned right, then left, and back to the right before it ascended and flew directly over his position. The witness photographed the helicopter as it began to yaw to the right. (see Figure 1.)

Figure 1. Photograph of the helicopter as it began the uncommanded right yaw. Photo courtesy of a witness.
