# Aviation Investigation Final Report

| <b>Location:</b> | Seldovia, Alaska | <b>Accident Number:</b> | ANC19FA035 |
| <b>Date &amp; Time:</b> | July 19, 2019, 10:10 Local | <b>Registration:</b> | N68083 |
| <b>Aircraft:</b> | De Havilland BEAVER DHC 2 | <b>Aircraft Damage:</b> | Substantial |

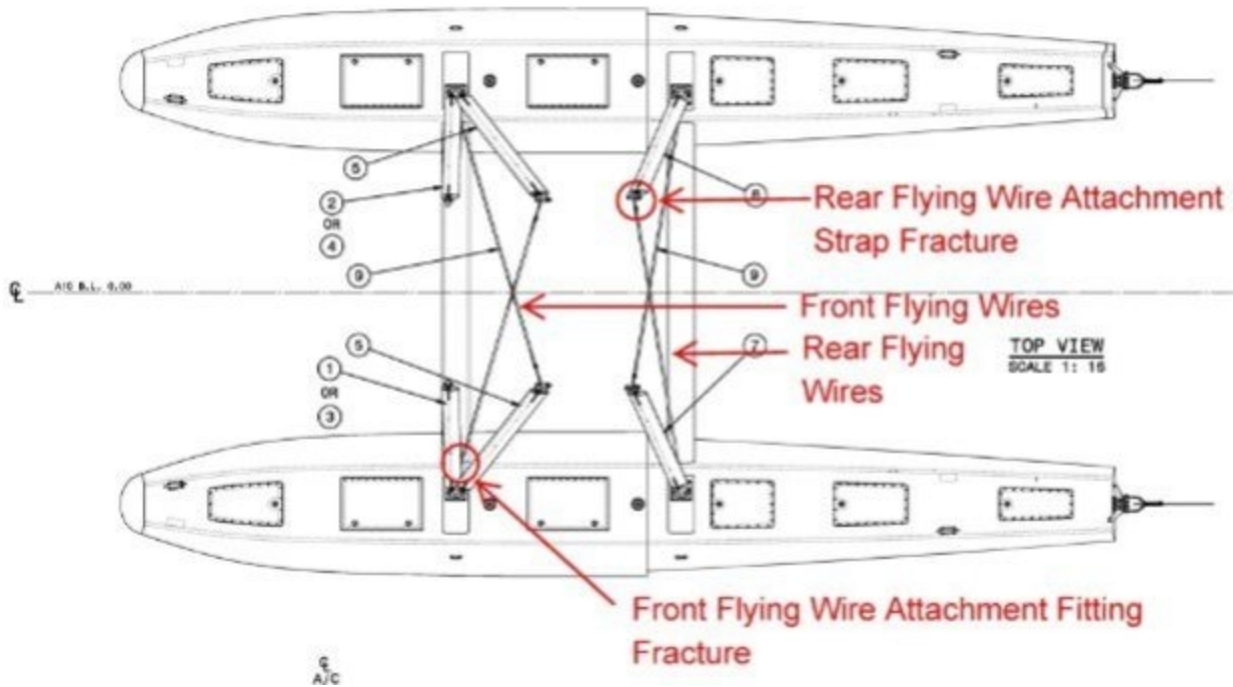
Figure 1- Float Assembly Diagram (courtesy of Aerocet)

The airplane nosed over in ocean waters and came to rest inverted. All major components were recovered except for the right wing, right aileron, and right lift strut. Flight control continuity was verified from the control yoke to the right fuselage bellcrank push/pull tube, the left aileron and elevators, and from the rudder pedals to the rudder. An examination of the floats and their attachment rigging revealed that the front left flying wire attachment fitting (attached to the left float) fractured, and the associated flying wire exhibited compression buckling signatures near the upper attachment point. The right rear flying wire attachment strap (attached to the fuselage) fractured, and the associated flying wire exhibited compression buckling signatures near the lower attach point. (See Figure 1). No significant deformation was present on the underside or nose of either float.

An examination of the aluminum flying wire attachment fittings revealed that the bolts for attaching the two left flying wire attachment fittings to the left float were bent, and the attachment hole in the intact left rear attachment fitting was elongated. Fractures in the left front attachment fitting and right rear attachment strap were consistent with ductile overstress fracture. Small areas of corrosion were observed on the fractured left forward flying wire attachment fitting; however, the total area of corrosion was a small percentage of the total cross-section, and the remainder of the fracture and associated deformation of the lug exhibited rough matte-gray features consistent with a ductile overstress fracture. In addition, small amounts of corrosion were also observed on the three intact flying wire attachment fittings.
