Aviation Investigation Final Report

Location:	Battleground, Washington	Accident Number:	WPR19LA200
Date & Time:	July 20, 2019, 16:20 Local	Registration:	N873BC
Aircraft:	Beech 33	Aircraft Damage:	Substantial
Defining Event:	Powerplant sys/comp malf/fail	Injuries:	2 None
Flight Conducted Under:	Part 91: General aviation - Personal

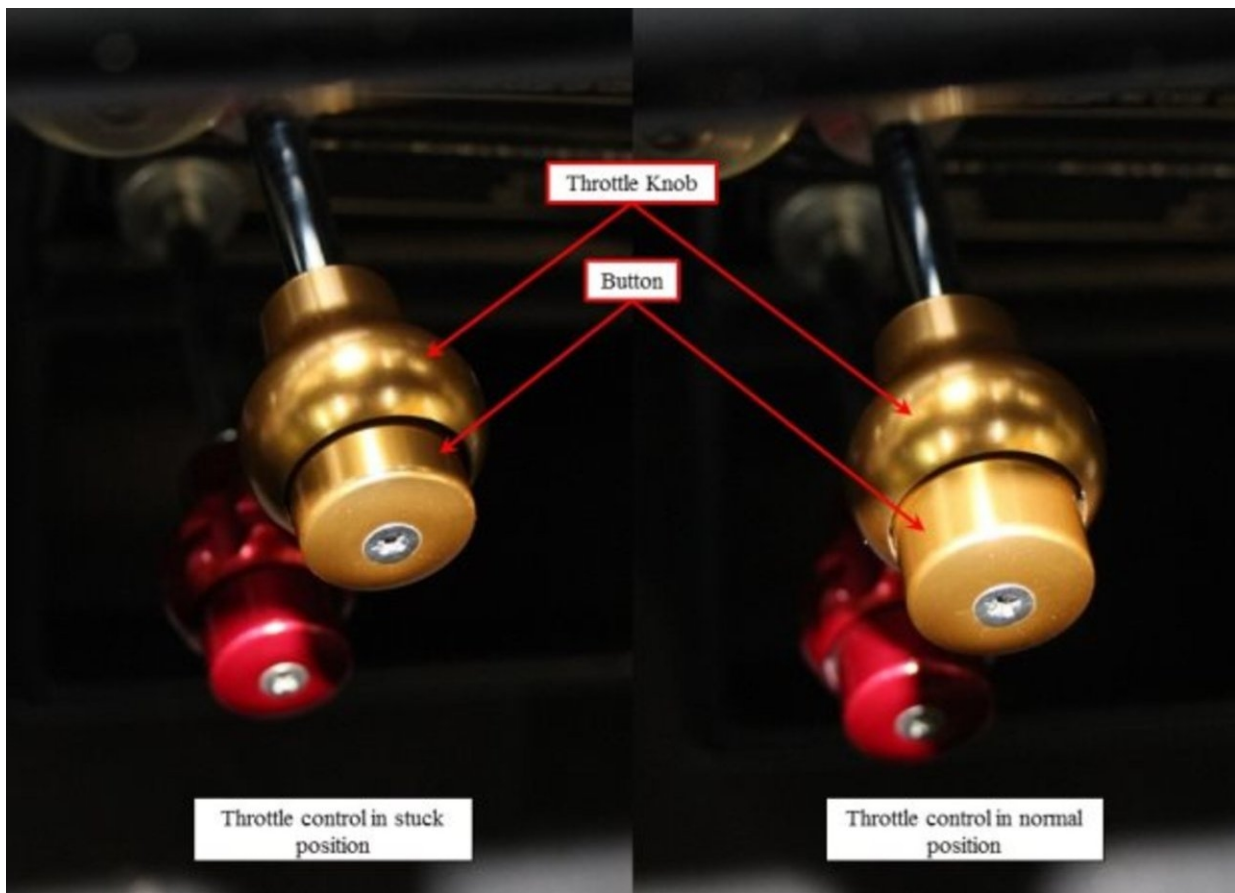
Postaccident examination of the airplane revealed no anomalies with the engine and most of the engine controls except for the throttle control. During engine runs, the throttle knob push button became intermittently stuck in a depressed position. Normally, turning the throttle knob counterclockwise from this position would reduce power; however, during the postaccident engine runs, a corresponding minor increase in power was observed. Although disassembly of the throttle mechanism revealed a loose nut in the throttle control assembly, it likely did not contribute to the throttle failure, as the nut would not have affected the knob's use to make power adjustments. Further, the throttle control could still be manipulated by rotating the throttle knob during the postaccident engine run.

Based on the pilot's practices, it is likely that the pushbutton became partially depressed when the pilot reduced the engine power to descend while inbound to his home airport. When the pilot realized the airplane had not decelerated and attempted to make a minor power adjustment by rotating the throttle knob counterclockwise, the throttle control failed, and the pilot either experienced sustained or a subtle increase in engine power, which resulted in a runway overrun and impact with an obstacle. The reason for the failure of the throttle control assembly could not be determined based on available evidence.

A second engine run was accomplished to examine the security of the throttle control mechanism. During this test, the throttle was reduced from 1,800 rpm to 800 rpm using the pushbutton mechanism, which became stuck in a halfway depressed position. With the button stuck in this position, an engine power reduction was attempted by rotating the knob counterclockwise. This movement would normally reduce engine power; however, only a corresponding minor increase in power was observed. This test was repeated multiple times with the same result.

Figure 1: Throttle Control in Both Stuck and Normal Positions

Disassembly of the throttle mechanism revealed that the spring and washer were present and had been installed correctly. The spring did not display any debris or anomalous wear that could have inhibited its movement. The throttle cable was secured with the nut and washer; however, the nut was loose and could be easily manipulated by hand. According to the manufacturer, a loose nut would prevent the knob from being held against the throttle shaft. This could allow the knob to spin freely when rotated by the pilot, thus preventing the throttle cable from moving in and out. If the nut was completely loose, the knob could separate from the throttle shaft. However, the loose nut would generally not impact the functionality of the button if the knob was not near the point of separation.
