Aviation Investigation Final Report

Location:	Boston, Massachusetts	Incident Number:	DCA23LA192
Date & Time:	February 27, 2023, 18:54 Local	Registration:	N280LJ (A1); N179JB (A2)
Aircraft:	LEARJET INC 60 (A1); Embraer ERJ 190-100 IGW (A2)	Aircraft Damage:	None (A1); None (A2)
Defining Event:	Runway incursion veh/AC/person	Injuries:	N/A (A1); N/A (A2)
Flight Conducted Under:	Part 91: General aviation - Positioning (A1); Part 121: Air carrier - Scheduled (A2)

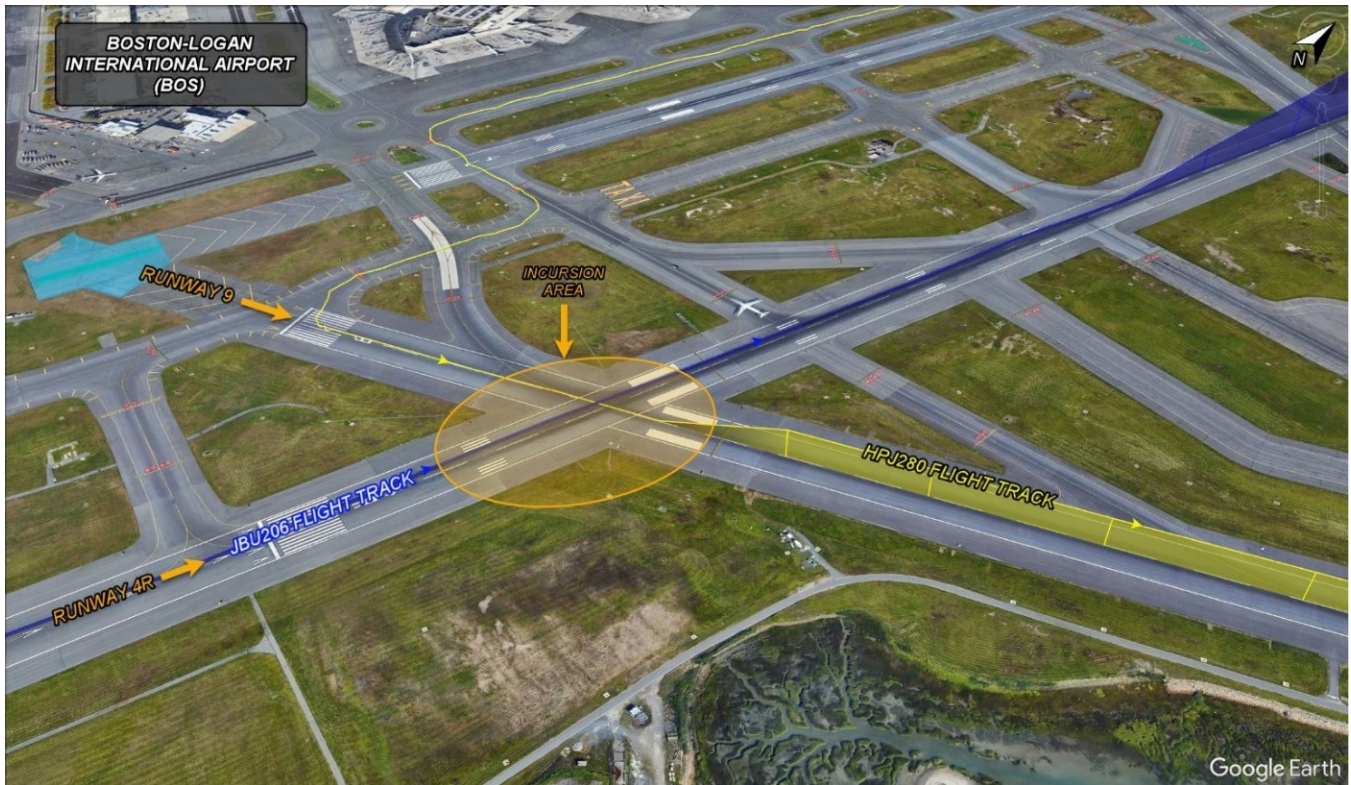
JBU206’s flight crew initiated a go-around while over runway 04R, prior to reaching the intersection with runway 09. The closest proximity between both airplanes occurred when JBU206 was about 30ft AGL during the landing flare, close to the point where both runways intersected, see figure 1. A video file taken by the occupant of the flight deck observer seat was provided to the NTSB and a screen capture from the video is shown in figure 2.

Figure 1. Flight tracks of both JetBlue (JBU206) and Hop-a-Jet (HPJ280) with yellow circle indicating incursion area.

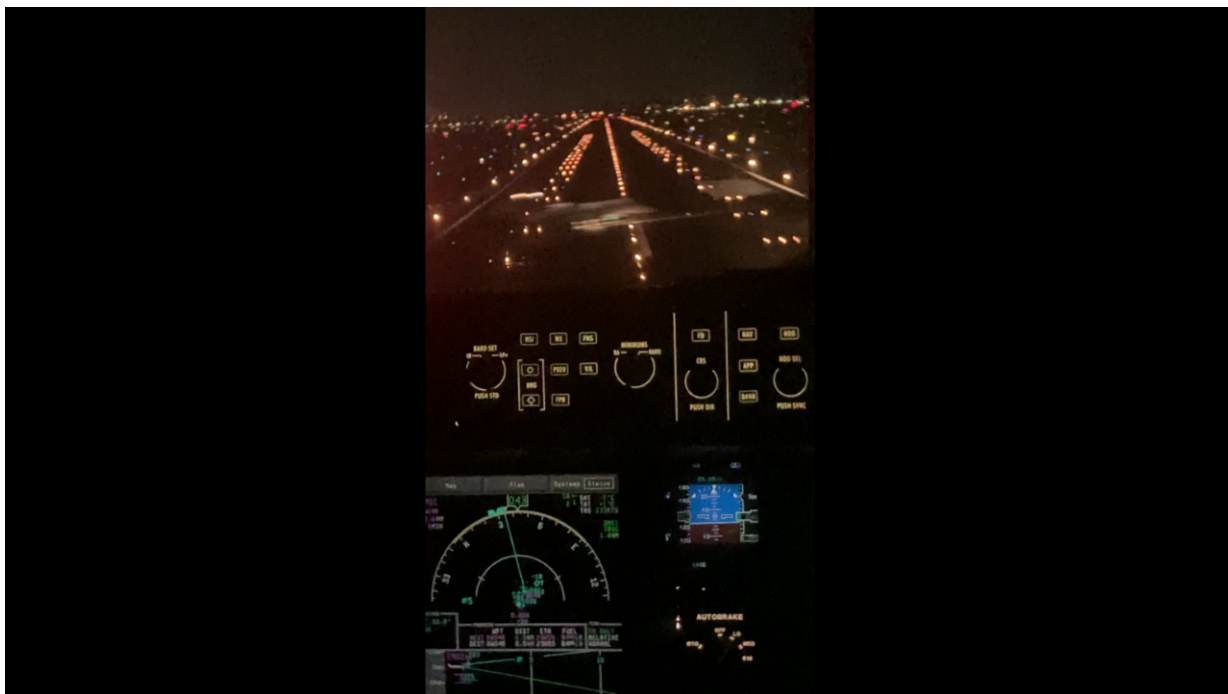
Figure 2: Screen capture from jump-seat occupant's video recording showing Lear 60 crossing runway centerline.
