Runway Overrun During Rejected Takeoff
Ameristar Air Cargo, Inc.,
dba Ameristar Charters, flight 9363
Boeing MD-83, N786TW
Ypsilanti, Michigan
March 8, 2017

Accident Report

NTSB/AAR-19/01
PB2019-100293

Aircraft Accident Report

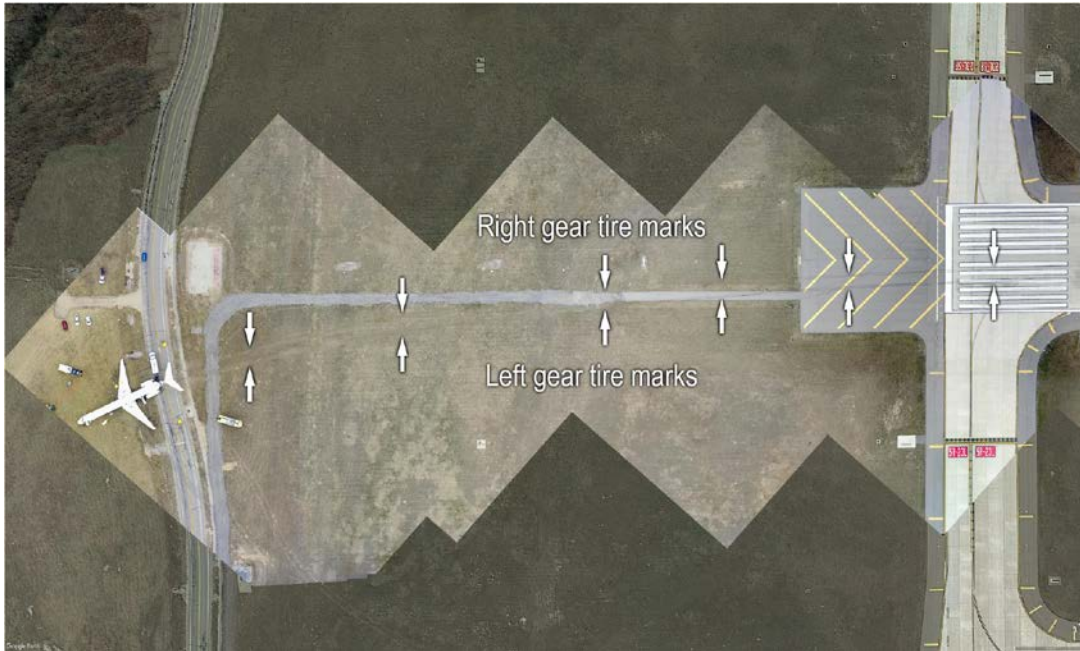
At 1452:23, the CVR captured sounds consistent with the airplane’s excursion from the paved surface. The airplane exited the paved surface off the departure end of runway 23L (including a 200 ft blast pad) and traveled about 950 ft across the grassy part of the runway safety area (RSA) before striking the airport perimeter fence and a raised, paved road before coming to a stop. The airplane came to rest on the fuselage belly with the tail on the road, about 1,150 ft west-southwest of the end of the runway (see figures 1 and 2).

Figure 1. Orthomosaic image of the airplane’s path from the end of runway 23L to its final location.

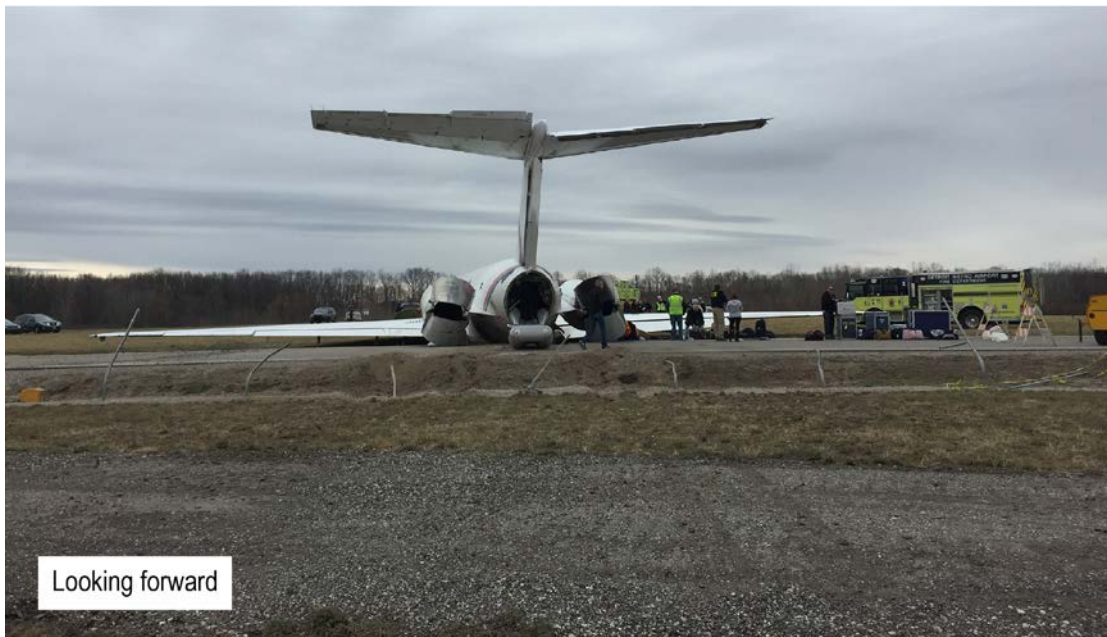
Figure 2. Rear view of the airplane wreckage.

As described in section 1.1, the airplane ran through the airport perimeter fence and struck a raised, paved road before coming to a stop with the tail resting on the road. The nose landing gear and both main landing gear were bent, fractured, and displaced aft; all examined fracture surfaces exhibited features consistent with overstress. The fuselage lower skin panel assemblies, including longeron and frames, exhibited severe buckling, deformation, missing sections, and severed internal structure at several locations; the damage was consistent with ground impact after the collapse of the landing gear.

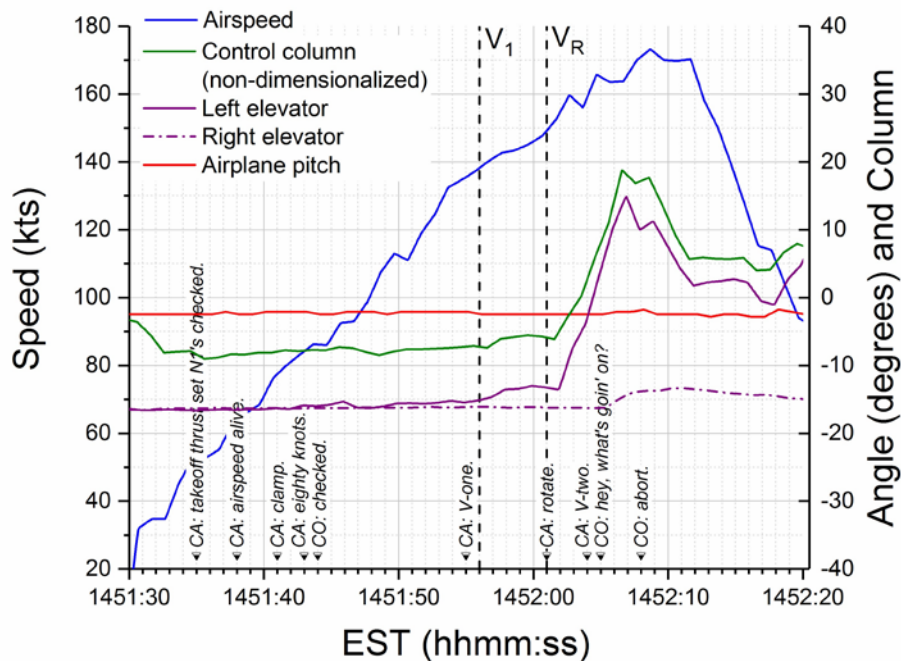
Five seconds later, at 1452:01 (when the check airman called “rotate”), the airspeed was about 151 kts, and a large control column input was applied over the next 8 seconds. The left elevator moved to about 15° TEU, and the right elevator remained about -16° TED until the last 3 seconds of maximum control column input, at which time the right elevator moved to about -13° TED. The airplane did not respond in pitch and did not rotate (see figure 10).

Figure 10. Airplane performance parameters over time.

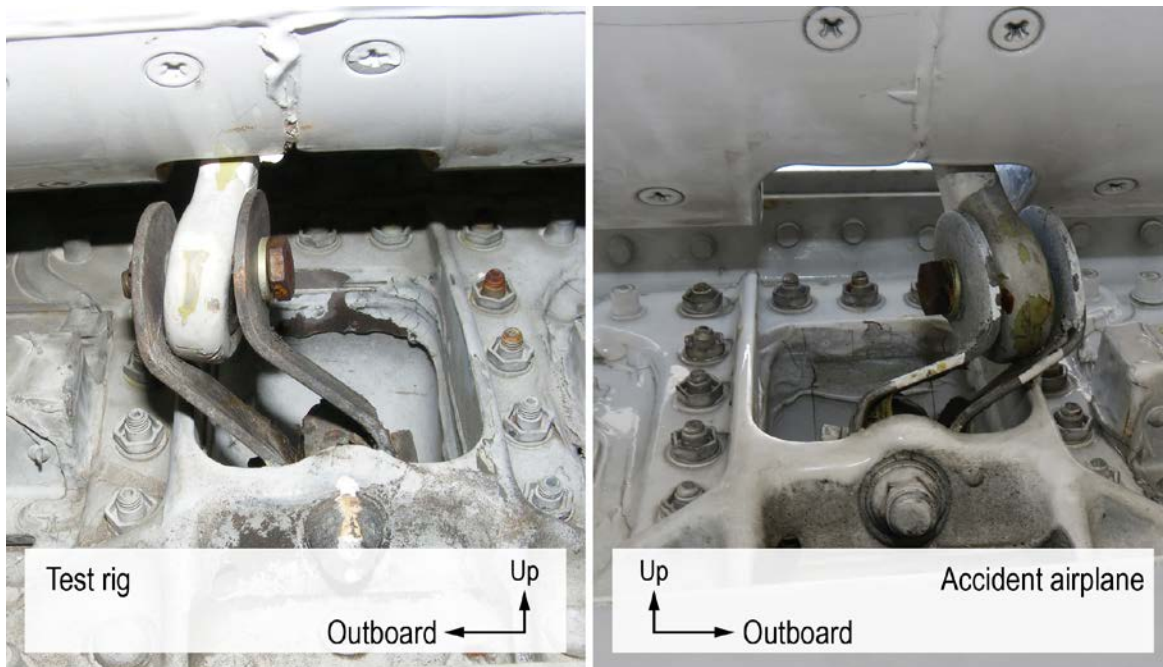
After the completion of the dynamic tests (described in the previous section), investigators sought to determine if adding a lifting force (to simulate airplane-nose-up air loading that would develop during the takeoff roll) would result in damage to the geared tab actuating crank and links similar to the damage observed on the accident airplane. With the geared tab inboard linkage in an overcenter position, an upward force was applied to hinge locations on the control tab. When the load cell reached about 800 lbs, the links began to fail; the load cell peaked at 975 lbs before the links completely bent outboard (see figure 15).

Figure 15. Damage to the left geared tab inboard links and actuating crank (left) after load testing versus damage observed postaccident on the accident airplane’s right geared tab inboard links and actuating crank (right).
