Aviation Investigation Report AIR-24-07

In-Flight Collision During Air Show Commemorative Air Force Boeing B-17G, N7227C, and Bell P-63F, N6763

Dallas, Texas
November 12, 2022

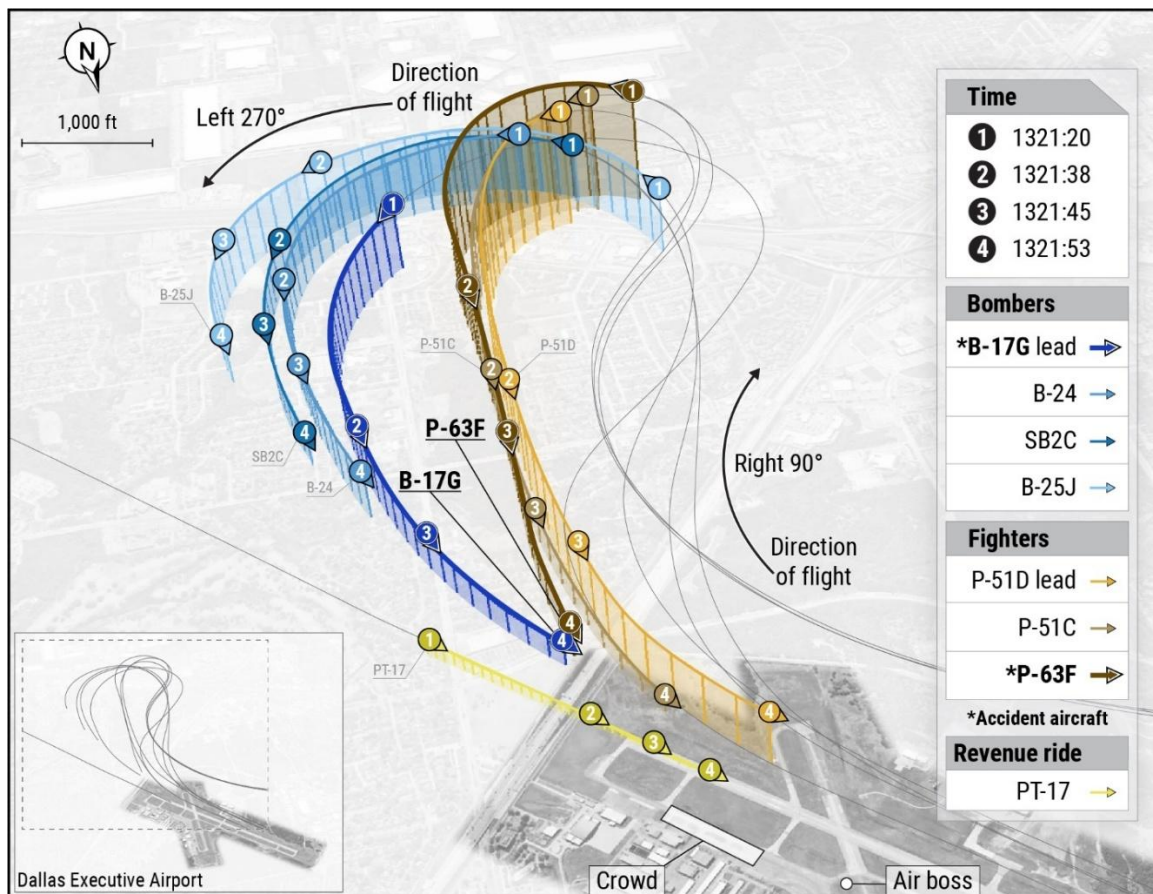
Position data for the Boeing B-17G and the Bell P-63F ended at 1321:53, when the airplanes had a lateral separation of about 150 ft at nearly the same altitude. An oblique view plot from the performance study shows the airplanes' relative positions throughout the final turn and descent that preceded the collision (see figure 7).

Figure 7. Oblique view (looking southwest) showing the airplanes' descending flight paths during the final turn up to 1321:53.

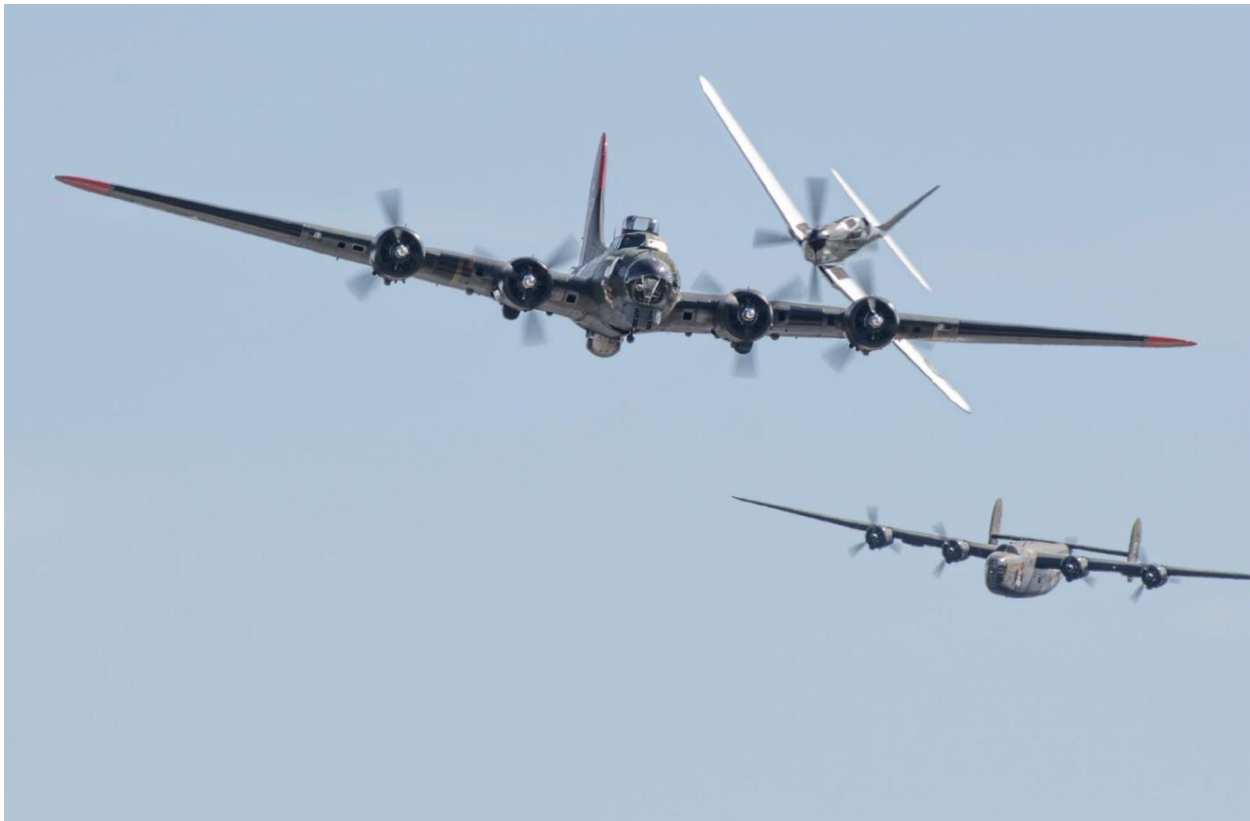
A witness in the crowd with a hand-held camera captured video that showed the collision. The video showed that each of the three fighters approached the show lines from a left turn, that is, in a left roll with flight deck canopies angled away from the Boeing B-17G (see section 1.8.2.2 for more information). A photograph taken by another witness in the crowd showed the relative positions of the Boeing B-17G, Bell P-63F, and the position 2 bomber before the collision (see figure 8).

Figure 8. Photograph showing, from left to right, the accident Boeing B-17G, accident Bell P-63F, and position 2 bomber before the collision. (Source: Gary Daniels)

Note: The Bell P-63F is in a left turn behind and off the left side of the Boeing B-17G and is ahead of the position 2 bomber.

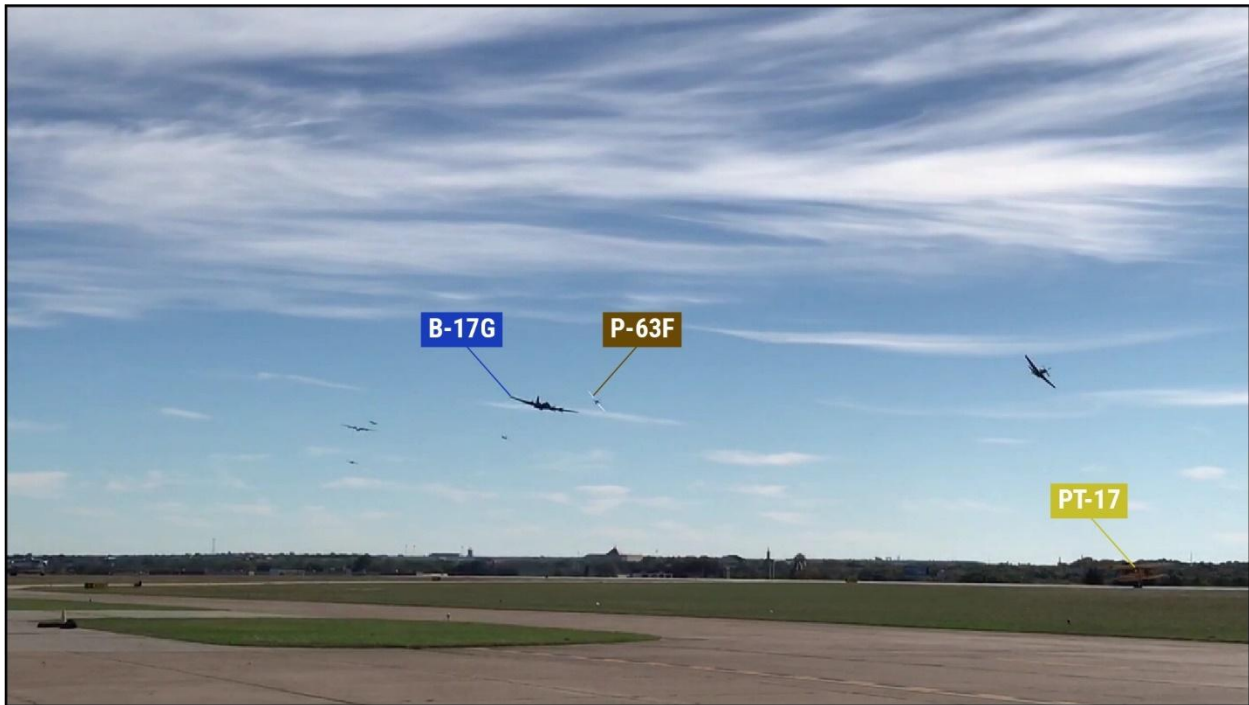
The video began 4.5 seconds before the collision and captured imagery at a rate of 30 frames per second. The video analysis was performed from video time 1.4 seconds to video time 4.5 seconds because the visibility of the Bell P-63F during the first 1.4 seconds of the video was poor. A still frame from the video at 0.63 seconds before the collision showed the Bell P-63F in a left turn behind and off the left side of the Boeing B-17G (see figure 11).

Figure 11. Video frame recorded 0.63 seconds before the collision showing the Bell P-63F in a left turn behind and off the left side of the Boeing B-17G. The revenue ride flight Boeing PT-17 is on the runway.

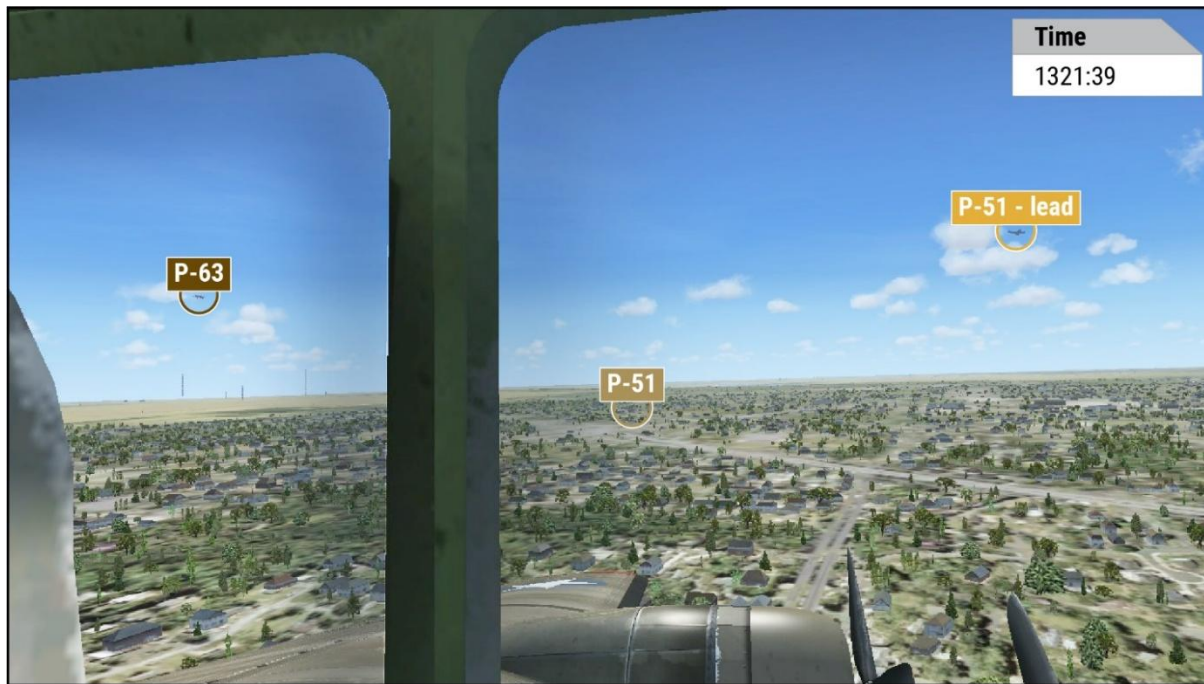
The visibility simulation determined that, at 1321:39 (which corresponds with the time that the air boss asked the Boeing B-17G crew if they could see the fighters in front and off to the left), the simulation showed that the model fighter lead and position 2 fighter were in view through the model Boeing B-17's forward left side window, and the model Bell P-63 was visible through the aft left side window (which, in the Boeing B-17G, would be behind the pilot's left shoulder) (see figure 15).

Figure 15. Simulation view from the flight deck left side windows of the model Boeing B-17 at 1321:39, showing the respective locations of the three model fighters.

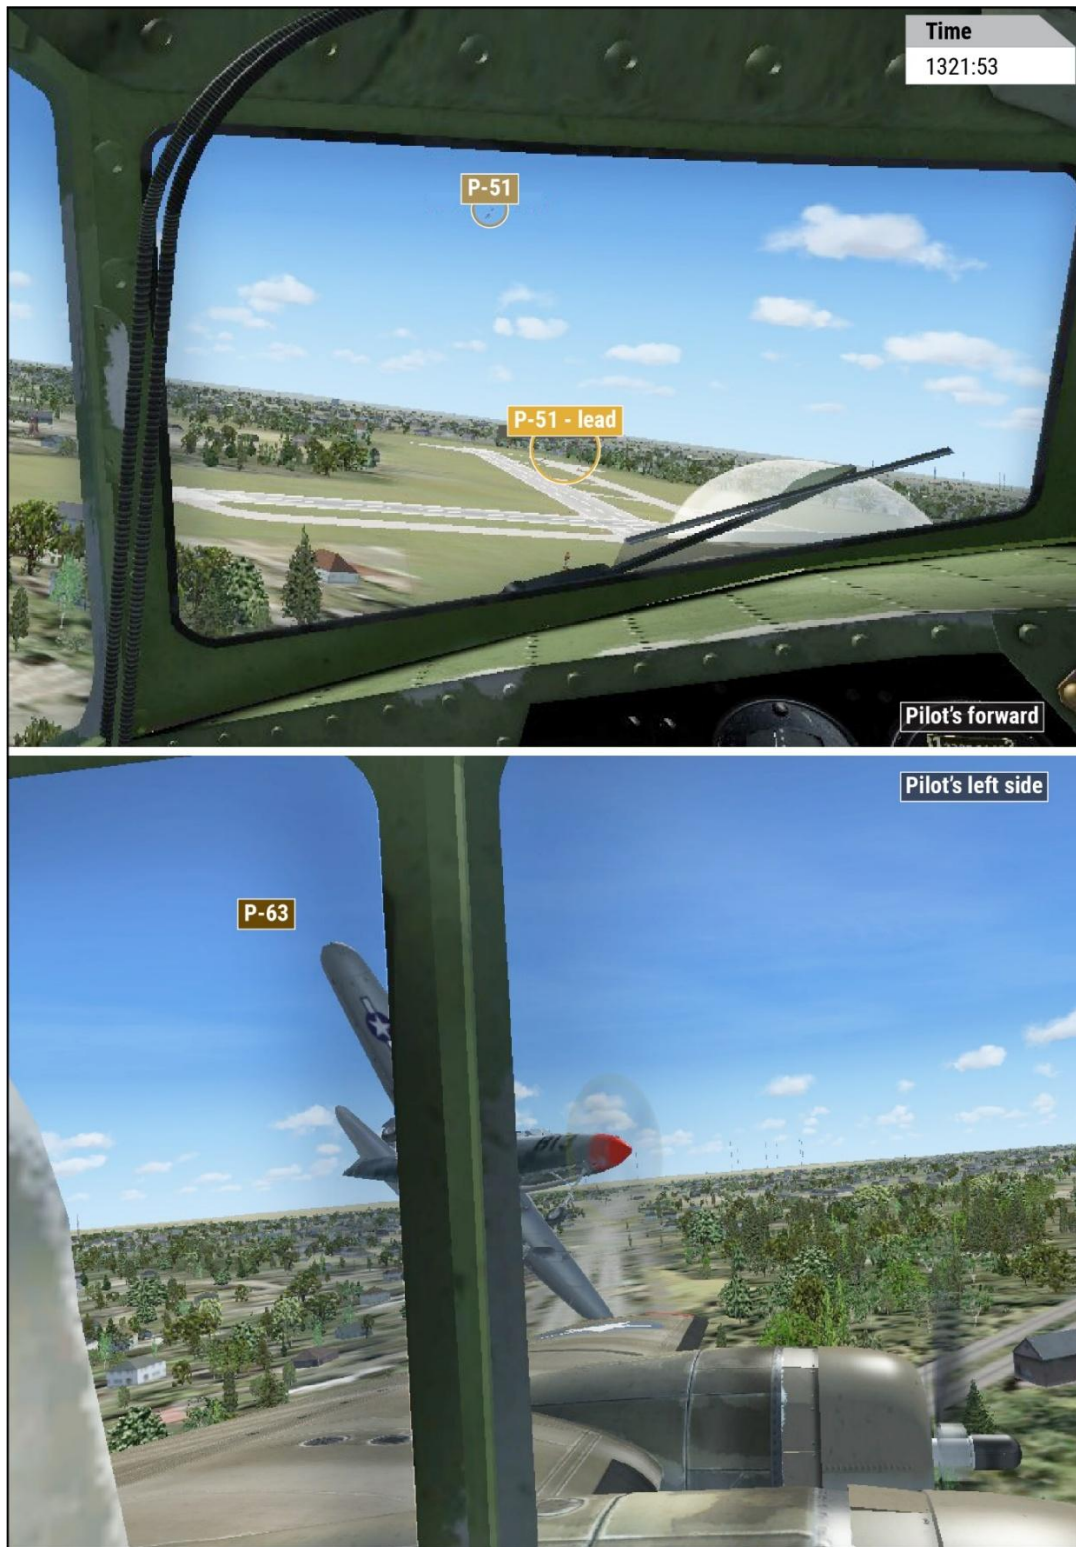
From 1321:44 to 1321:52, the view of the model Bell P-63 was obscured by the structure between the model Boeing B-17's forward and aft left side windows.²⁸ The model Bell P-63 could not be seen again in any view from the model Boeing B-17's flight deck until 1321:53, when it became rapidly visible from the left side windows (see figure 16).

²⁸ Examination of an exemplar Boeing B-17 flight deck showed that the pilot's seat back was even with the structure between the forward and aft left side windows.

Figure 16. Pilot's forward (top image) and left side (bottom image) simulation views from the model Boeing B-17 flight deck at 1321:53, showing the respective locations of the three model fighters.

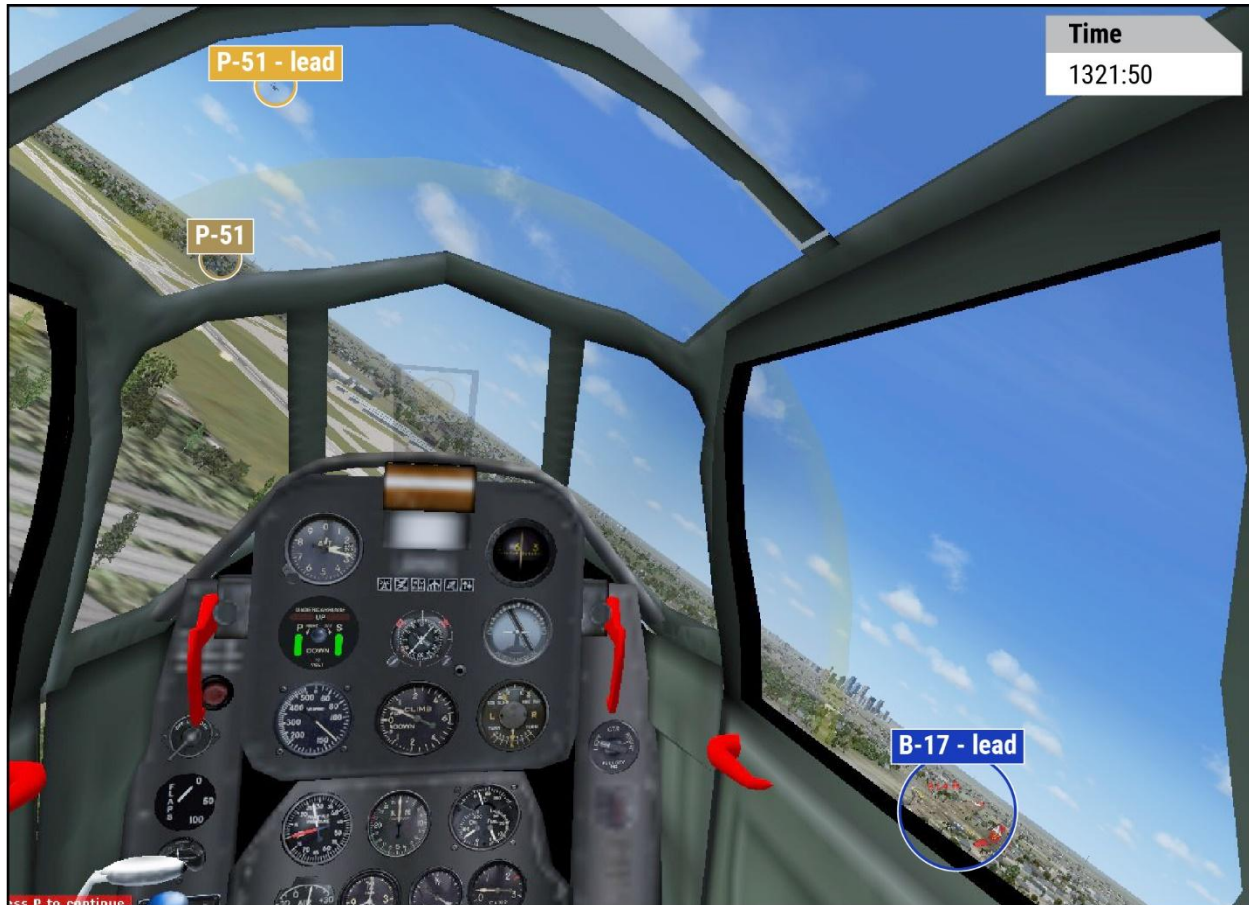
The visibility simulation determined that the model Boeing B-17 was visible from the model Bell P-63's flight deck from 1321:22 to 1321:24 (visible through the front window) and from 1321:34 to 1321:50 (visible through the right side window), but it was likely blocked from view from 1321:50 up to the collision at 1321:54 (see figure 17).²⁹

Figure 17. Simulation view from the flight deck of the model Bell P-63 at 1321:50, showing the locations of the model Boeing B-17 and the two other model fighters.
