Aviation Investigation Report AIR-22-09

Implement Special Federal Aviation Regulation for Air Tours near Ketchikan, Alaska

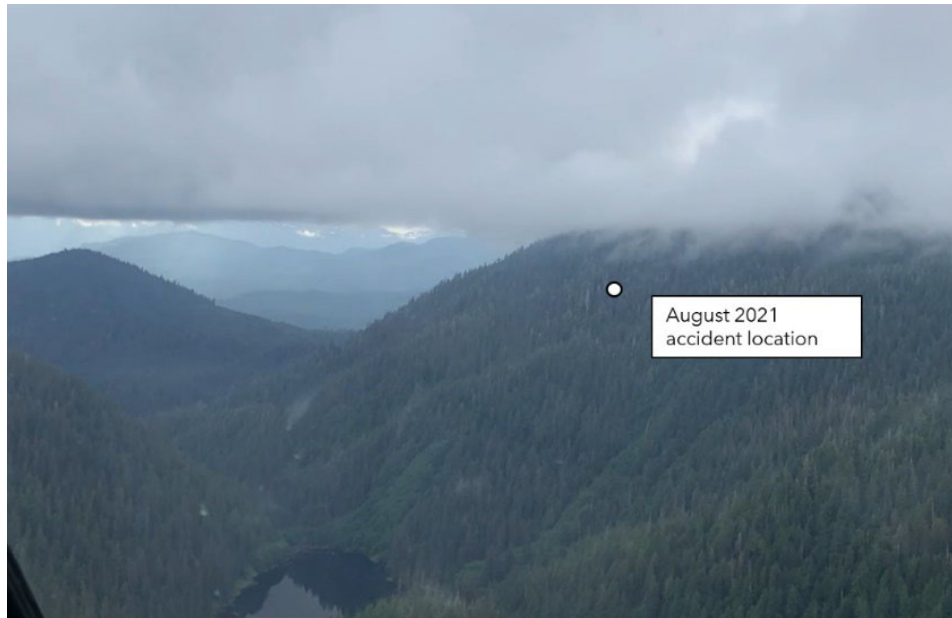
Based on passenger photographs and videos, the accident pilot likely flew close to the right side of the valley where the accident occurred. Ketchikan air tour pilots typically fly along the side of valleys to avoid collisions with other aircraft or to provide more room to reverse course if they observe deteriorating weather ahead, such as low clouds or poor visibility (see the accident valley in figure 1). However, many valleys in the area are too narrow for an airplane to make a full 180° turn to avoid entering or to escape an inadvertent entry into IMC.³ In postaccident interviews, two pilots familiar with the valley where the accident occurred stated that they thought it was likely too narrow to safely execute a 180° turn in an airplane.

Figure 1. August 2021 accident location with obscured mountaintops and reduced visibility. (Source: NTSB)

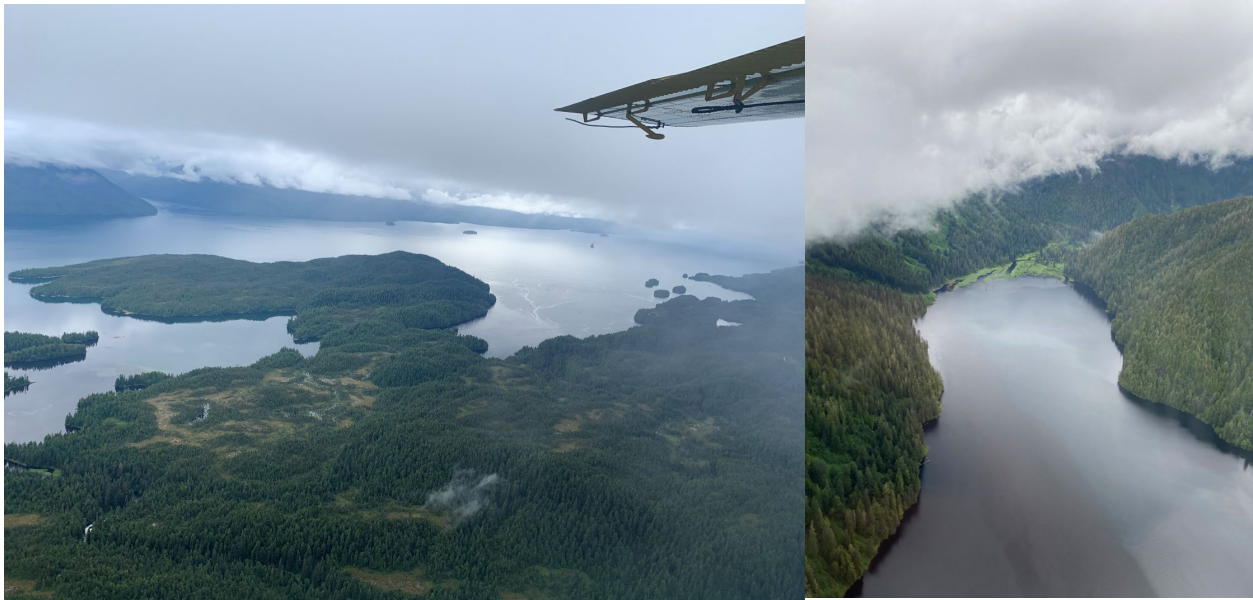
Figure 2. Photographs taken by passengers from the August 2021 accident flight. (Source: NTSB)

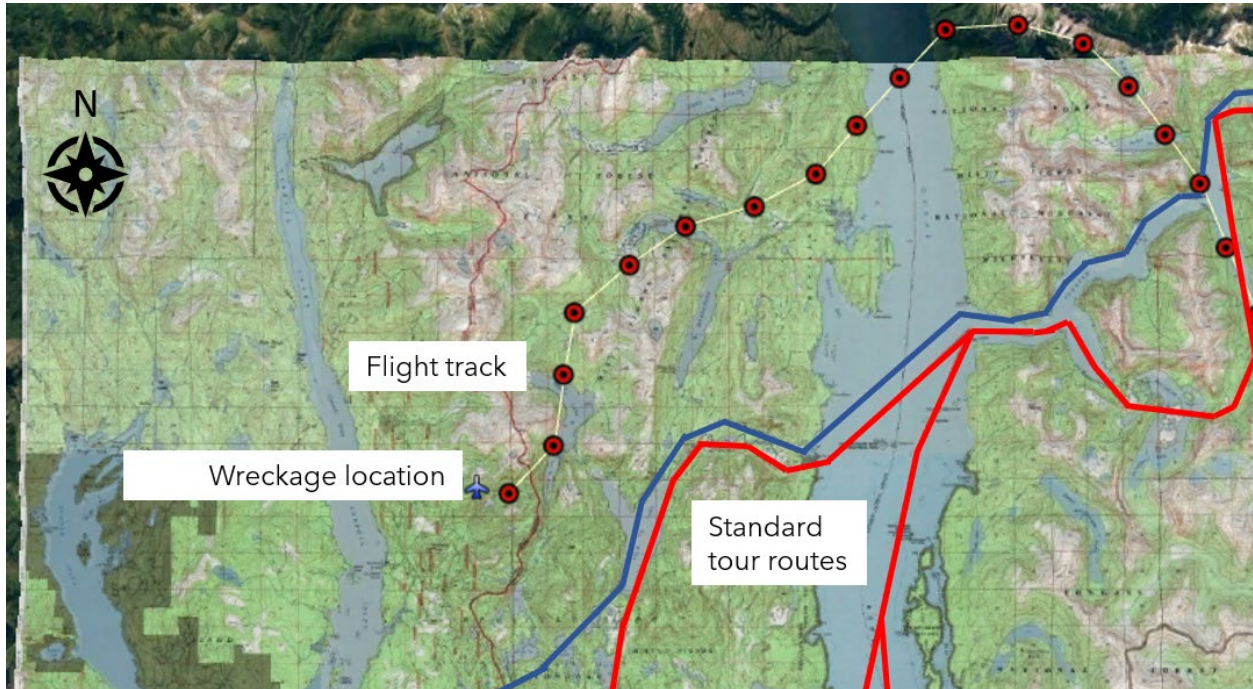
operational elements such as standard routes, reporting points, and best practices.⁸ Although the operator of the August 2021 accident flight was a signatory of this voluntary LOA, compliance with the LOA was not required, and the accident pilot was not following the standard routes in the LOA at the time of the accident as shown in figure 3.

Figure 3. August 2021 accident flight track compared to the standard tour routes in the LOA. (Source: Tongass Aircraft Pilots Association)

Note: The red lines are the LOA's outbound standard routes, the blue line is the LOA's inbound standard route, and the yellow line with red dots is the accident airplane's flight track.
