# National Transportation Safety Board

## Safety Recommendation Report

### Revise Processes, Procedures, and Reporting Capabilities for Automated Weather Systems

<b>Accident Numbers:</b>	WPR19FA084/DCA18MM028
<b>Operator:</b>	Private Pilot/Ride the Ducks Branson
<b>Locations:</b>	Near Ely, Nevada/Table Rock Lake, near Branson, Missouri
<b>Date:</b>	February 15, 2019/July 19, 2018

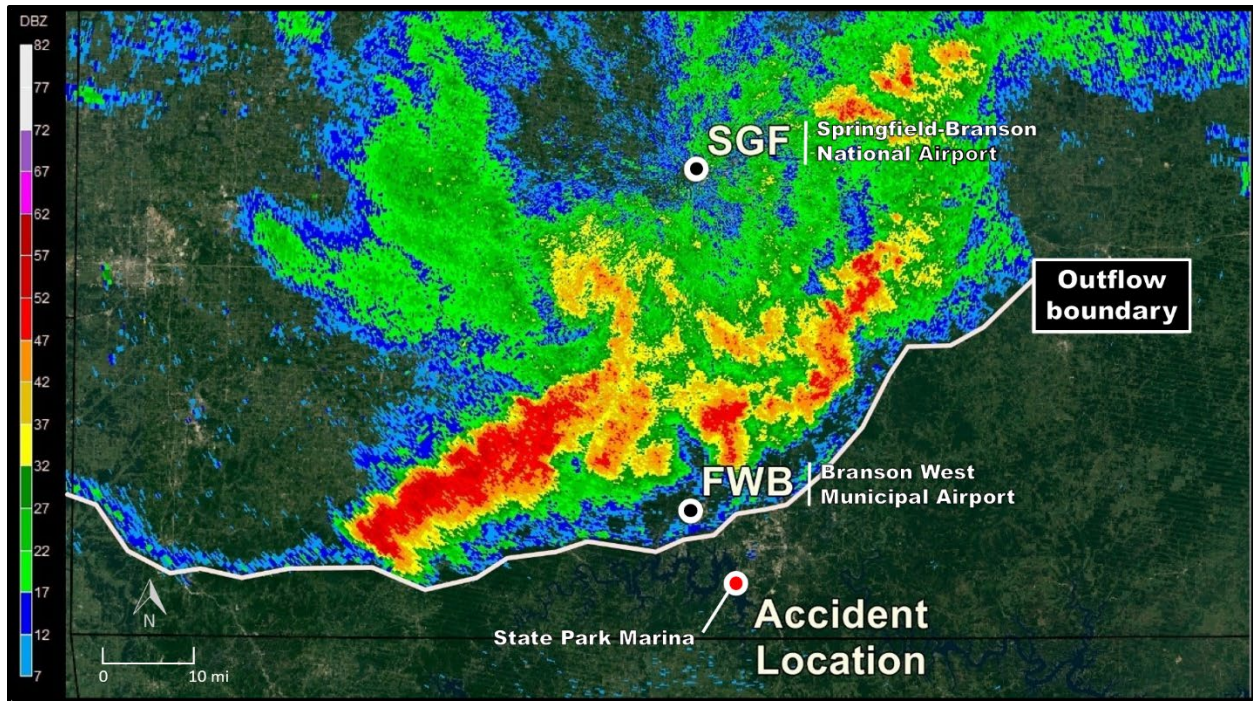
Weather radar imagery identified an “outflow boundary,” which can introduce strong and/or shifting wind at the surface, slightly ahead of the heavy rainfall region of the derecho; the outflow boundary led the advancement of the derecho to the south-southeast both preceding and during the accident time.<sup>16</sup> The following figure presents a weather radar image of the derecho at 1851, just after its outflow boundary passed over FWB.

**Figure.** Weather radar image at 1851.
