Safety Recommendation Report

Addressing Systemic Problems Related to the Timely Repair of Traffic Safety Hardware in California

Accident Number:	HWY18FH011
Location:	Mountain View, California
Date:	March 23, 2018
Recommendation Number:	H-19-13
Adopted:	August 12, 2019

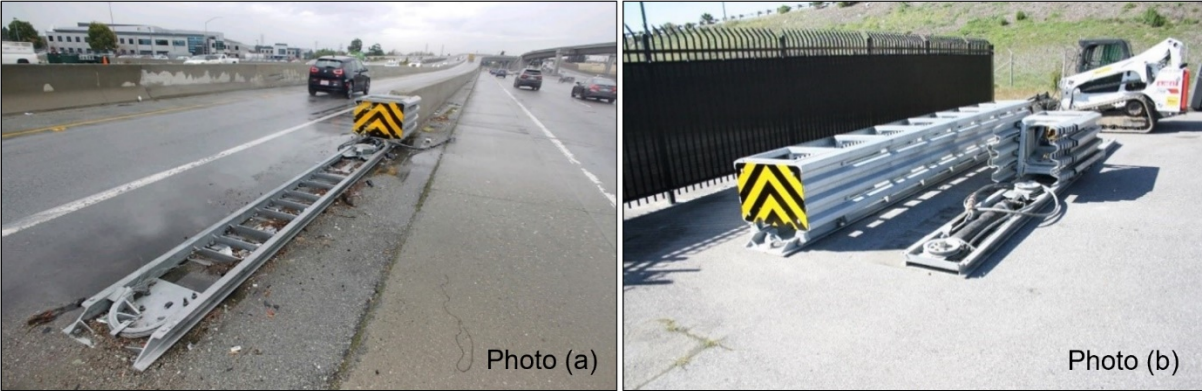
On the day of the crash, the crash attenuator was in a nonoperational, damaged state due to a previous crash, which occurred on March 12, 2018. Figure 1(a) (photograph on the left) depicts the precrash condition of the attenuator as photographed by a Caltrans worker on March 20, 2018, 3 days before the subject crash. Figure 1(b) (photograph on the right) shows an undamaged crash attenuator beside the damaged attenuator. Figure 2 shows the condition of the attenuator following the Mountain View crash.

Figure 1. (a) Fully collapsed crash attenuator as it was before the subject crash; it had been damaged during an earlier collision. A Caltrans worker took the photograph on March 20, 2018. (Source: Caltrans) (b) An undamaged attenuator (left) beside the crash-damaged attenuator (right). (Source: Caltrans)

NTSB investigators attempted to determine why the crash attenuator had not been repaired before the March 23, 2018, crash. Investigators learned that the attenuator was damaged 11 days earlier, on March 12, 2018, at 10:30 p.m., during a single-vehicle traffic collision. A 2010 Toyota Prius, operated by a 31-year-old male driver, was traveling southbound on US-101, entered the gore area, and collided with the crash attenuator at a speed in excess of 75 mph. The

The California Highway Patrol (CHP) responded to the March 12 crash but did not notify Caltrans of the damage to state property as required by policy and interagency operational agreements.⁸ Two Caltrans maintenance workers patrolling the area discovered that the crash attenuator was damaged and nonfunctional on March 20, 2018. The maintenance workers took pictures of the damage and forwarded them to the maintenance supervisor. The maintenance supervisor directed the workers to put cones and barricades up until a new crash attenuator could be located to replace the damaged attenuator.⁹

No date was scheduled for the replacement because the Caltrans maintenance supervisor had to locate a replacement attenuator. The maintenance supervisor told the NTSB that staffing shortages, other necessary repair work, and 12-hour storm patrol shifts that were required on March 21 and 22 delayed the immediate repair of the attenuator. In addition, the supervisor did not have a replacement crash attenuator at the local maintenance facility and had to call other facilities to find one. When two crash attenuators were found at a neighboring Caltrans maintenance facility, the supervisor had to obtain higher management approval from Caltrans District 4 to install them at the crash location because they had been reserved for installation at other locations.

Develop and implement a corrective action plan that guarantees timely repair of traffic safety hardware and includes performance measures to track state agency compliance with repair timelines. (H-19-13)

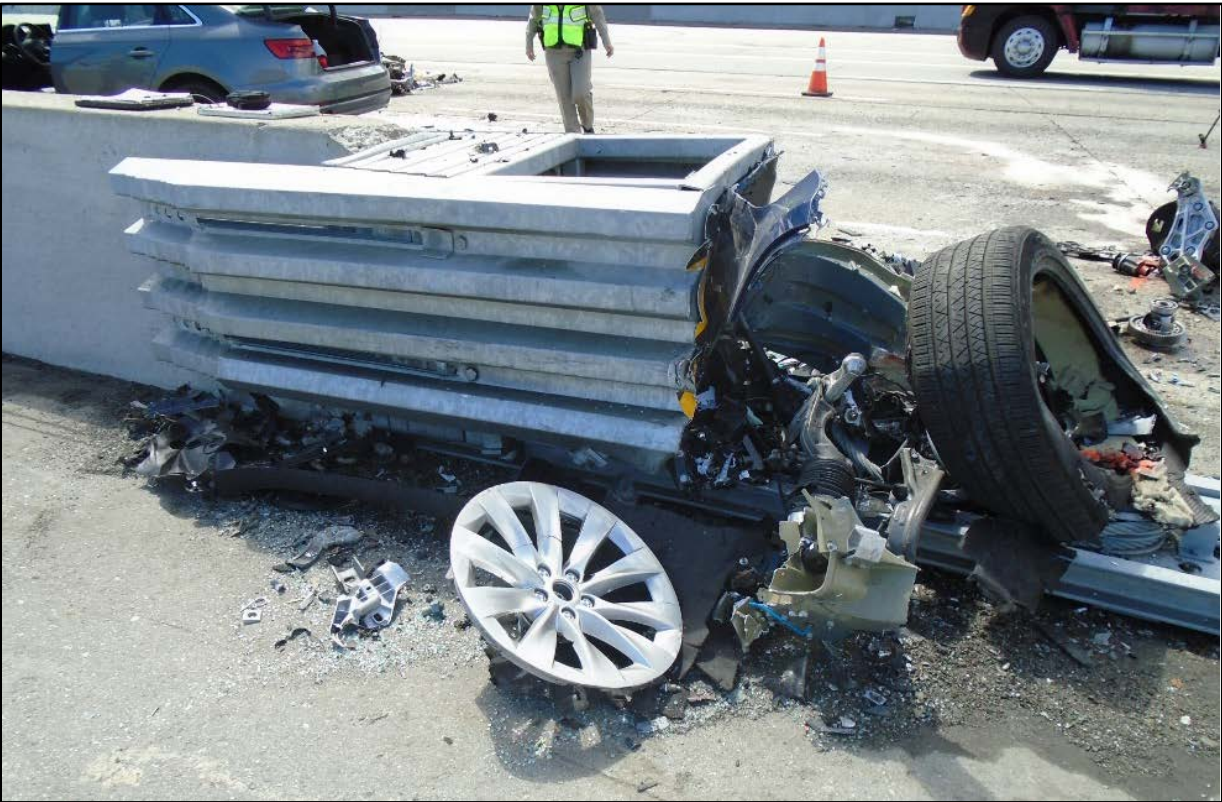
Figure 2. Postcrash photograph of the damaged crash attenuator with vehicle components lodged inside its hollow interior section. (Source: California Highway Patrol)
