Fire aboard Roll-on/Roll-off Passenger Vessel *Caribbean Fantasy*
Atlantic Ocean, 2 Miles Northwest of San Juan, Puerto Rico
August 17, 2016

Marine Accident Report

NTSB/MAR-18/01
PB2018-101068

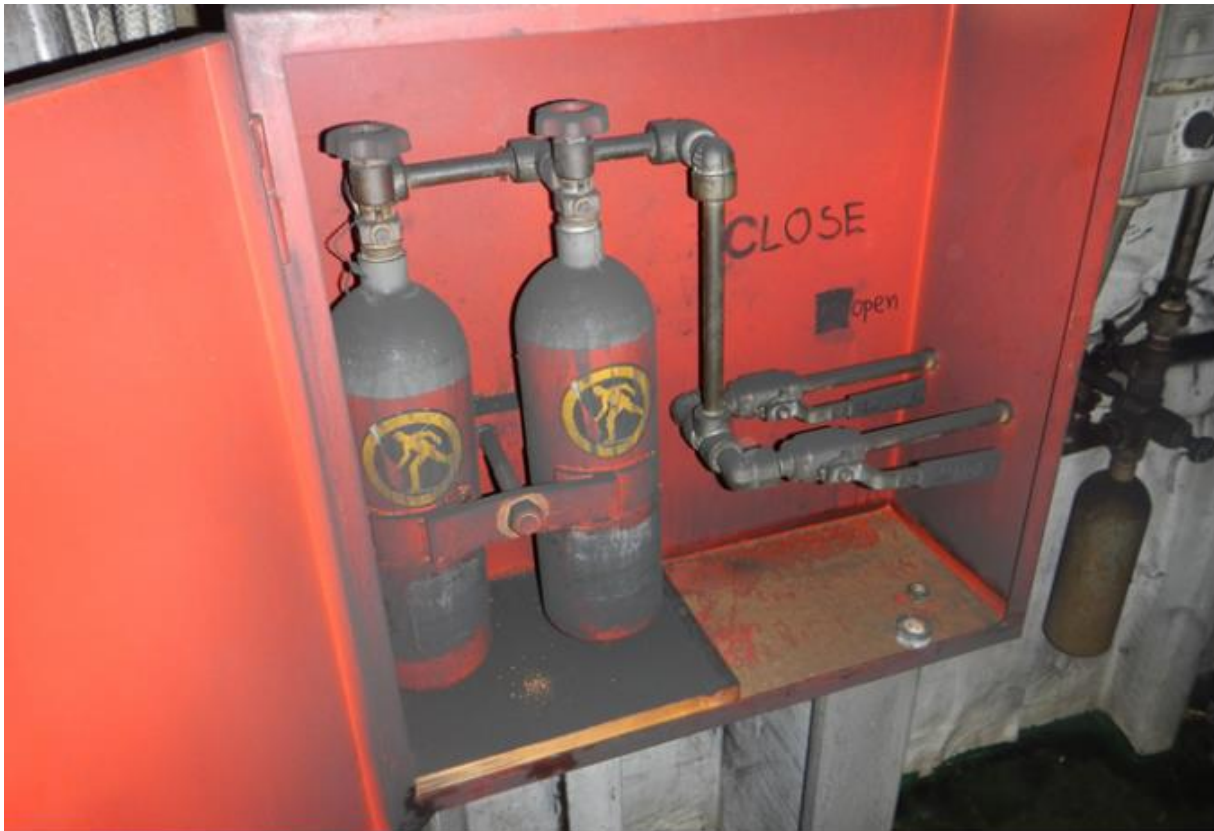
Upon confirming that the engine room was evacuated and all persons in the space were accounted for, the master gave the order to release CO₂. The staff captain complied by operating the two valves needed to activate the system. At 0737, the staff captain informed the bridge by radio that CO₂ had been released. The staff captain remained at the CO₂ station and was joined by the chief engineer shortly thereafter. The staff captain verified that he heard the CO₂ bottles discharge, and he and the chief engineer noted frost on the valves and piping (a common indicator of movement of gas through discharge lines). They then departed the CO₂ station.

Figure 4. CO₂ system activation station postaccident. Both actuation valves are in the open position.

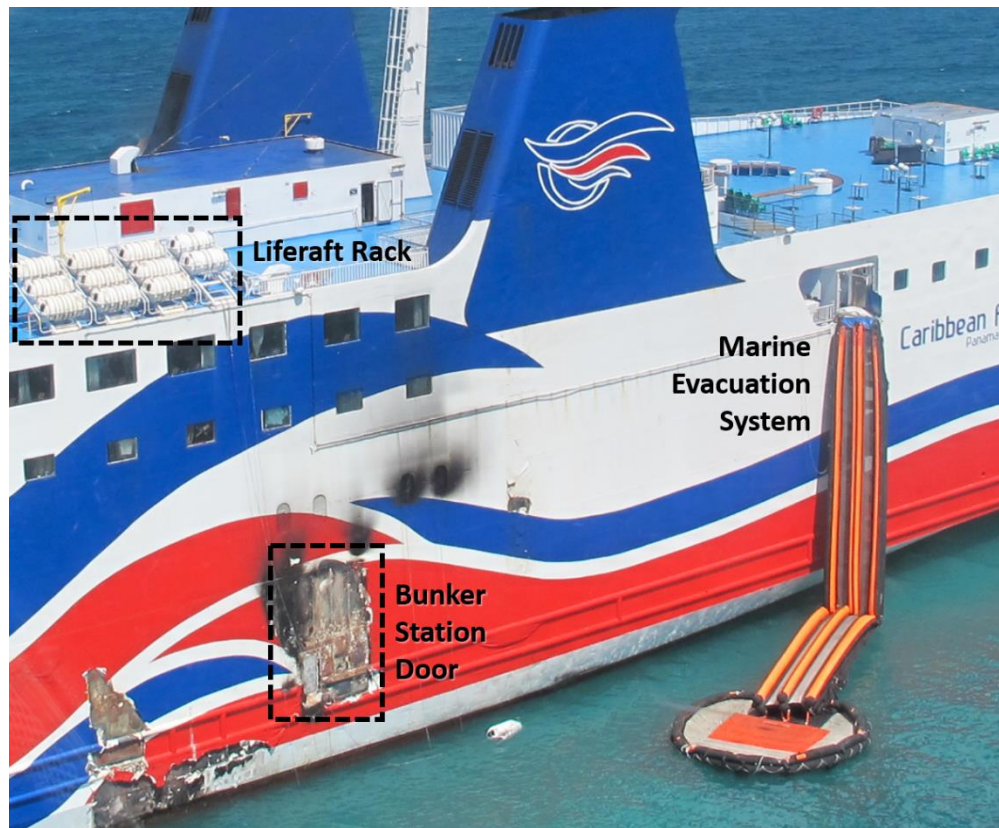
Figure 6. Port side of *Caribbean Fantasy* on the day after the accident. Note the angle of the MES and the single liferaft container floating in the water.

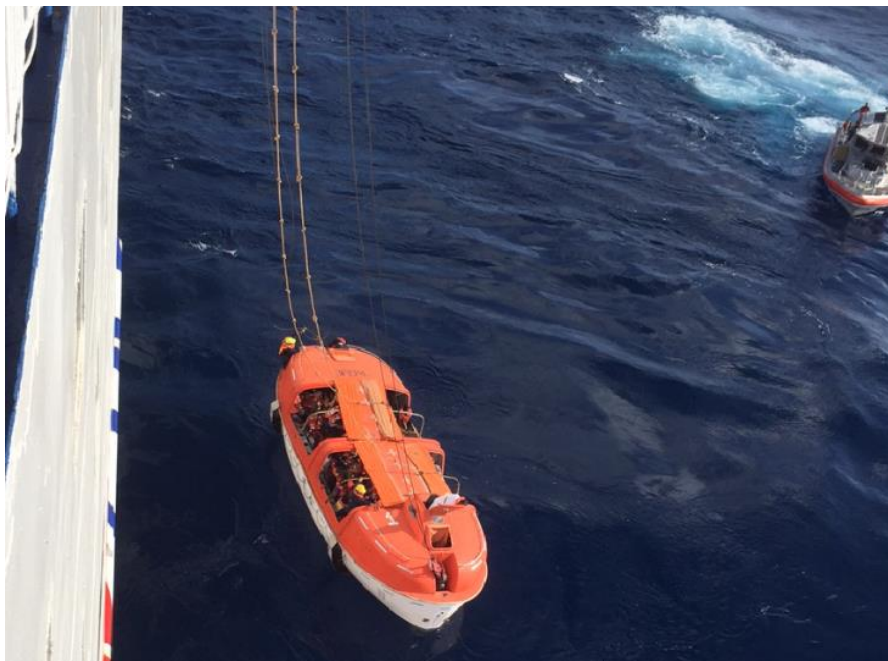
Two minutes later, the commander of lifeboat no. 1, which was now in the water, reported that he was unable to release the hooks that connected the boat to the davit falls (wire ropes). The master replied, “The release works; you don’t know how it works, but it works.” The lifeboat no. 1 commander was then given instructions over the radio to break the clear plastic cover on the hooks’ release mechanisms, which was an override procedure for the hooks’ hydrostatic interlock systems.

Figure 7. Lifeboat no. 1 in the water and unable to open the release hooks, about 0825. (Photo provided to Coast Guard by a *Caribbean Fantasy* passenger)

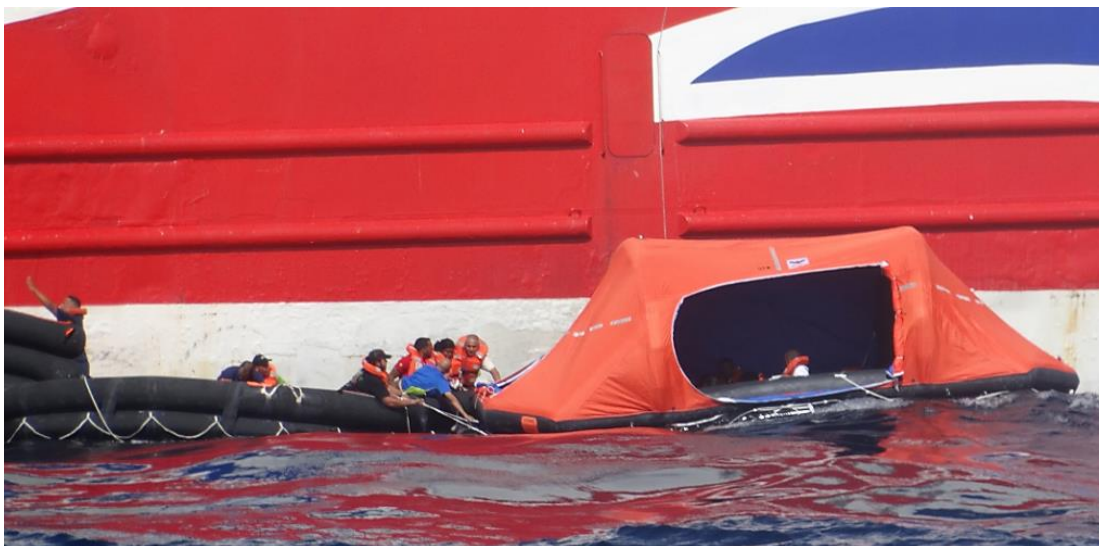
By 0912, liferafts had been pulled alongside the MES platform, but the large openings in the raft canopies that allowed for mass boarding were facing away from the platform. With the smaller opening facing the platform, the loading process was slowed. The master contacted the Coast Guard by radio and requested assistance with the raft alignment. After some confusion due to the master's accent and use of unfamiliar terminology, the OSC responded that assistance would be provided to help turn the liferafts.

Figure 9. Liferaft at the starboard-side MES platform with the main access opening facing away from the platform, about 0923. (Photo by Coast Guard)

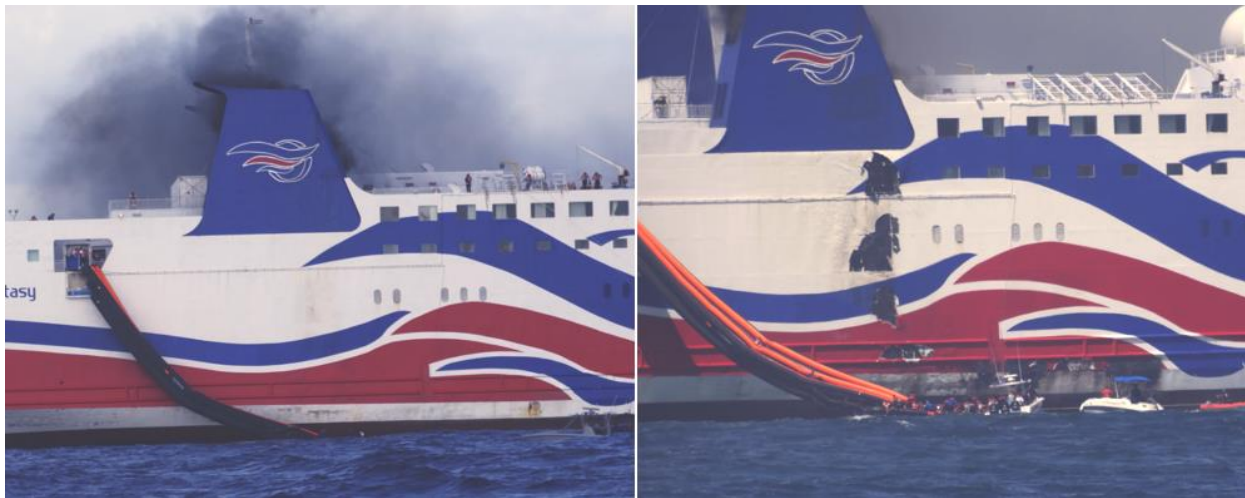
The fire continued to burn on the *Caribbean Fantasy* throughout the abandonment of the ship. The intense heat generated by the fire caused paint on both sides of the ship to blister and eventually burn off, falling into the water. On the starboard side of the ship, this included paint above the waterline, forward of the MES, and adjacent to the engine casings extending from the engine room to the stacks. Although close to the MES, none of the pieces of paint that fell came into contact with the slide, platform, or any of the liferafts.

Figure 12. On the left, at 0853, paint is starting to blister at the waterline. On the right, at 1049, large pieces of paint are missing from the ship’s side starting at the waterline and extending to the stack. (Photos by Coast Guard)

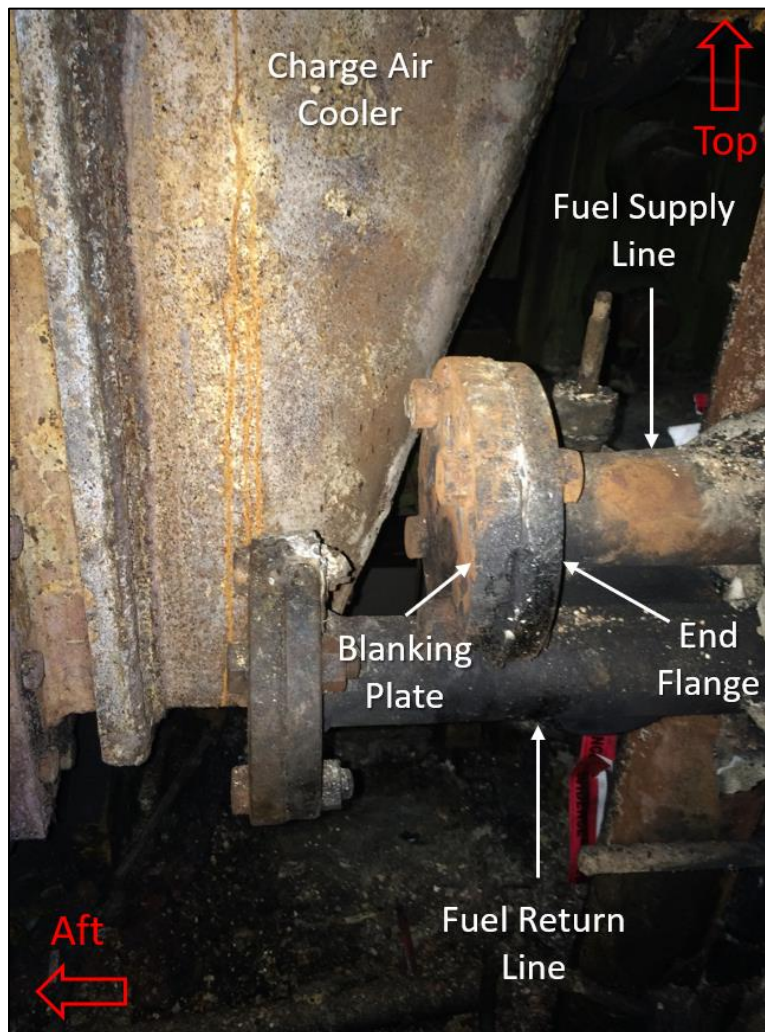
The end flange on the port main engine fuel system supply line where the leak was reported to have occurred was closed off using a blanking plate and four threaded bolts and nuts, with gasket material between the flange and plate.²⁵ During postaccident examination, the end flange, gasket, and blanking plate were found heavily sooted and covered with fuel. In the vicinity of the end flange, an area of clean burn was found on the turbocharger exhaust duct.

International standards). The plate's diameter did not match the flange, and it did not have a raised face. Further, the blanking plate had eight unused fastener holes in addition to the four that were used to secure it to the flange.

Figure 15. Postaccident photo of the fuel supply line end flange on the port main engine. A similar end flange for the fuel return line is below the supply end flange.

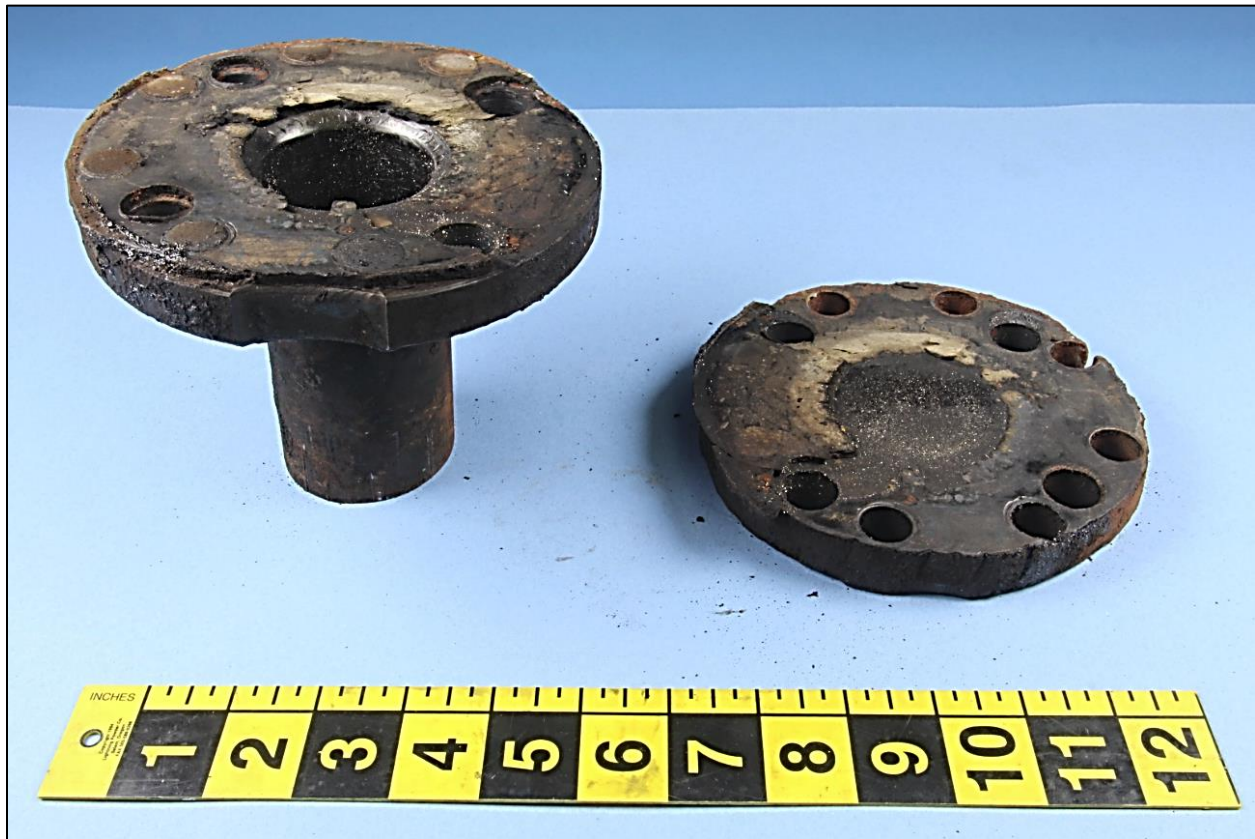
There was no inspection of or lifecycle management for the gasket material for any of the main engine fuel supply and return lines. Gaskets were being replaced only after failure. (Maintenance records showed that the starboard fuel supply end flange gasket had been replaced on August 11 as a result of a discovered leak. The replacement gasket for the starboard end flange was hand-cut by the motorman performing the repair.)

Figure 16. Fuel supply line end flange and gasket material, left, and blanking plate, right.

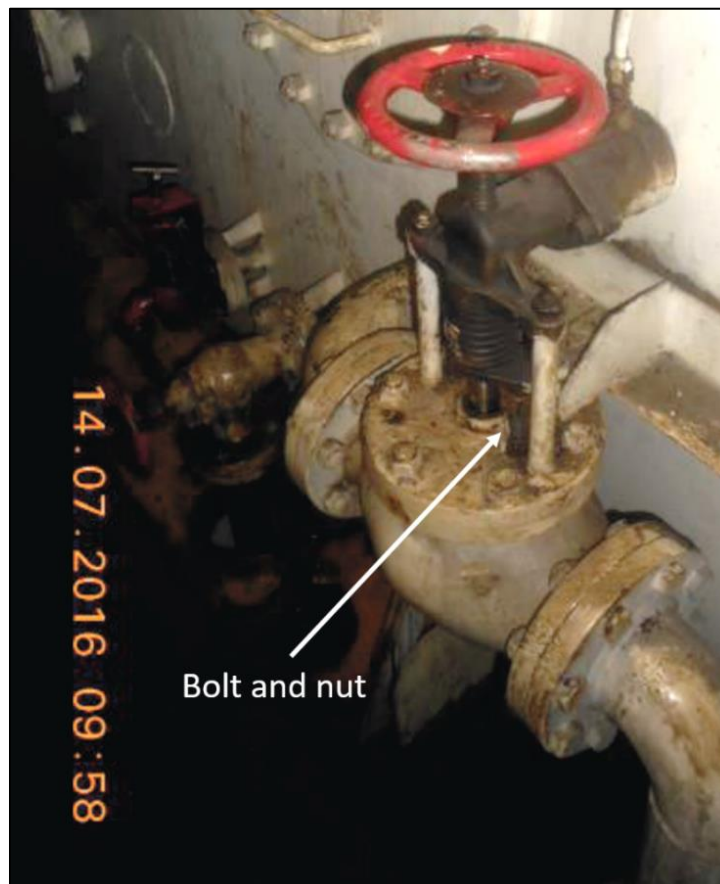
After the *Caribbean Fantasy* had been detained in Gibraltar in early July 2016, a RINA surveyor conducted a “Port State Control Preventive Assessment” to verify the deficiencies recorded. In the surveyor’s report, a photograph of the portside lube oil storage tank QCV shows a bolt and nut lodged in the valve mechanism, which would have prevented the valve from operating as designed. No deficiencies relating to QCVs were recorded in the narrative section of the RINA report form.²⁸

Figure 17. Enlargement from photograph of the portside lube oil storage tank QCV in RINA Port State Control Preventive Assessment report.

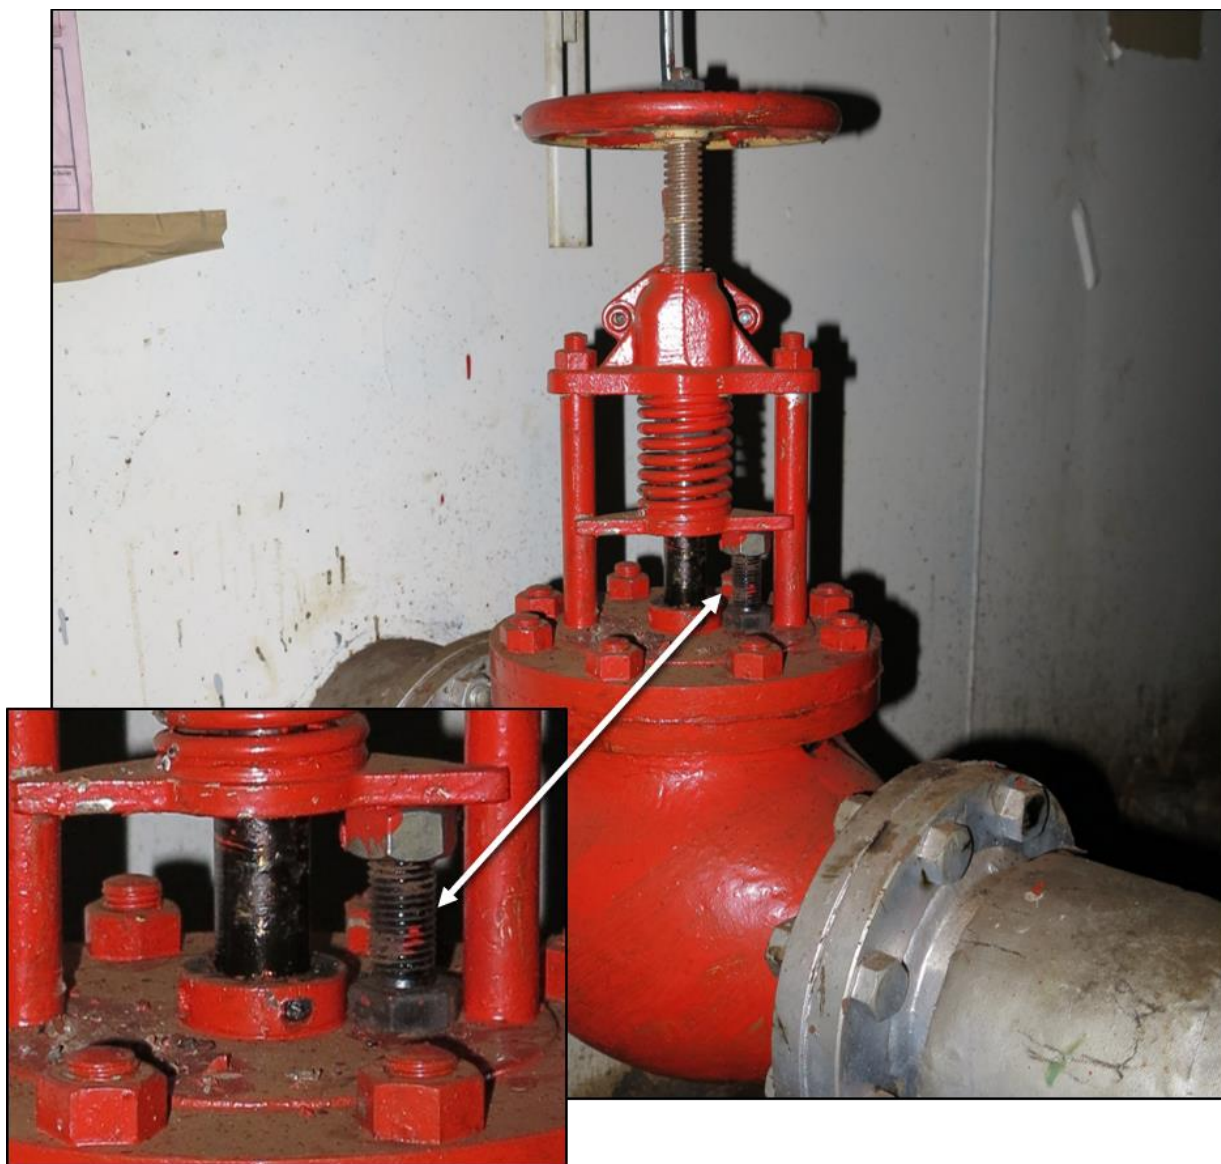
After the accident, investigators discovered that all eight fuel and lube oil QCVs were blocked open with a bolt and nut, which rendered the valves unable to isolate fuel and lube oil from the main engine room during the fire.

Figure 18. Postaccident photo of *Caribbean Fantasy's* starboard heavy fuel oil (HFO) storage tank QCV that was blocked open with a bolt and nut.

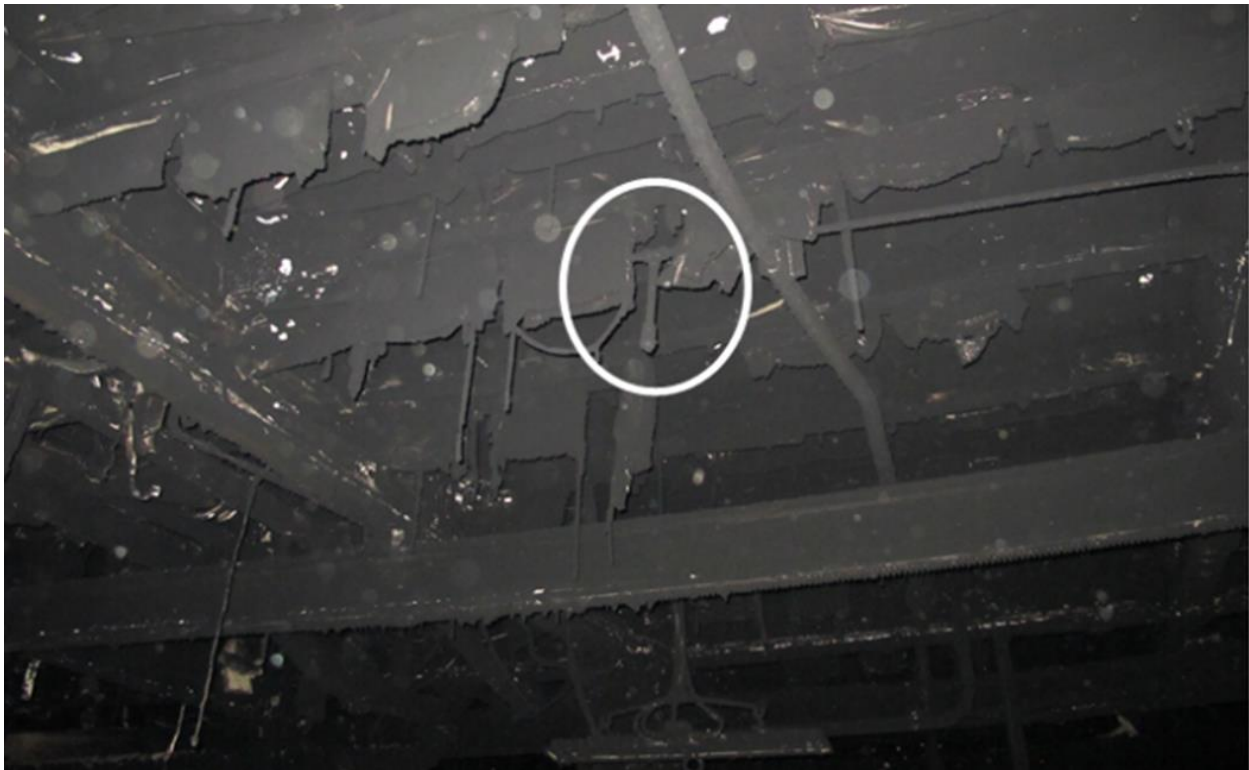
Figure 19. Water-mist system nozzle after the fire.

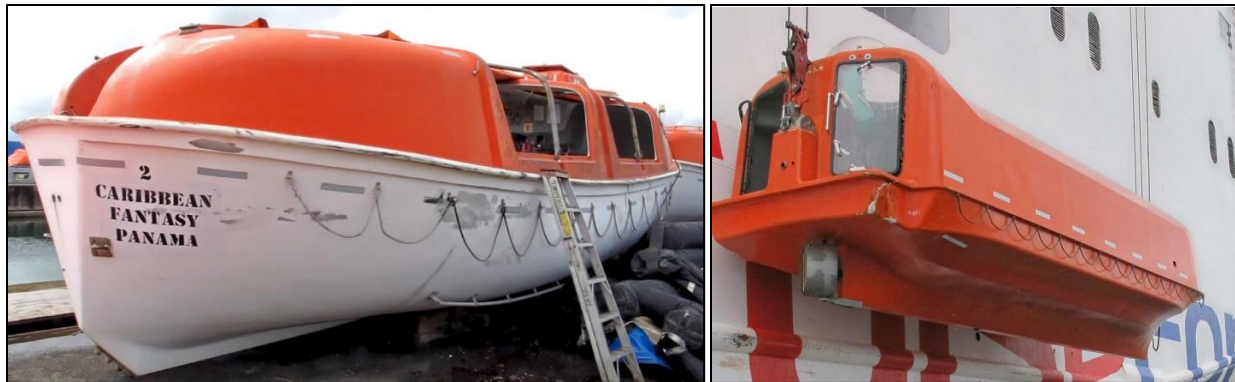
Figure 20. Photo left is *Caribbean Fantasy* lifeboat no. 2 on the pier in San Juan after the accident. Photo right is lifeboat no. 3 suspended from the davit falls on *Caribbean Fantasy* after the accident.

- Lifeboats no. 1, no. 2, and no. 3 incurred GRP, hand rail, and hatch damage that included fractures and laminate shearing.

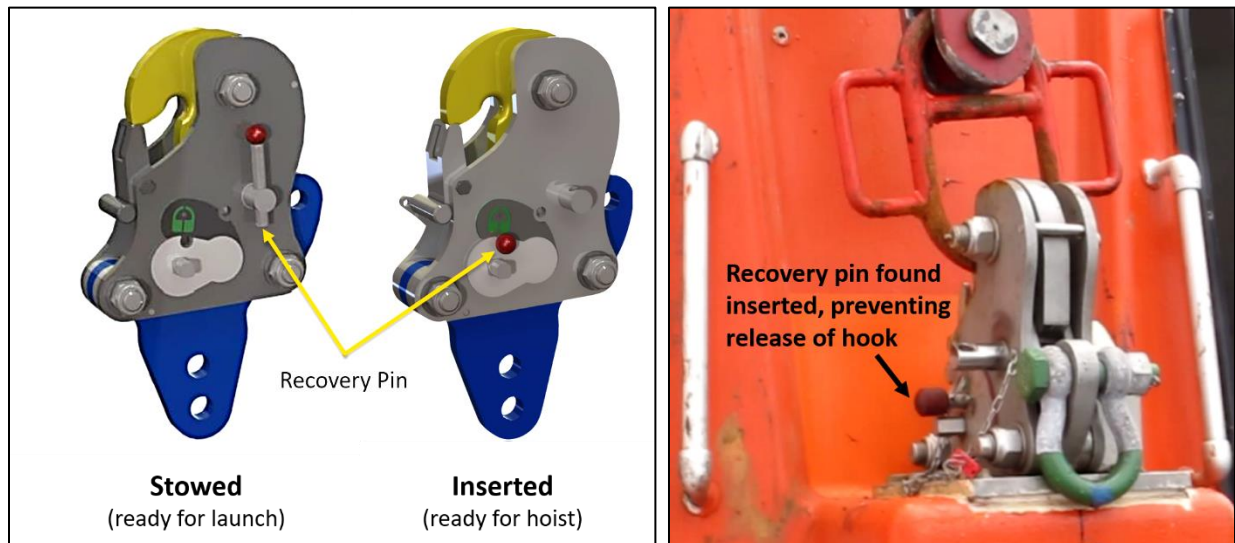
The *Caribbean Fantasy* entered the port of San Juan with lifeboat no. 3 hanging by its falls at the ship's side. When investigators examined the lifeboat after the accident, they found the safety pin for the release handle inserted in the RCU, and the clear plastic cover for the interlock override was intact. A successful release test was conducted dockside by dropping the boat onto truck tires after operating the release handle. Before the test, the team examined the release hooks and found the recovery pins in the position for recovering the lifeboat—inserted through the hook mechanism to lock it closed and prevent it from accidentally opening during hoisting. (When a lifeboat is not being hoisted, recovery pins should be in the stowed position—in a holder mounted on the side of the hook—in preparation for immediate lowering and launching of lifeboats in an emergency.) According to the commander of lifeboat no. 3, the pins were put in the recovery position prior to the attempted hoist of the lifeboat back to the embarkation deck. It could not be determined if the pins were in the stowed or recovery position prior to the boat being lowered.

Figure 22. At left, the U-hook with recovery pin in stowed and inserted positions. (Source: *U-Hook 3–6–10–15 ton Operation and Maintenance Manual*) At right, *Caribbean Fantasy* lifeboat no. 3 aft hook with the recovery pin inserted in the hook mechanism.

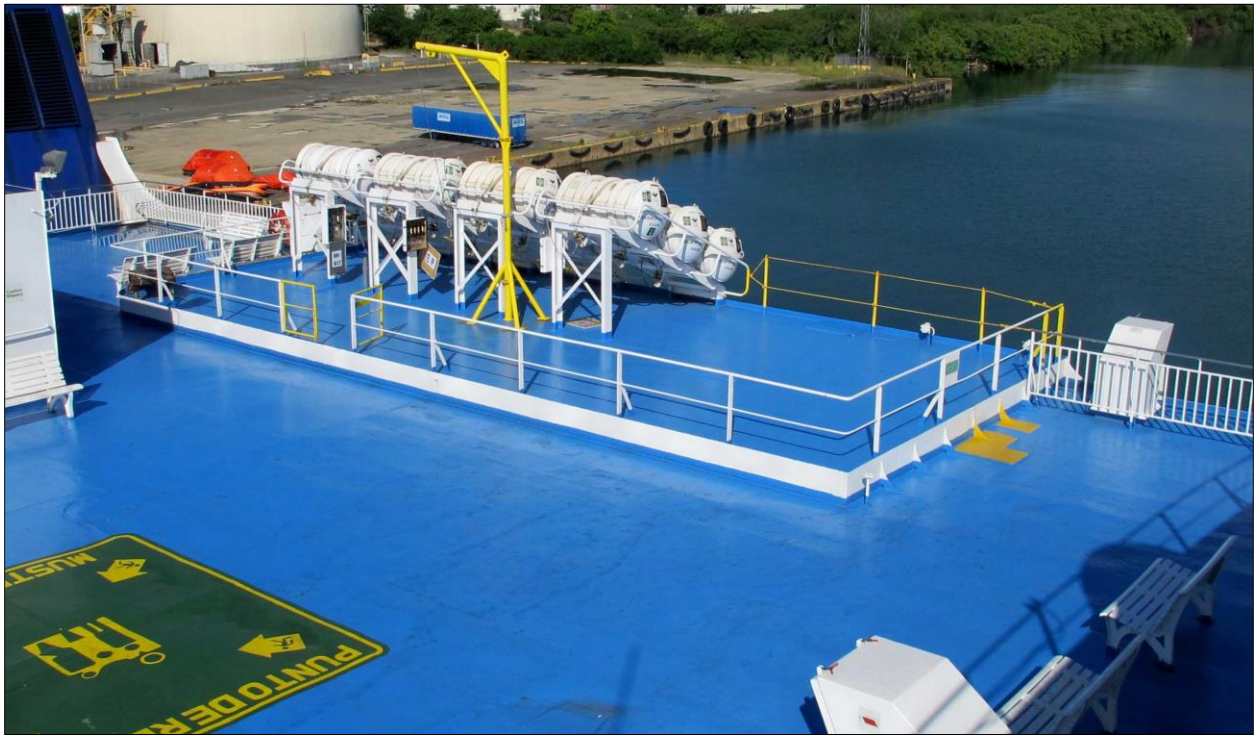
Figure 24. Postaccident photo of the portside liferaft containers and storage racks on board the *Caribbean Fantasy*.

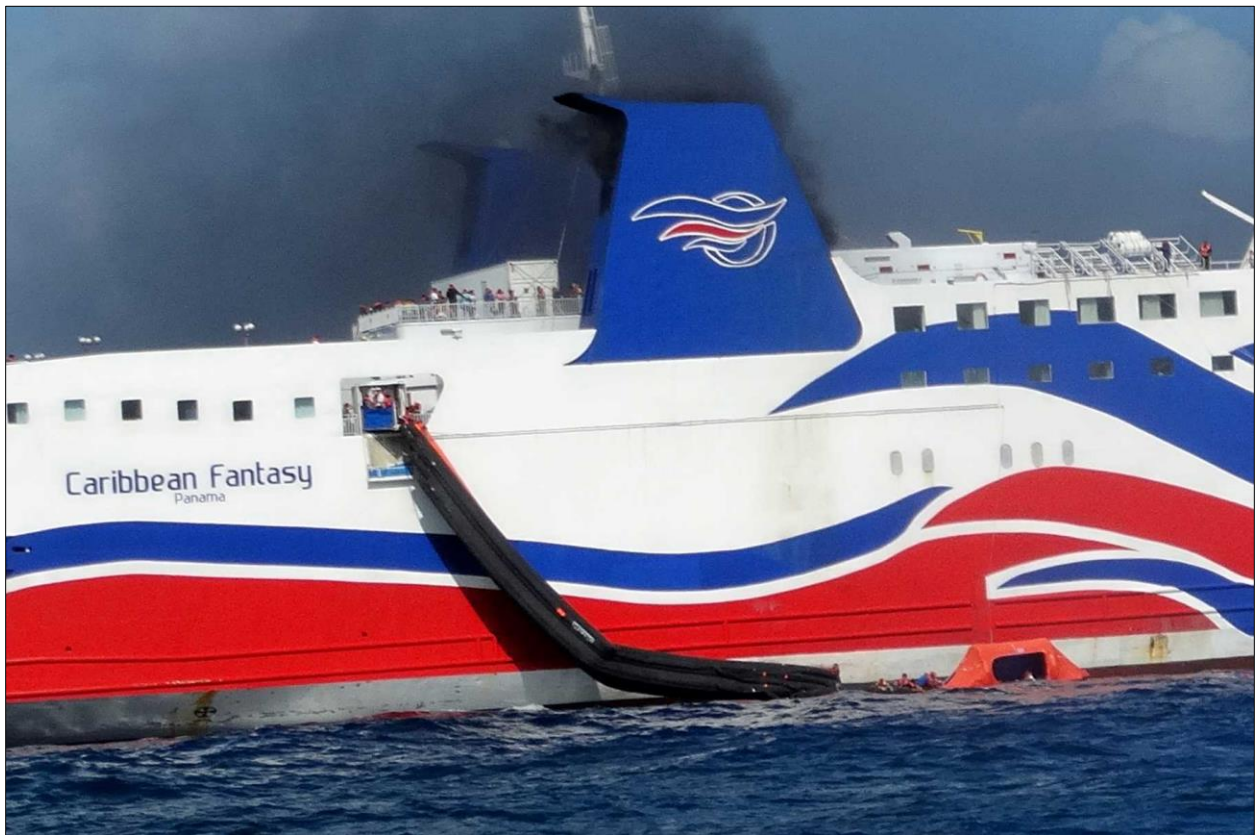
During his interview with investigators, the staff captain said that the starboard-side MES deployed as designed, but the crew could not use the bowsing line because it had parted (investigators were not able to determine how or when the line parted). He said that the crew added nitrogen from the spare refilling valve to overcome the effects of the wind, which were causing the slide to collapse, and sent passengers down the slide even though the slide deployed with a steep angle. Investigators determined that the MES slide angle was about 54 degrees to the waterline after it inflated. For safe use of the system, the manufacturer's recommended angle was 30–35 degrees. Eventually, a Coast Guard small boat used a line attached from the MES platform to the bow of the boat to pull the platform forward and improve the alignment of the slide.

Figure 25. *Caribbean Fantasy* starboard-side MES deployed at about a 54-degree angle to the waterline, about 0923 on the morning of the accident. (Photo by US Coast Guard)

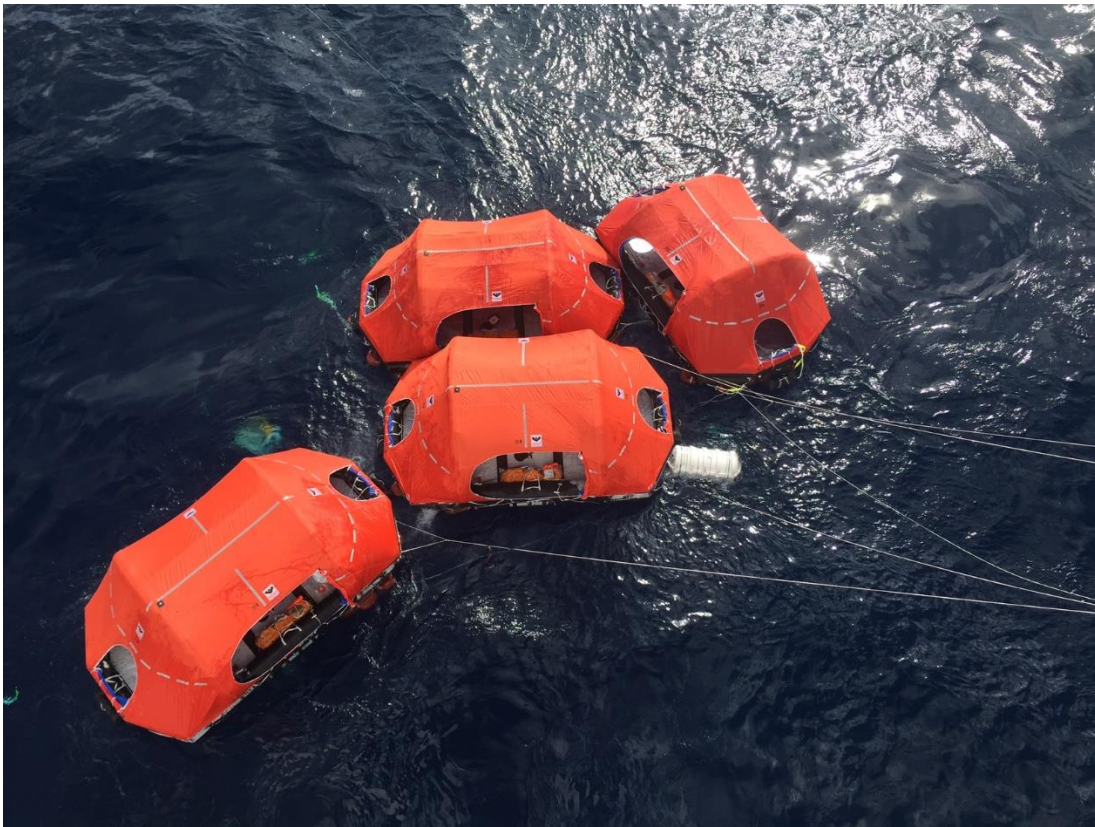
The liferafts were designed to be inflated by crewmembers once they were pulled alongside the MES platform, but some of the starboard-side liferafts inflated early. A crewmember said he saw four rafts inflate before being pulled to the platform, and a passenger took a photograph showing four empty inflated liferafts with lines still connected to the ship. At the time this took place, the *Caribbean Fantasy* was drifting in a sideways motion at about 1 to 2 knots with the wind on its starboard side.

Figure 26. Inflated liferafts without passengers, about 0844 on the morning of the accident. (*Caribbean Fantasy* passenger photo provided by Coast Guard)

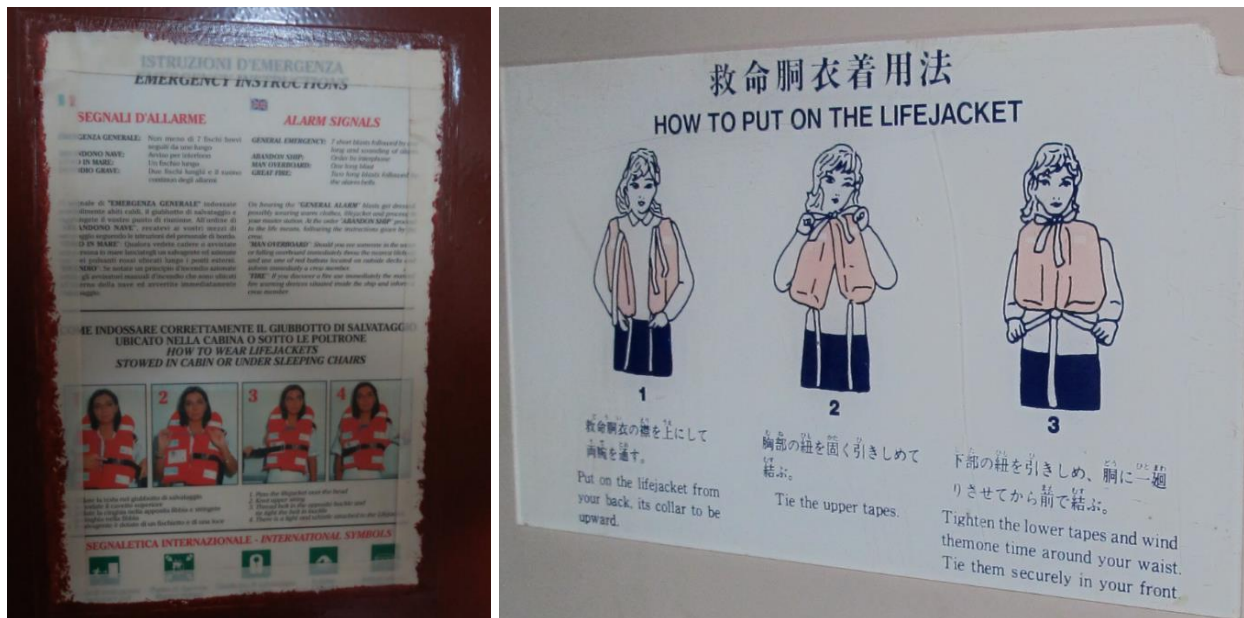
fire on the placard was “two long blasts followed by the alarm bells,” whereas the emergency plan and station bill had no specific signal to inform passengers of a fire. In another example, lifejacket donning instructions found posted on board were in Japanese and English and provided directions for lifejackets no longer in use aboard the *Caribbean Fantasy*.

Figure 27. Left: Emergency instruction sign in English and Italian on the back of a deck 6 cabin door. Note the masking tape covering the outer edges of the emergency instructions. Right: Lifejacket donning instruction sign in English and Japanese found on deck 6 near fire locker no. 2. The instructions were for lifejacket types not carried on board at the time of the accident.
