Issued November 28, 2023

MIR-23-26

# Crane Wire Failure on Cargo Ship

## *Thorco Basilisk*

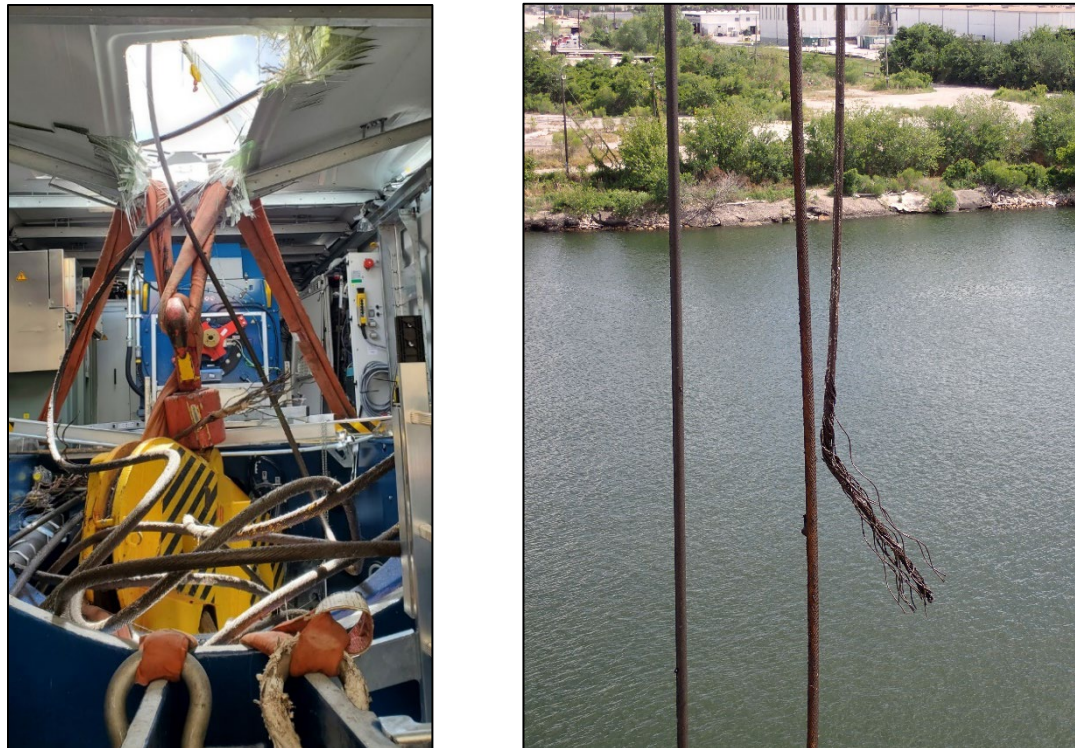
The nacelle sustained damage to its outer fiberglass housing structure and its internal components, including the yaw bearing, hydraulic unit, electrical component top boxes, transformers, and main converter. The nacelle's rear transport frame was also damaged from the impact with the tween deck.

Damages to the vessel included indentations to two of the pontoons making up the tween deck in cargo hold no. 1, including damage to the substructures and side plate in cargo hold no. 1.

**Figure 5.** Crane no. 1's block smashed into the top of the damaged nacelle (*left*) and its parted wire rope on the crane side (*right*). (Source: US Coast Guard)

Following the casualty, the *Thorco Basilisk* crew cut the parted wire rope and secured the crane until repairs could be made and new wire rope installed. A postcasualty damage survey conducted by DNV-GL directed that cargo crane no. 1 be secured and not used until the wire rope was replaced and crane no. 1 be load tested by the classification society. The *Thorco Basilisk* continued to operate using the undamaged cranes (nos. 2 and 3), calling on additional ports before arriving in Hamburg, Germany on August 30. Between August 30 and September 5, technicians from the crane manufacturer, MacGregor, inspected each of the three cargo cranes and replaced the crane wire ropes on all three cargo cranes.

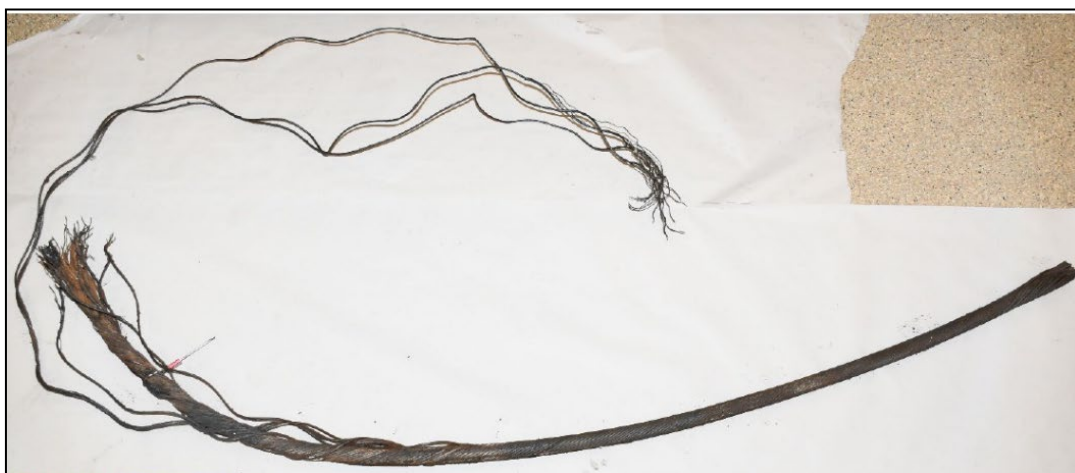
**Figure 7.** *Thorco Basilisk* parted hoisting wire rope (crane side of fracture). (Source: Engineering Systems Inc)

The resulting report concluded that the primary failure mechanism of the hoisting wire rope was corrosion and wear, followed by "monotonic ductile overload failure" of the remaining wire cross sections. The report noted that the wire rope sections exhibited "a significant level of external corrosion" with a severity rating of about 60%; a severity rating of 100% would require that the wire rope be discarded. However, because a reference diameter from when the wire rope was installed on board the *Thorco Basilisk* was unavailable, a quantitative severity rating based on uniform decrease in wire rope

diameter from wear could not be assigned. Examination of the external condition of the wire rope samples showed “obvious uniform corrosion,” and that the wires visually displayed “roughness and pitting,” with the most severe corrosion observed nearest to the fracture location. Examination of internal corrosion also revealed “uniform corrosion of internal surfaces” visible near where the wire rope became unraveled.

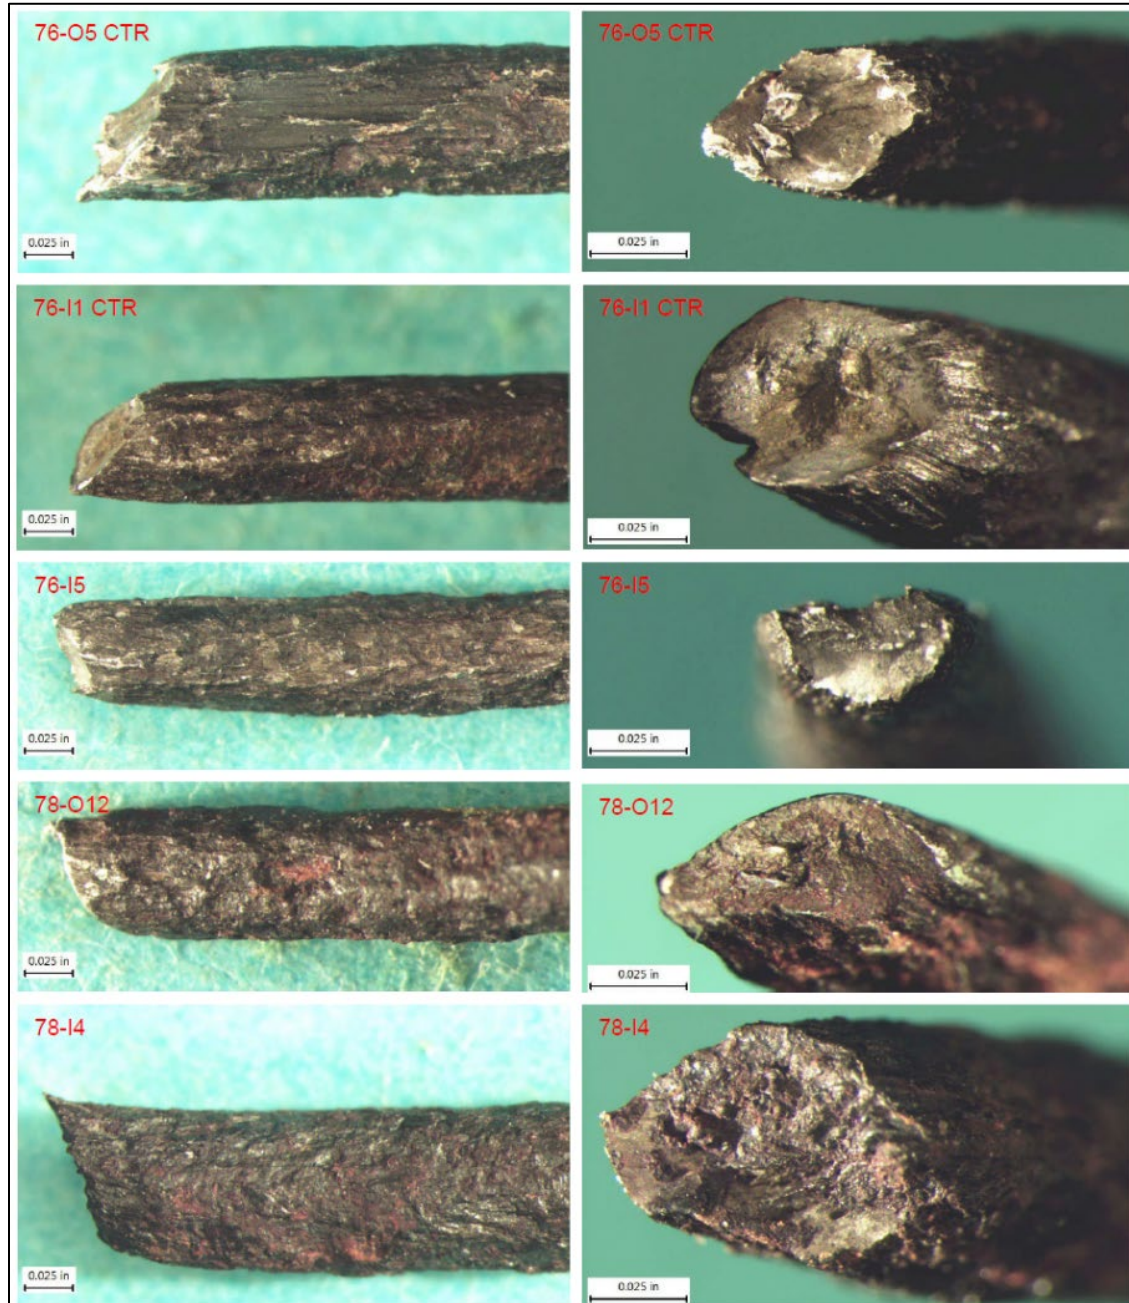
**Figure 8.** Views of wire ductile fractures from the side (*left*) and perpendicular to the fracture surface (*right*) found in strands of the failed wire rope. (Source: Engineering Systems Inc)

The report noted a localized increase of about 10% in wire rope diameter near the eye connecting to the lifting block and stated this increase would warrant discard (replacement). The report also stated that there were no broken wires on the examined segments, and the visible signs of external corrosion could not be fully appreciated (observed) until the grease was removed.

After the casualty, samples of crane no. 1's hoisting wire rope were examined to determine what had caused the wire rope to fail. The examination noted a localized increase in wire rope diameter near the eye and stated this increase would warrant discard (replacement). However, based on stevedores' and vessel crew's statements, investigators determined that the increase in diameter near the eye occurred postcasualty when the lifting block fell through the fiberglass housing of the nacelle unit and therefore had not contributed to the failure of the wire rope. The examination also found significant external corrosion, as well as roughness and pitting, and "uniform corrosion of internal surfaces" of the hoisting wire rope. This corrosion and wear caused some of the individual wires comprising the strands of the hoisting wire rope to part (fail) when crane no. 1 lifted the nacelle unit, subsequently causing the strand and then the remaining wire strands to become overloaded and fail.
