Railroad Investigation Report RIR-22/13

CSX Transportation Derailment with Hazardous Materials Release and Fire

Draffin, Kentucky
February 13, 2020

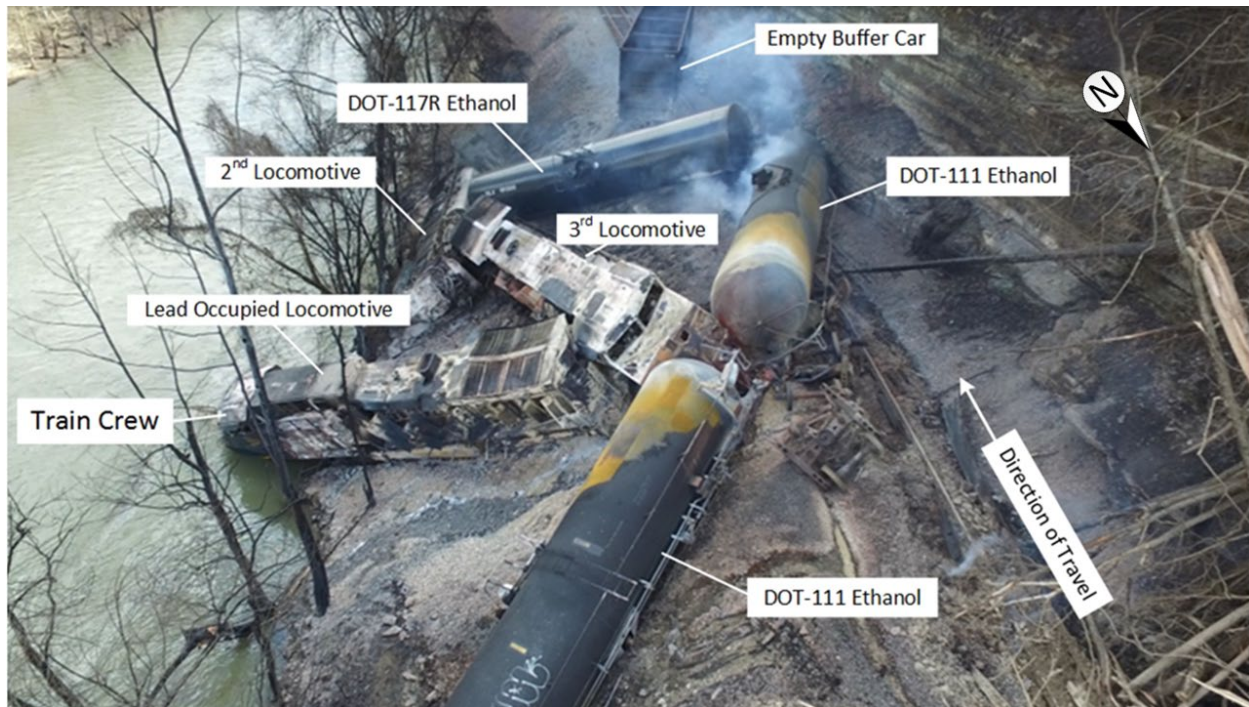
On February 13, 2020, at 6:46 a.m. local time, CSX Transportation (CSX) freight train K42911, a high hazard flammable train (HHFT) carrying denatured ethanol, derailed in Draffin, Kentucky.¹ (See figure 1.) The derailment occurred at milepost 123.8 of the CSX Kingsport Subdivision, on track between a hillside and the Russell Fork River. In the 2 weeks before the derailment, the area had received a substantial amount of precipitation, which resulted in a mudslide immediately before the derailment that covered the tracks with a mass of loose mud, vegetation, sand, soil, and rock. As a result of the derailment, the engineer and the conductor sustained minor injuries. The train, consisting of 3 lead locomotives, 1 front-end buffer car, 96 loaded tank cars, and 1 rear-end buffer car, was 6,045 feet-long and weighed 13,172 trailing tons. All three locomotives, the front-end buffer car, and four loaded tank cars at the front end of the train derailed.

Figure 1. Derailment scene. (Photograph courtesy of Pike County Office of Emergency Management with overlay annotations by the National Transportation Safety Board.)

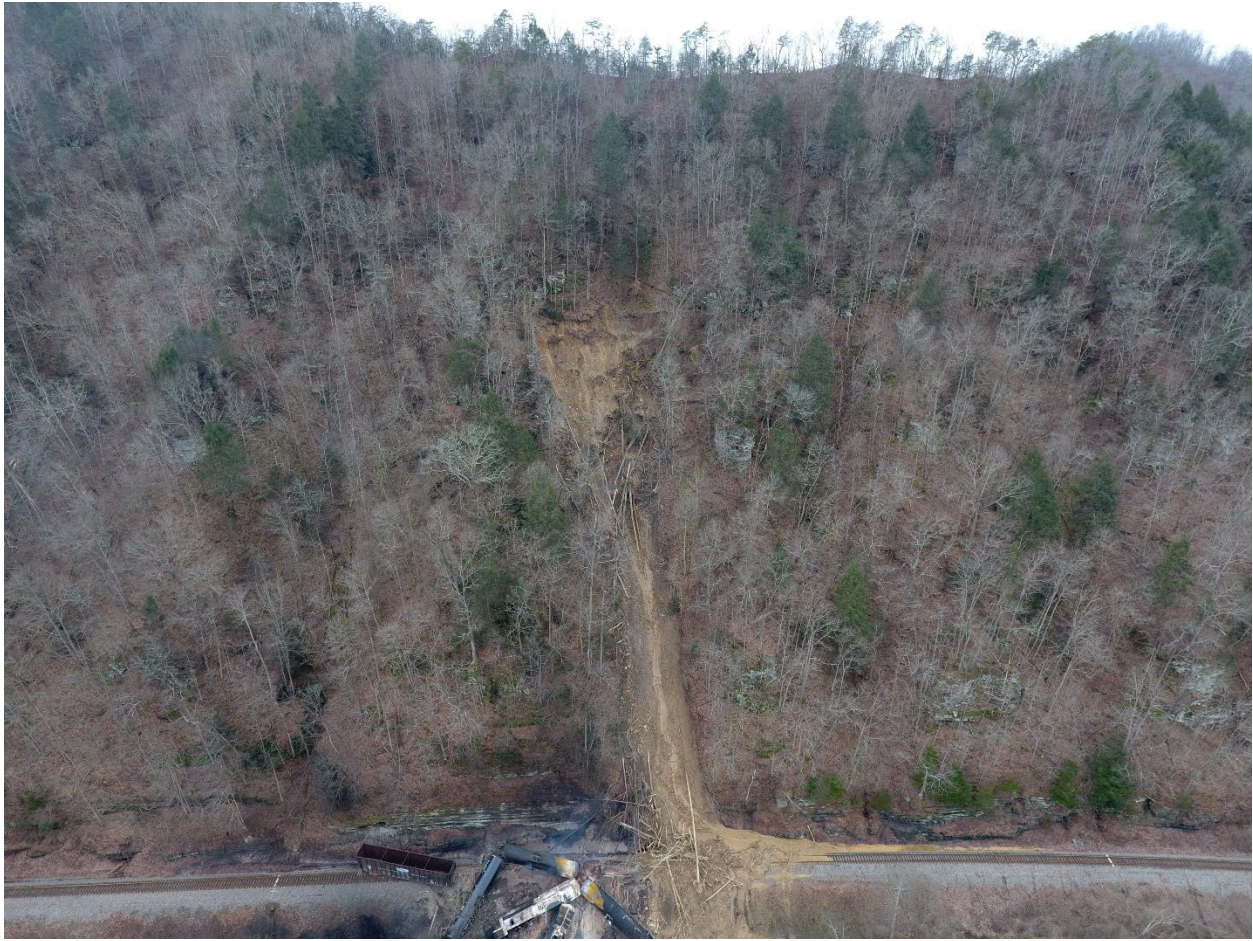
In an interview with the National Transportation Safety Board (NTSB), the engineer said that the debris from the mudslide was about as high as the nose of the lead locomotive, which would have been about 10 feet high. He stated that he was able to activate the train's emergency brake before the derailment, the sight distance ahead of the train had been about five car lengths due to rain, fog, curves, and darkness.³ According to wireless uploads from the train's trip optimizer, the train had been traveling between 24 and 25 mph, which was within the authorized speed limit for the tracks.⁴ Figure 2 shows the derailment scene and the mudslide.

Figure 2. View of the derailed cars and the mudslide.

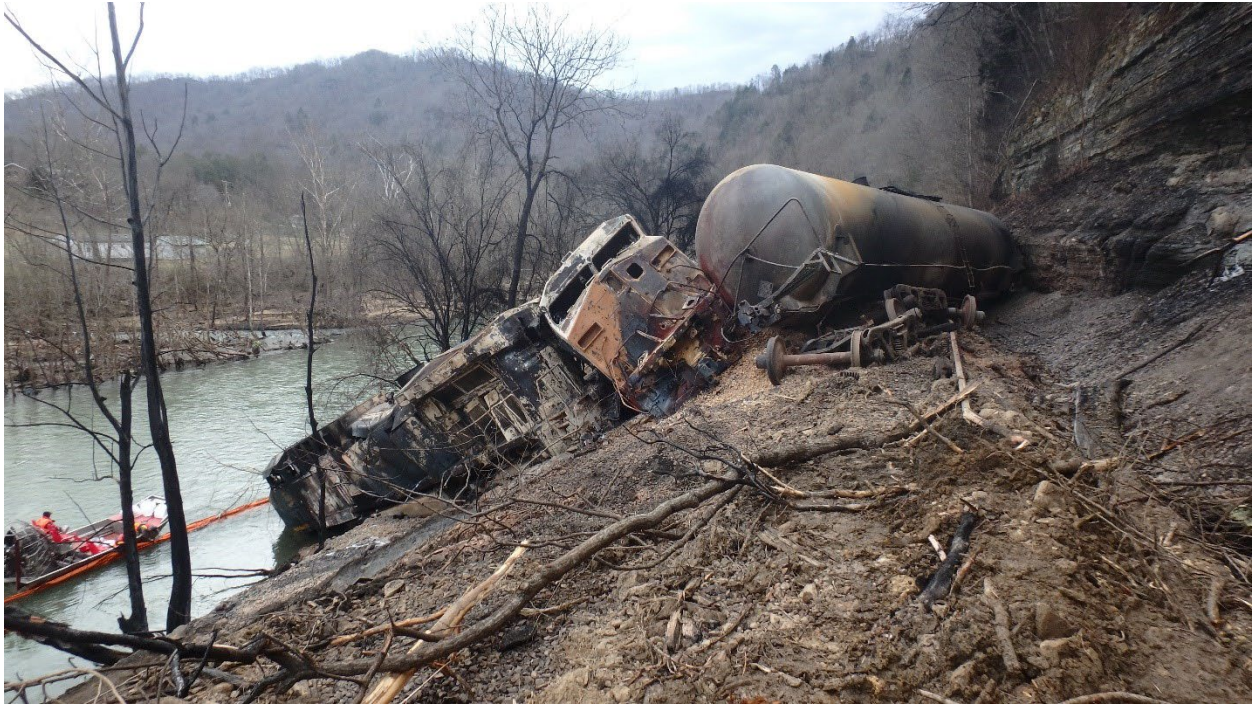
The train derailed toward the rain-swollen Russell Fork River, remaining upright with the cab of the lead locomotive partially submerged. (See figure 3.)

Figure 3. Derailed locomotives and ethanol tank car, as viewed from the north.

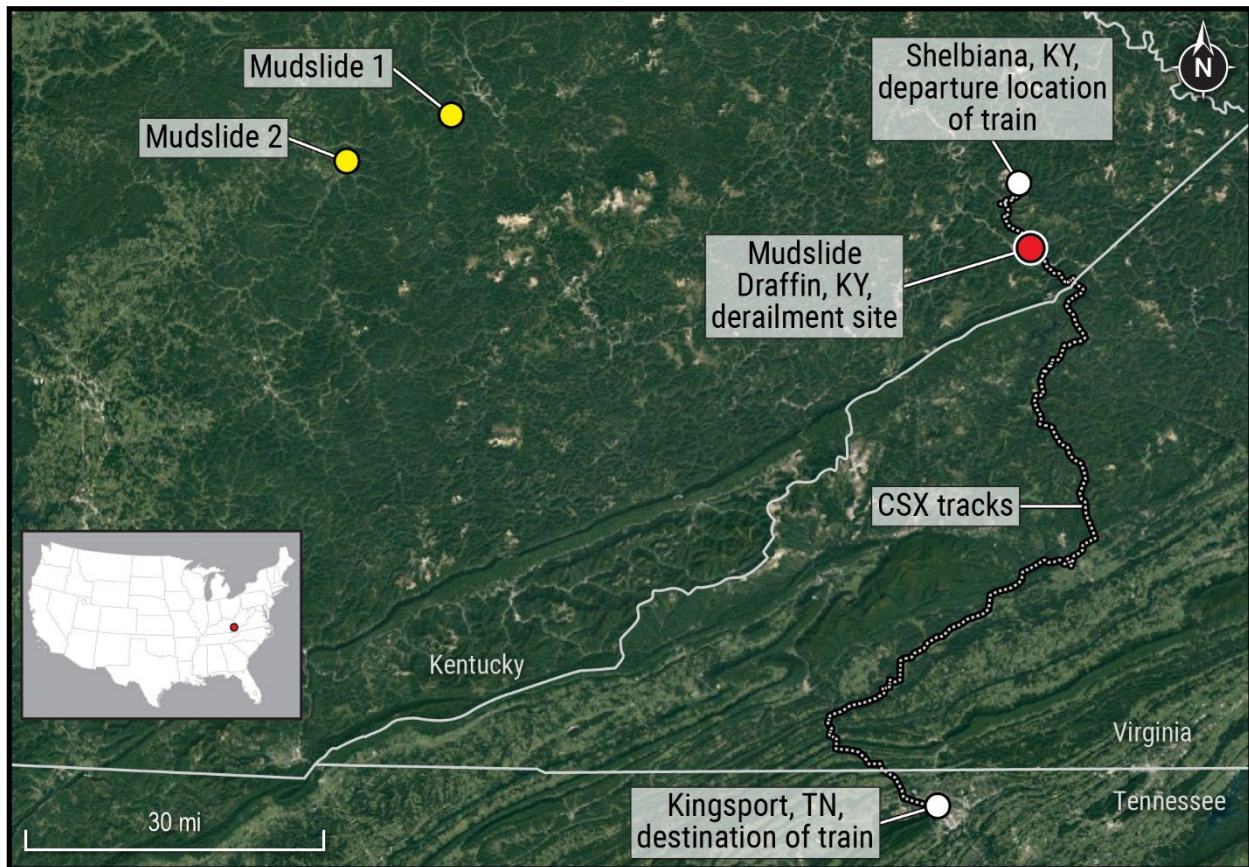
Two local storm reports issued by the National Weather Service the evening before the accident (February 12) at 10:27 p.m. and 11:40 p.m. reported mudslides in Yeadon, Kentucky, and Eversole, Kentucky. The mudslide near Yeadon, Kentucky, was 50 miles west-northwest of the derailment site (mudslide 1) and the mudslide near Eversole, Kentucky, was 60 miles west-northwest of the derailment site (mudslide 2).¹¹ Figure 4 shows a satellite image with the location of the two mudslides the evening before the derailment, as well as the origination and destination points for the train and the location of the derailment.

Figure 4. Location of two mudslides the evening before the derailment in relation to the train's departure location, destination, and the derailment site.

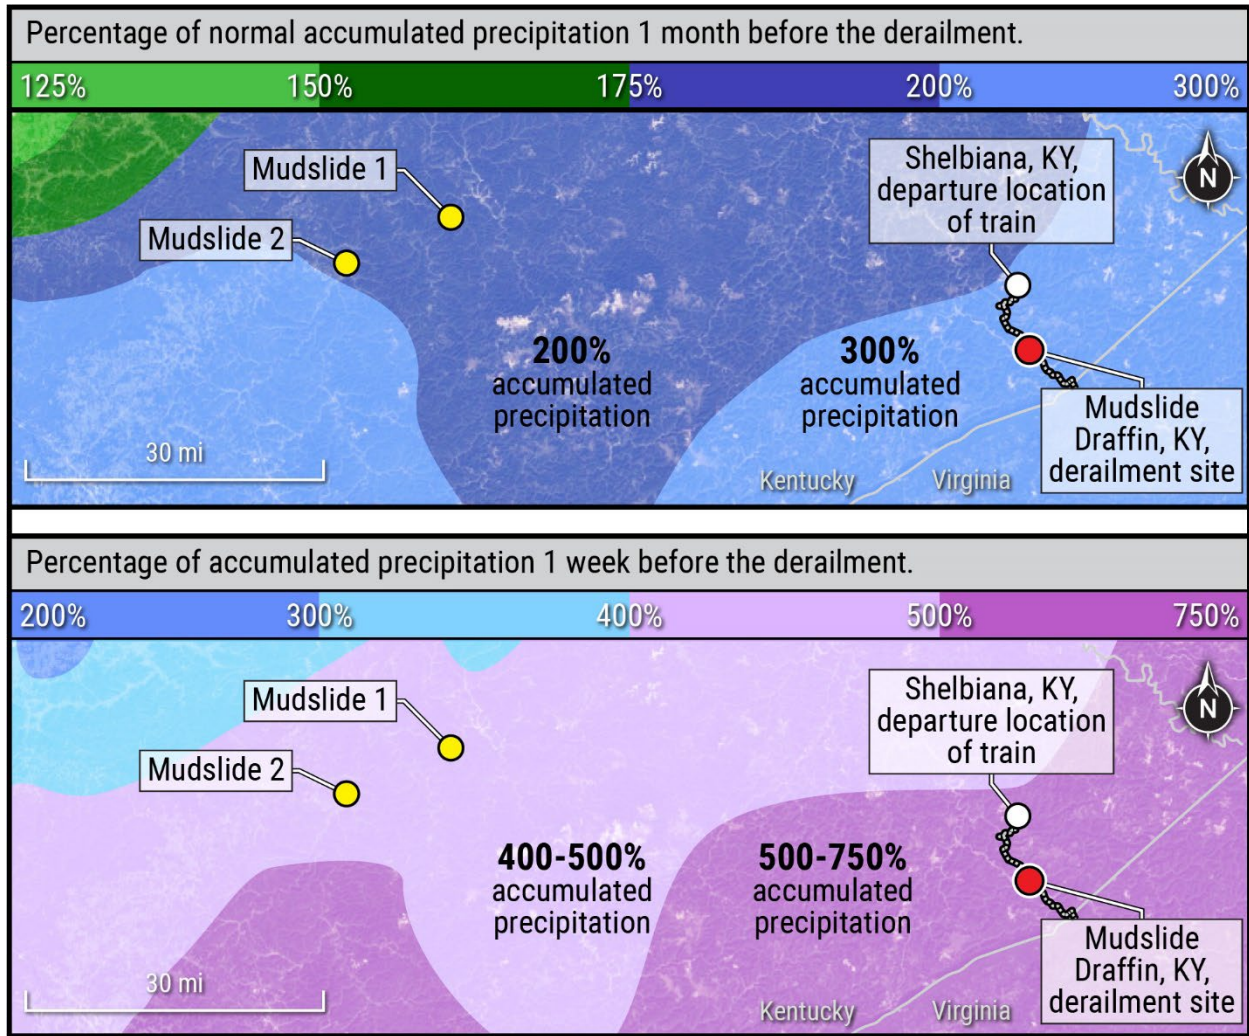
Figure 5. Graphic displays of the percentage of normal accumulated precipitation for both 1 month and 1 week before the derailment.
