Railroad Investigation Report RIR-23-14

Norfolk Southern Railway

Contract Roadway Worker Fatality

Reed, Pennsylvania
December 8, 2021

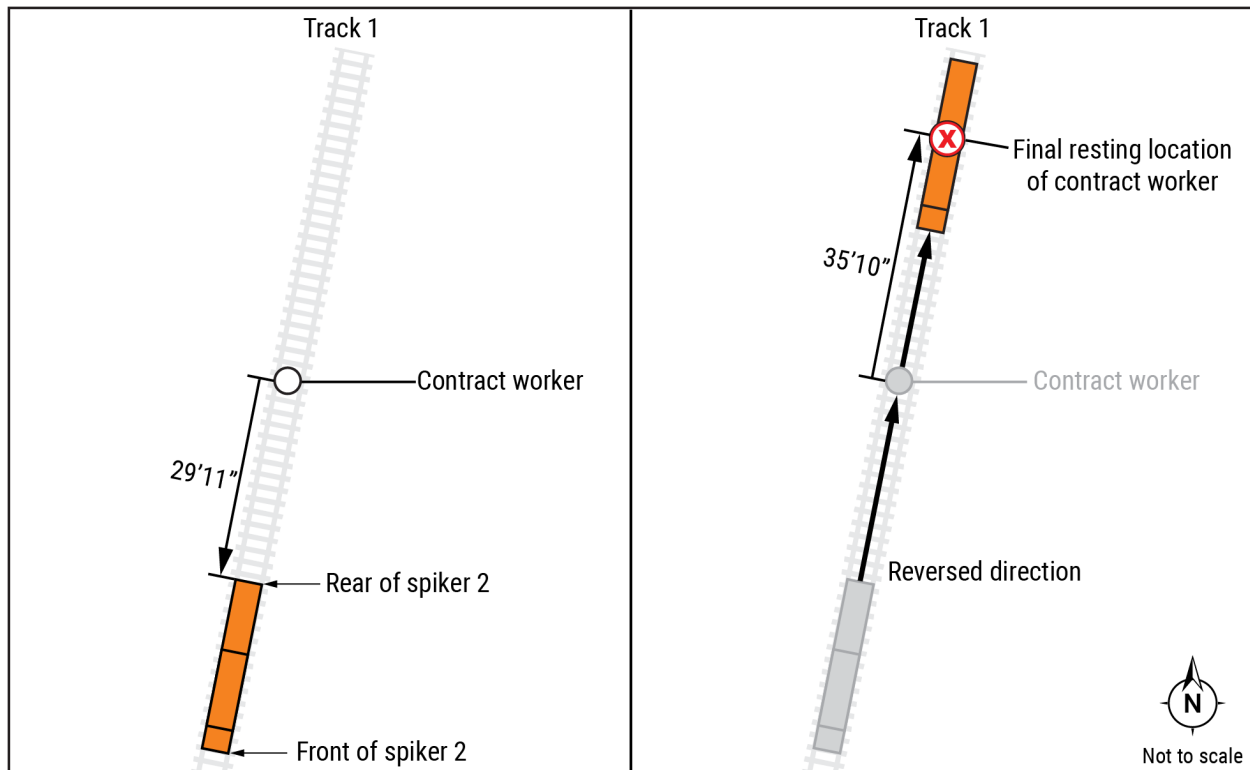
Figure 1 shows the accident location before impact, with the contract worker located 29 feet 11 inches north of the rear of Spiker 2 on the main track 1, and the final resting location of the contract worker beneath Spiker 2, 35 feet and 10 inches north of his original location as measured during postaccident site examinations.

Figure 1. Positions of Spiker 2 and contract worker before and after the accident.

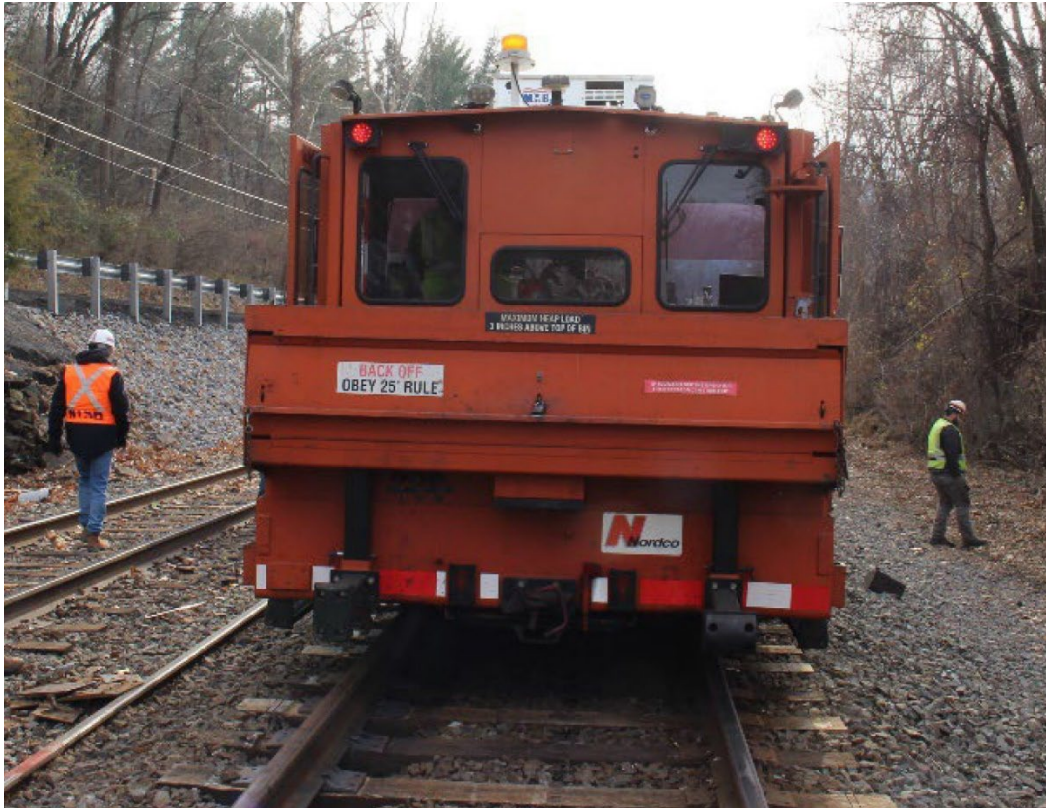
The spikers were also equipped with rear view mirrors as required by FRA regulations, one on each side of the machine.⁸ Warning signs affixed to the rear of the spikers alerted personnel to the standoff distance of 25 feet (NS 2019). (See figure 3.) According to the NS rail gang supervisor, some RMMs in the NS fleet are equipped with backup video cameras. The spikers working on the day of the accident were not.

Figure 3. Standoff warning sign on the rear of Spiker 2.

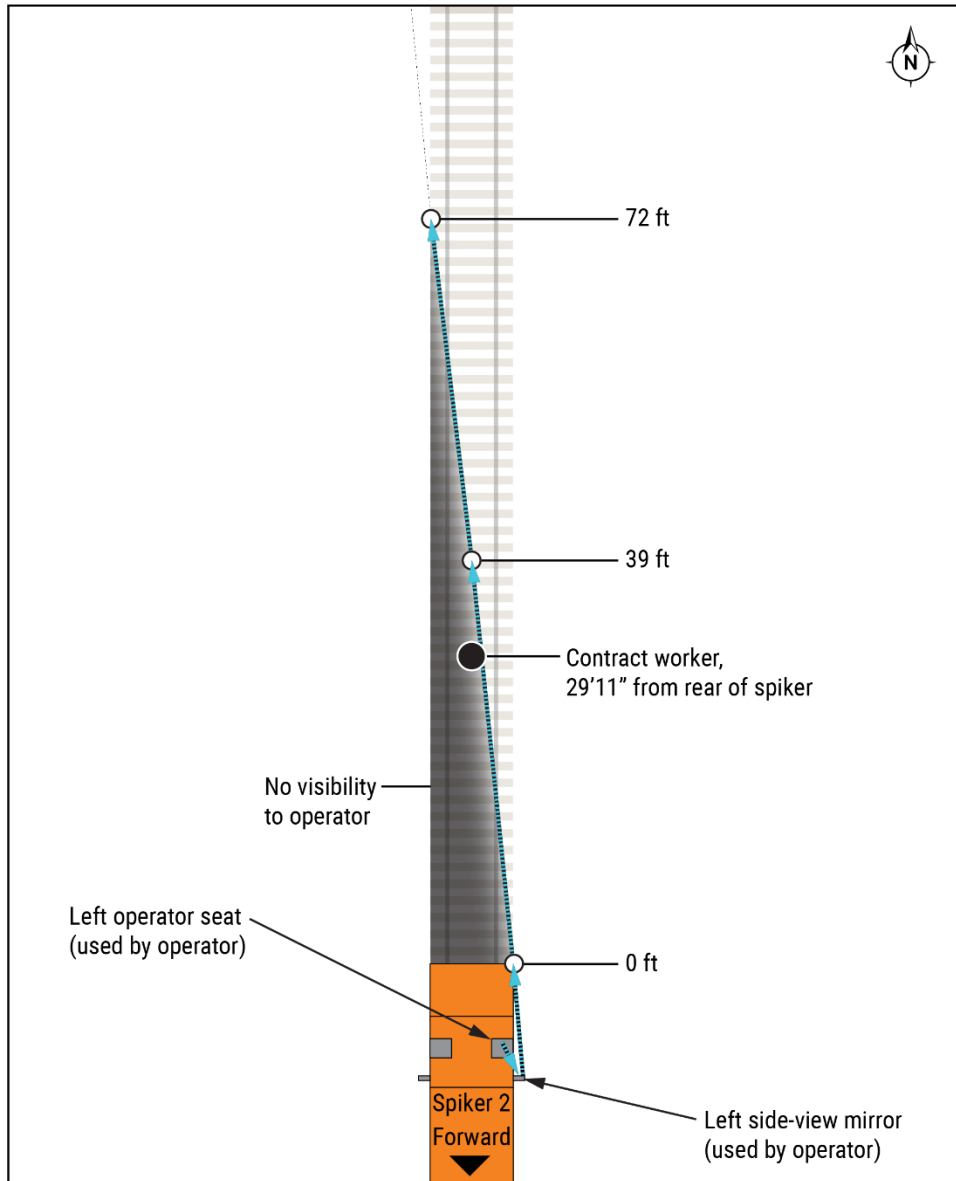
The white dots in figure 4 represent the points at which Subject 2, standing in three locations on the track, first became visible to Subject 1. This point was 72 feet from the rear of Spiker 2 on the left side of the track, 39 feet from Spiker 2 in the center of the track, and 0 feet from Spiker 2 on the right side of the track. The black dot represents the position of the contract worker just before the accident sequence.

Figure 4. Diagram of sight distance observations for Spiker 2.
