National Transportation Safety Board

Left Engine Failure and
Subsequent Depressurization
Southwest Airlines Flight 1380
Boeing 737-700
Philadelphia, Pennsylvania
April 17, 2018

Investigator-in-Charge
presentation

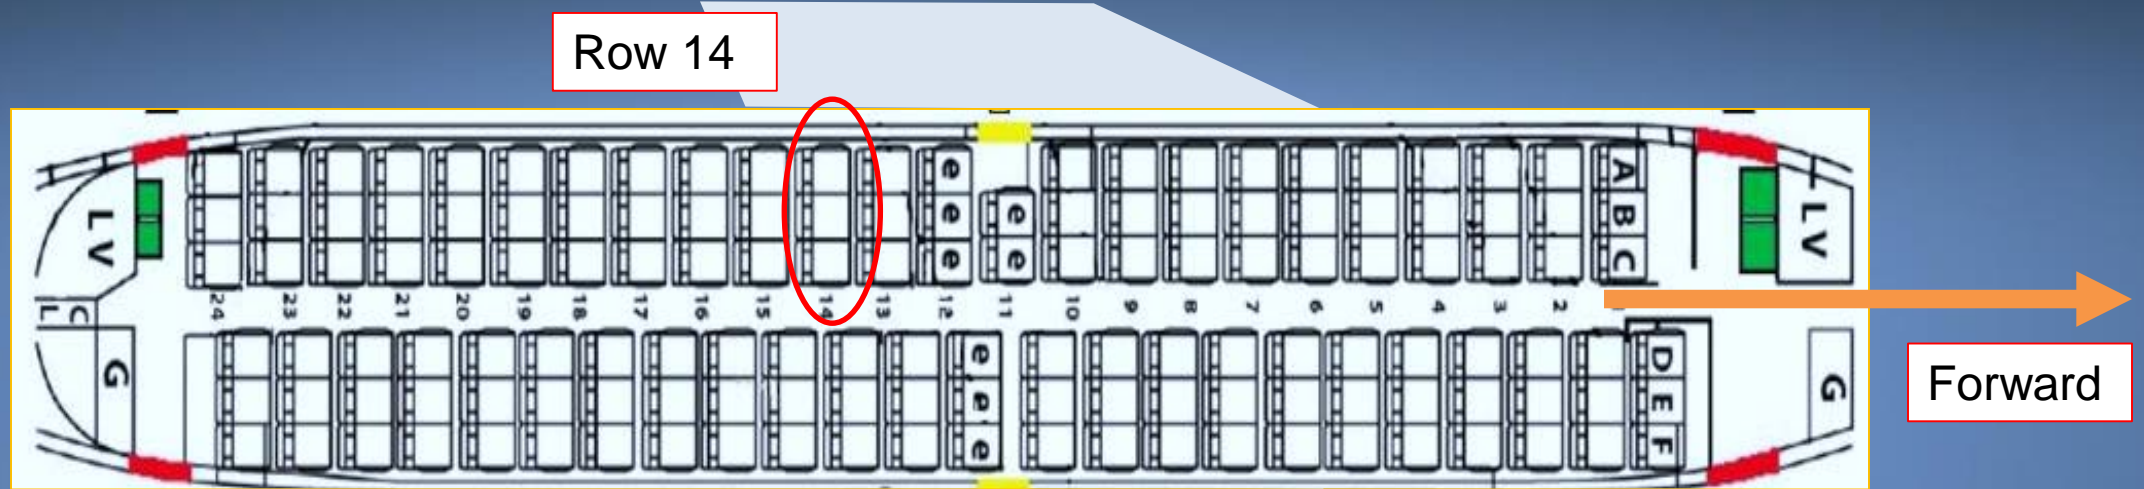
History of Flight: Cabin Safety

- Assisted injured passenger
- Passengers from row 14 required reseating
- Flight attendants not secured for landing

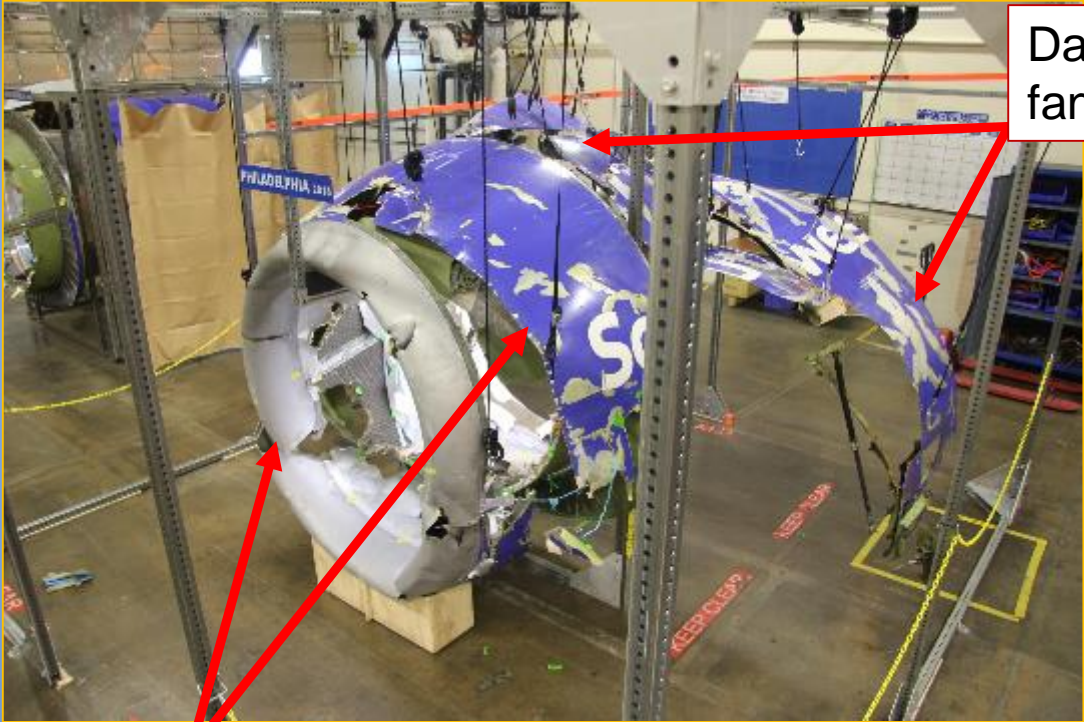
Inlet remnants

Damaged fan cowl

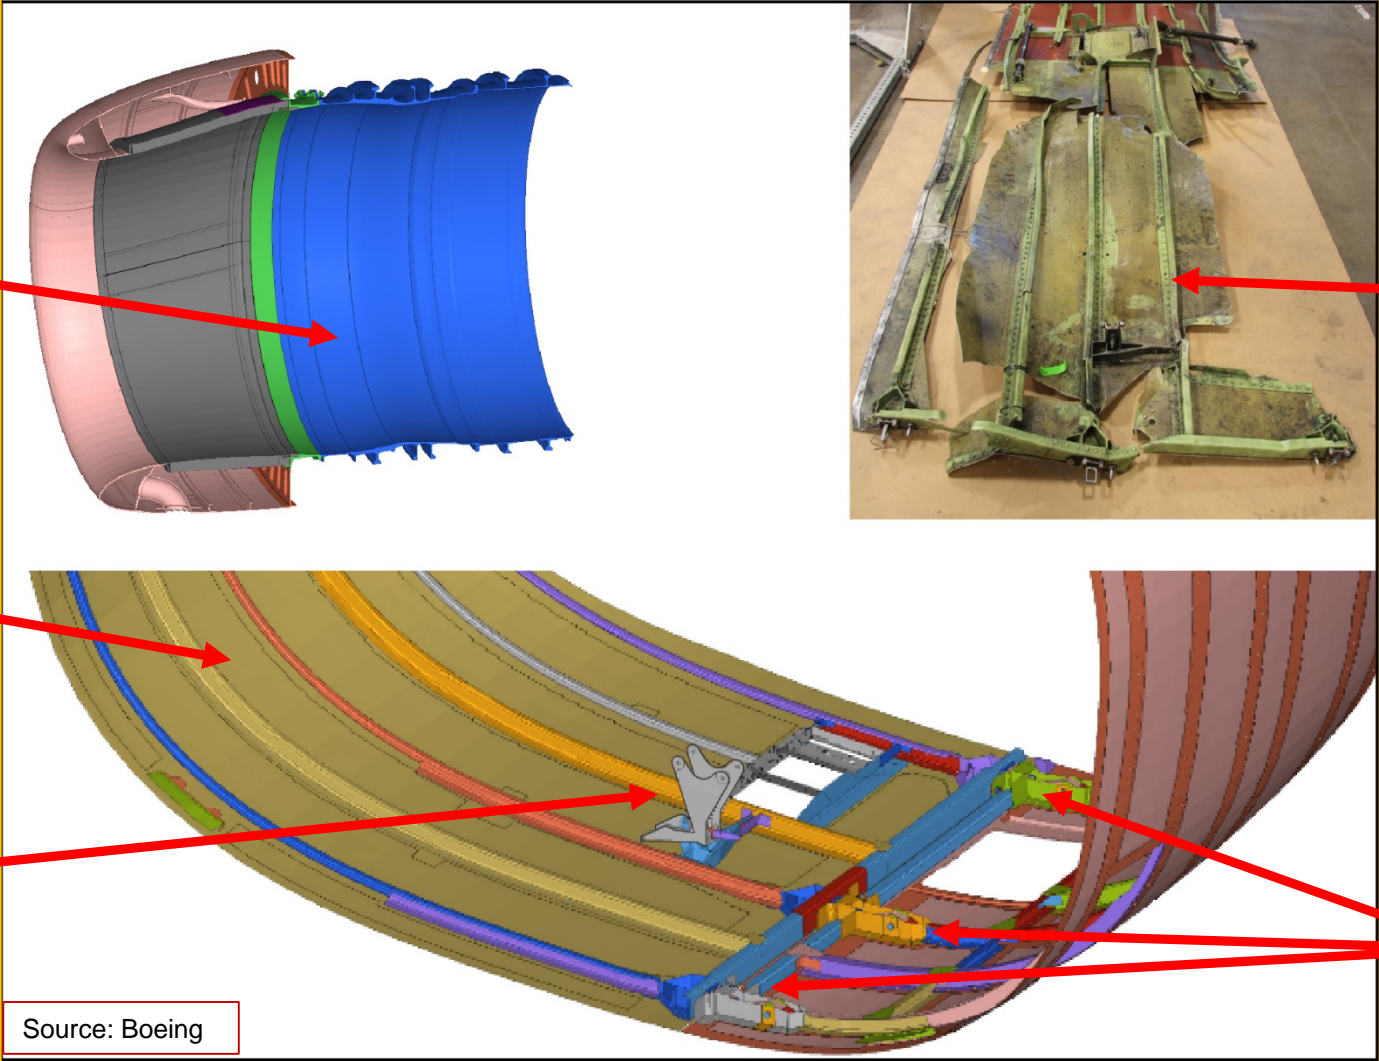
Cutaway of engine fan case

Damaged fan cowl portions
