National Transportation Safety Board

Left Engine Failure and
Subsequent Depressurization
Southwest Airlines Flight 1380
Boeing 737-700
Philadelphia, Pennsylvania
April 17, 2018

Powerplants and Materials
presentation

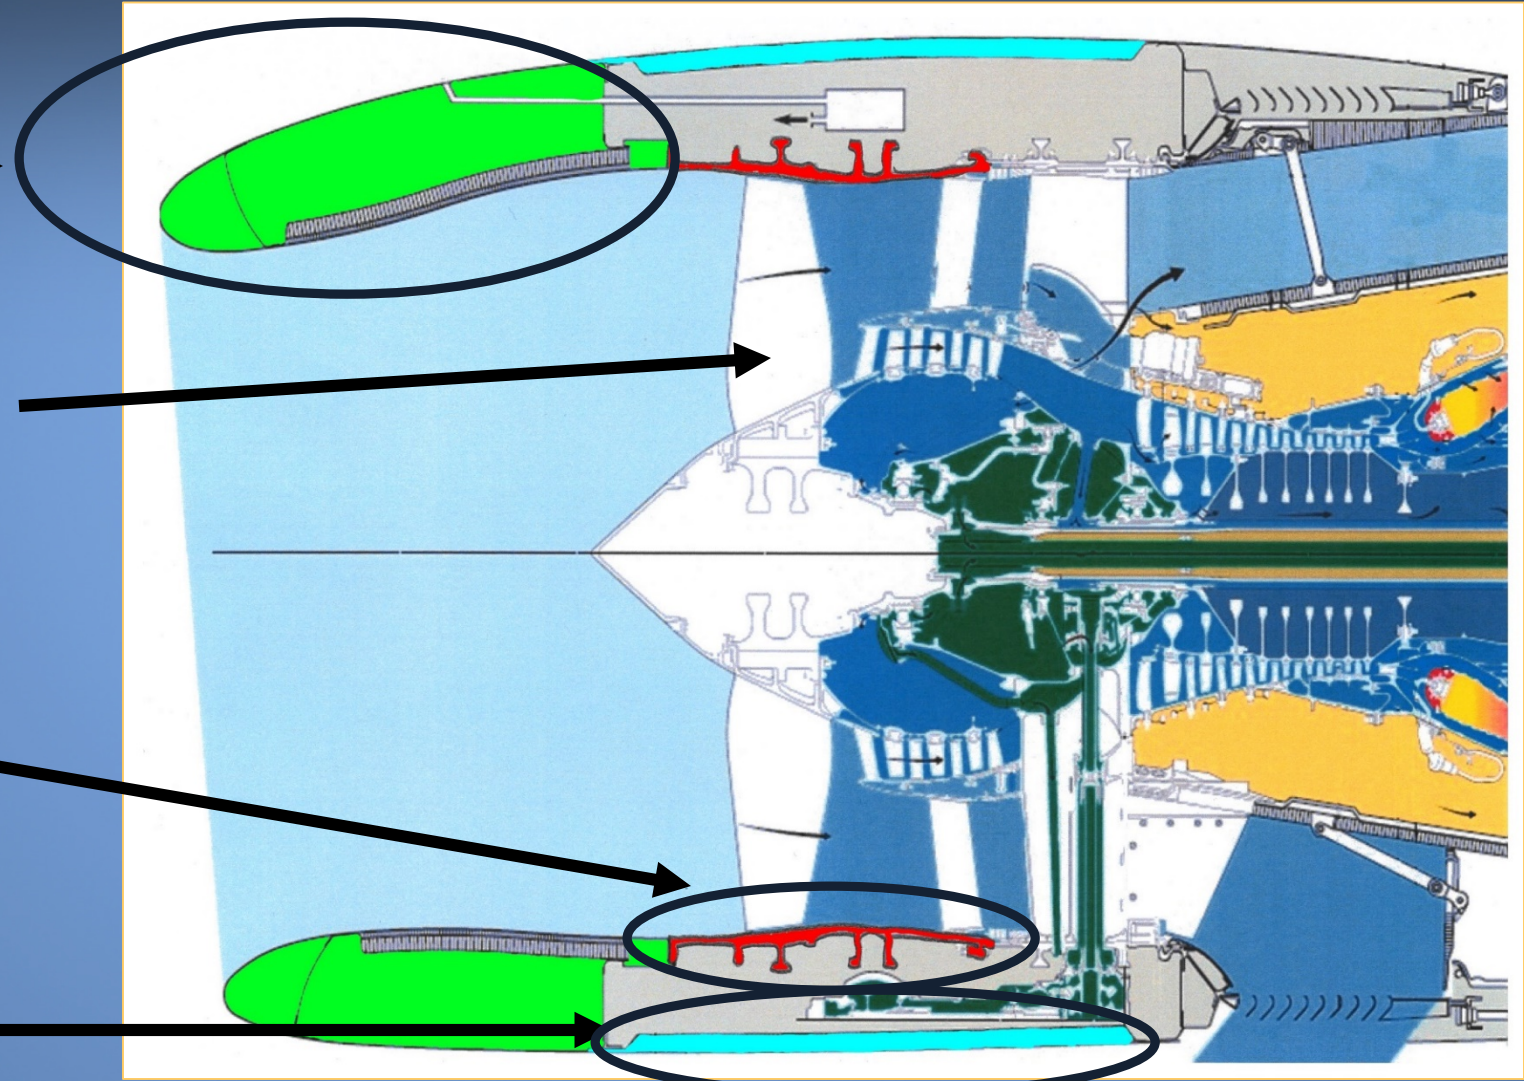
Failed Fan Blade

Fatigue crack

Fractured fan blade dovetail

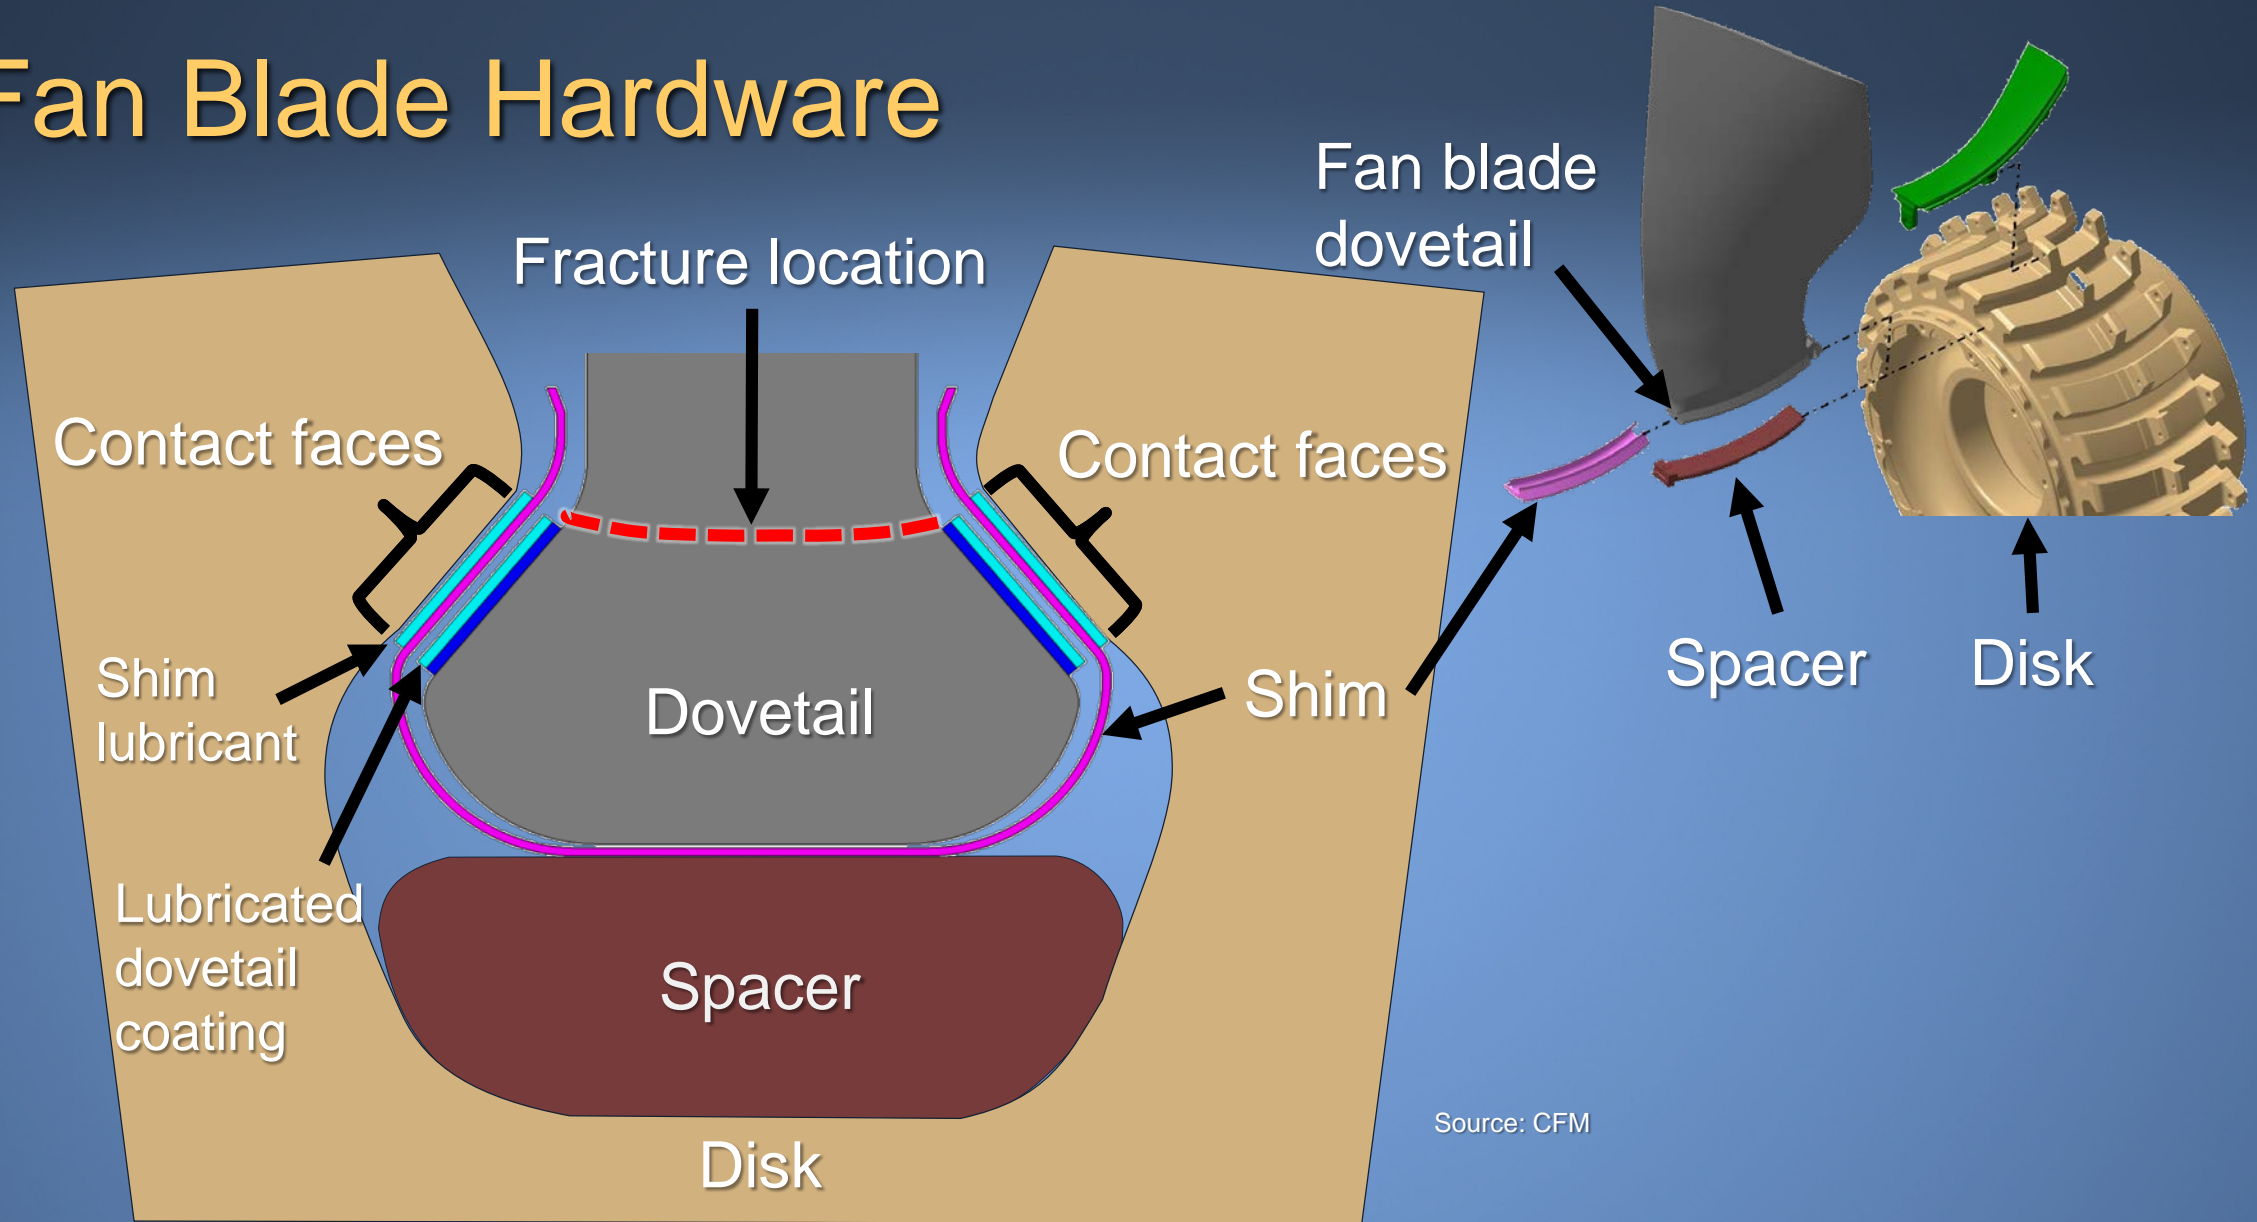
Fatigue Fracture

Likely Cause of Fatigue Crack Initiation

- Dovetail stresses greater than expected
- Dovetail coating damage and thickness variations
- Pressure face friction and edge loading
- Loss or relaxation of compressive residual stress

Fatigue Crack Growth

- One fatigue striation approximates one flight cycle
- Estimated 20,000 flight cycles total crack growth
- 10,712 flight cycles since last overhaul
- Crack likely not detectable by FPI at last overhaul or by visual inspections at relubrication
