# National Transportation Safety Board

Left Engine Failure and  
Subsequent Depressurization  
Southwest Airlines Flight 1380  
Boeing 737-700  
Philadelphia, Pennsylvania  
April 17, 2018

Aircraft Structures  
presentation

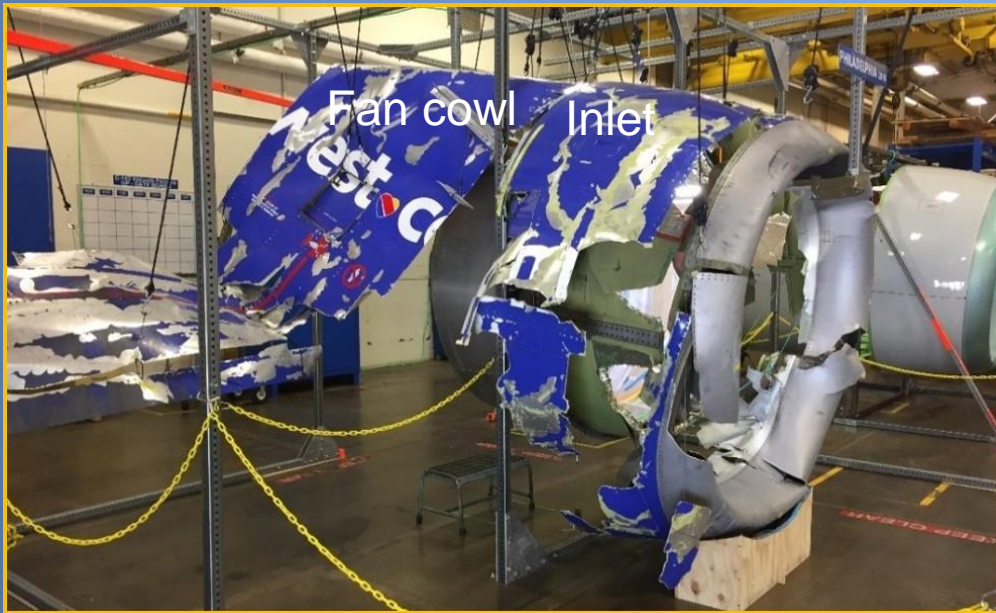
Inboard View

# Inlet Failure

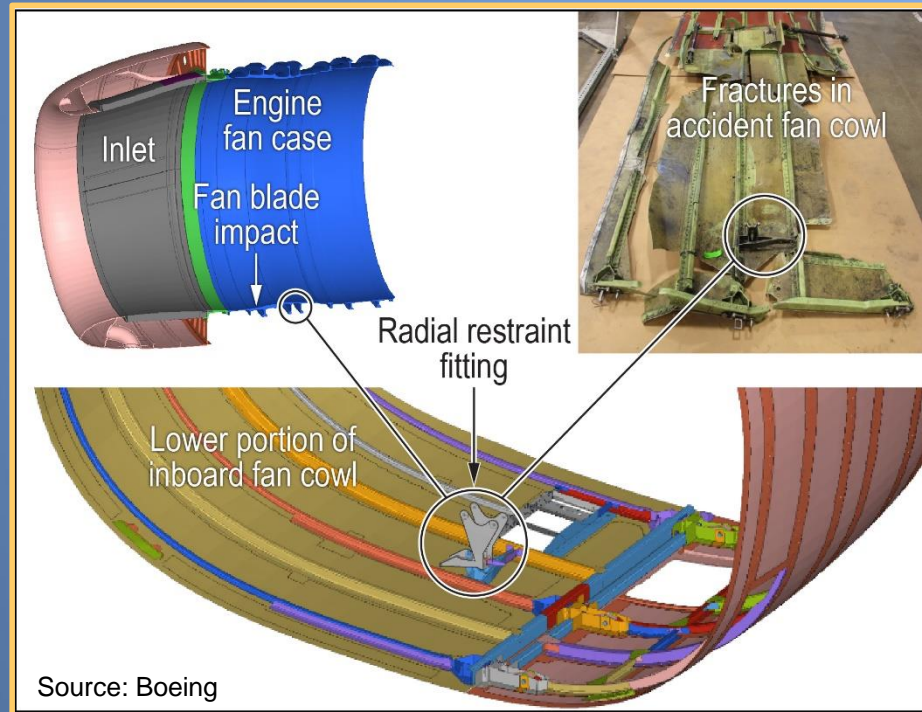
## Radial Restraint Fitting

# Fan Cowl Failure

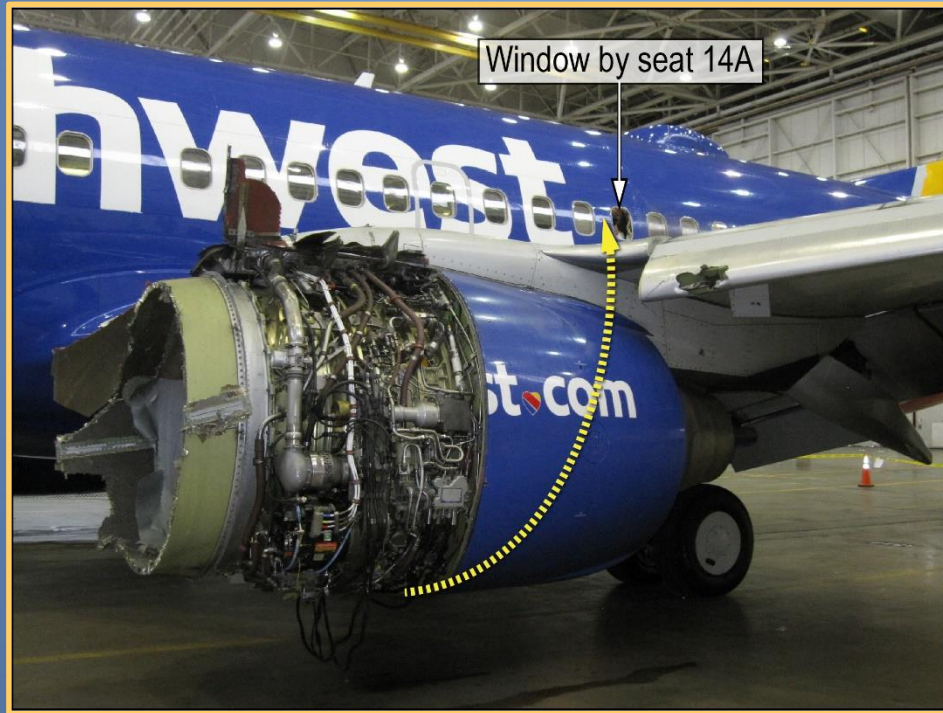
## Inboard Aft Latch Trajectory

# Accident Sequence
