National Transportation Safety Board

Left Engine Failure and
Subsequent Depressurization
Southwest Airlines Flight 1380
Boeing 737-700
Philadelphia, Pennsylvania
April 17, 2018

Survival Factors
presentation

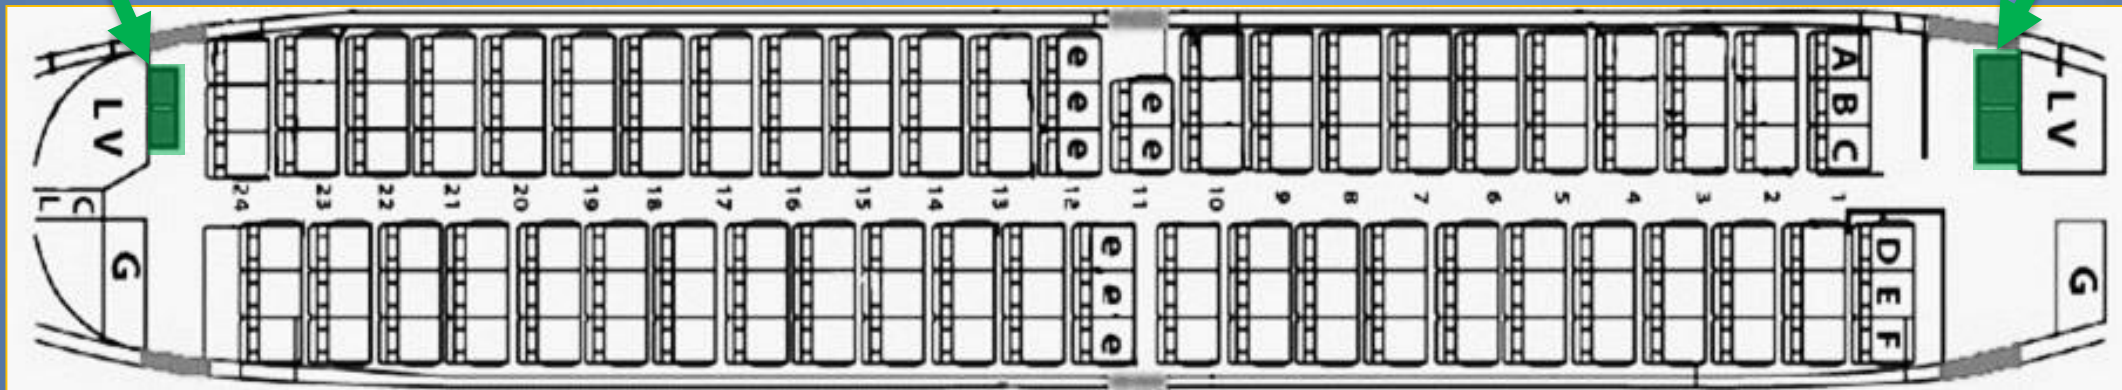
143 Passengers
143 Cabin seats

Forward
