Atlas Air Inc., Flight 3591
Boeing 767-375BCF
Trinity Bay, Texas
February 23, 2019
Operational Factors
Presentation

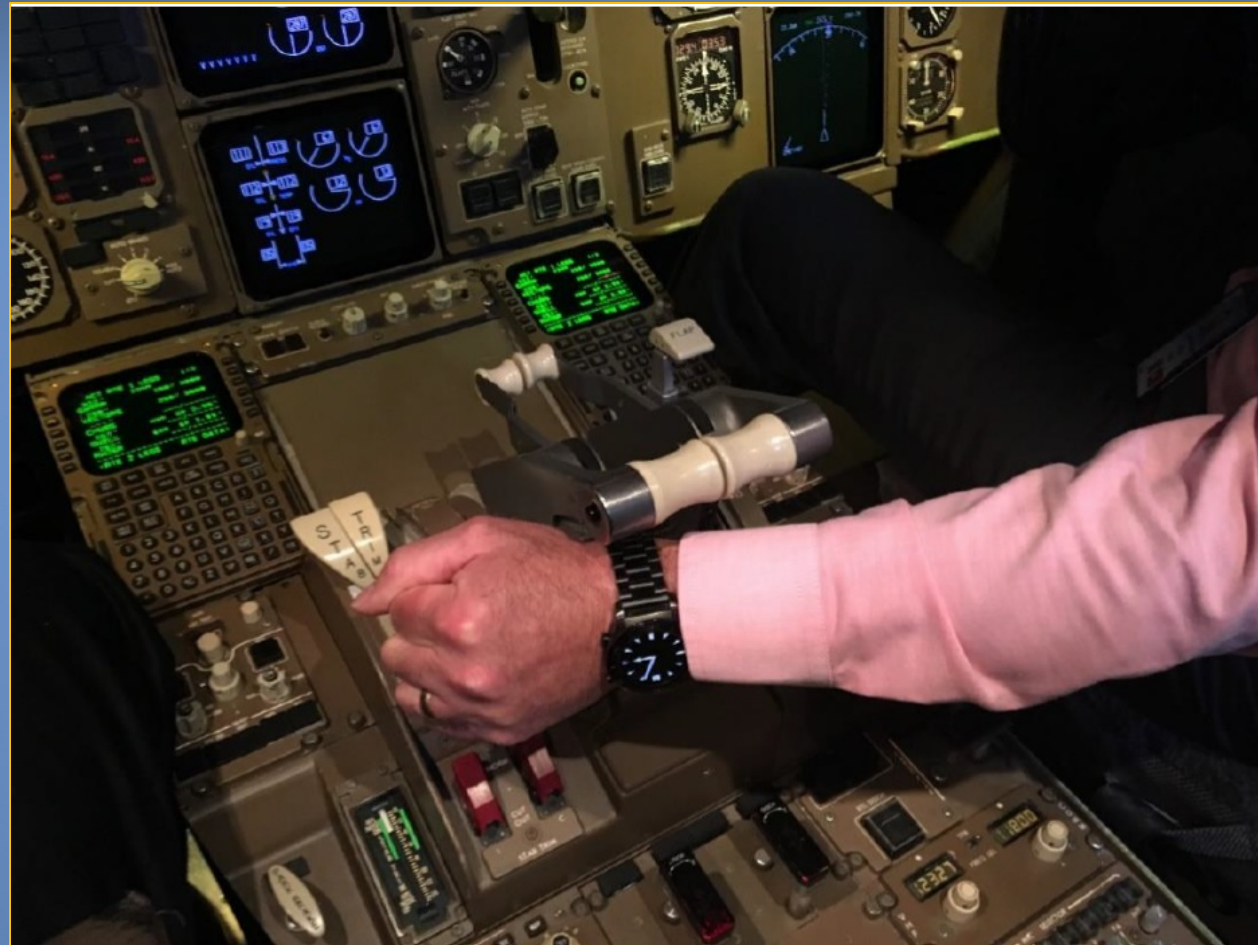
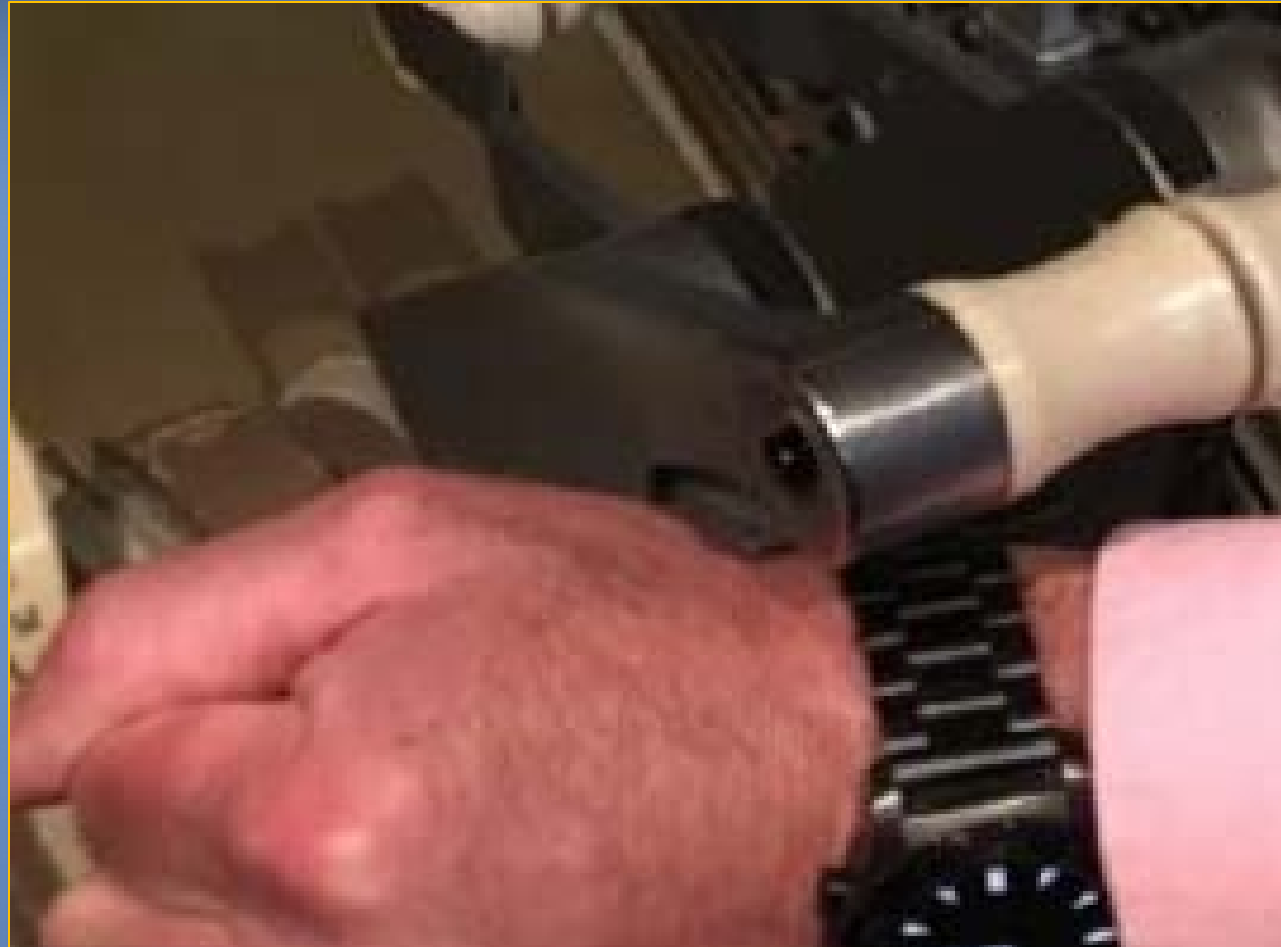
Inadvertent Go-Around

- FO did not effectively scan and interpret instruments, incorrectly concluded airplane was stalling
- Manual control inputs overrode autopilot
- FO had history of impulsive actions during training scenarios
