# National Transportation Safety Board

Capsizing and Sinking of Commercial Fishing  
Vessel *Scandies Rose*  
Sutwik Island, Alaska  
December 31, 2019

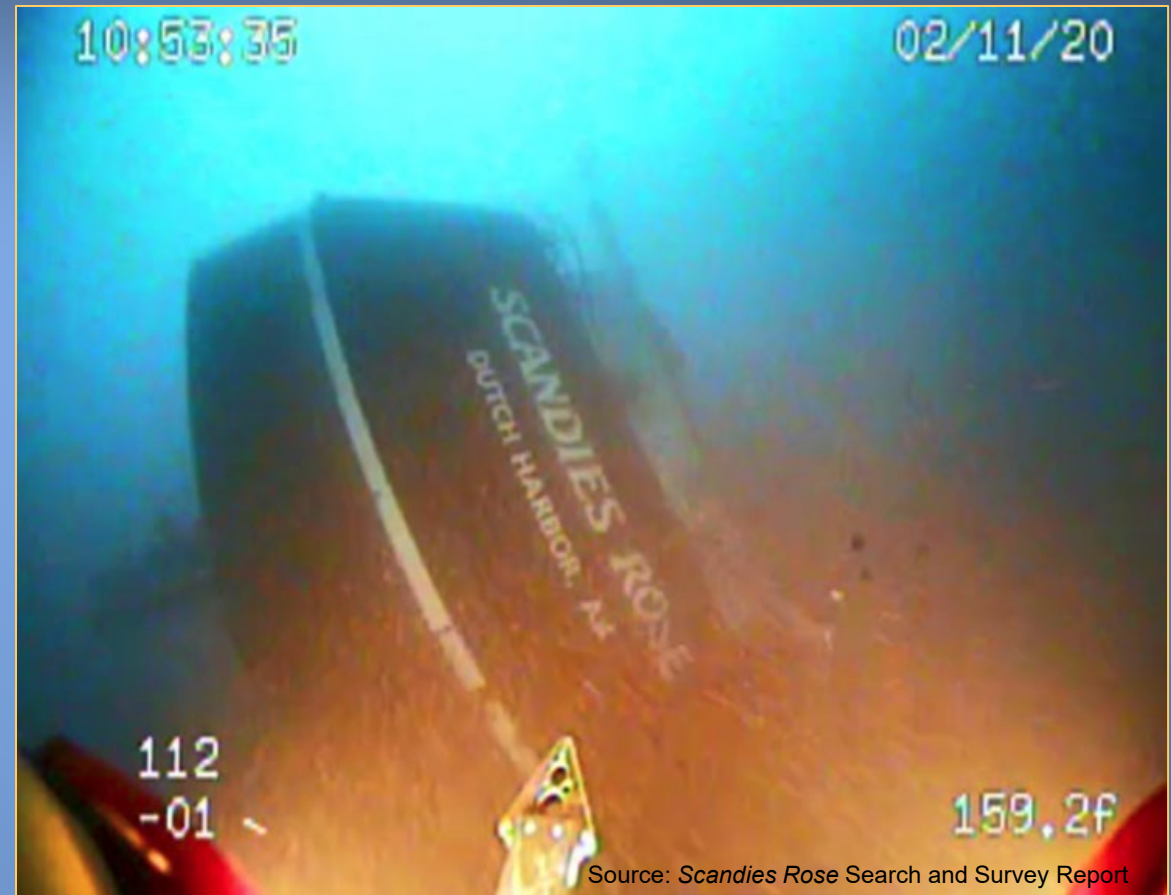
- Vessel located in 160 feet of water, 1,100 feet from mayday position
- Emergency Position Indicating Radio Beacon (EPIRB) was not located
- No visual indication of hull breaches

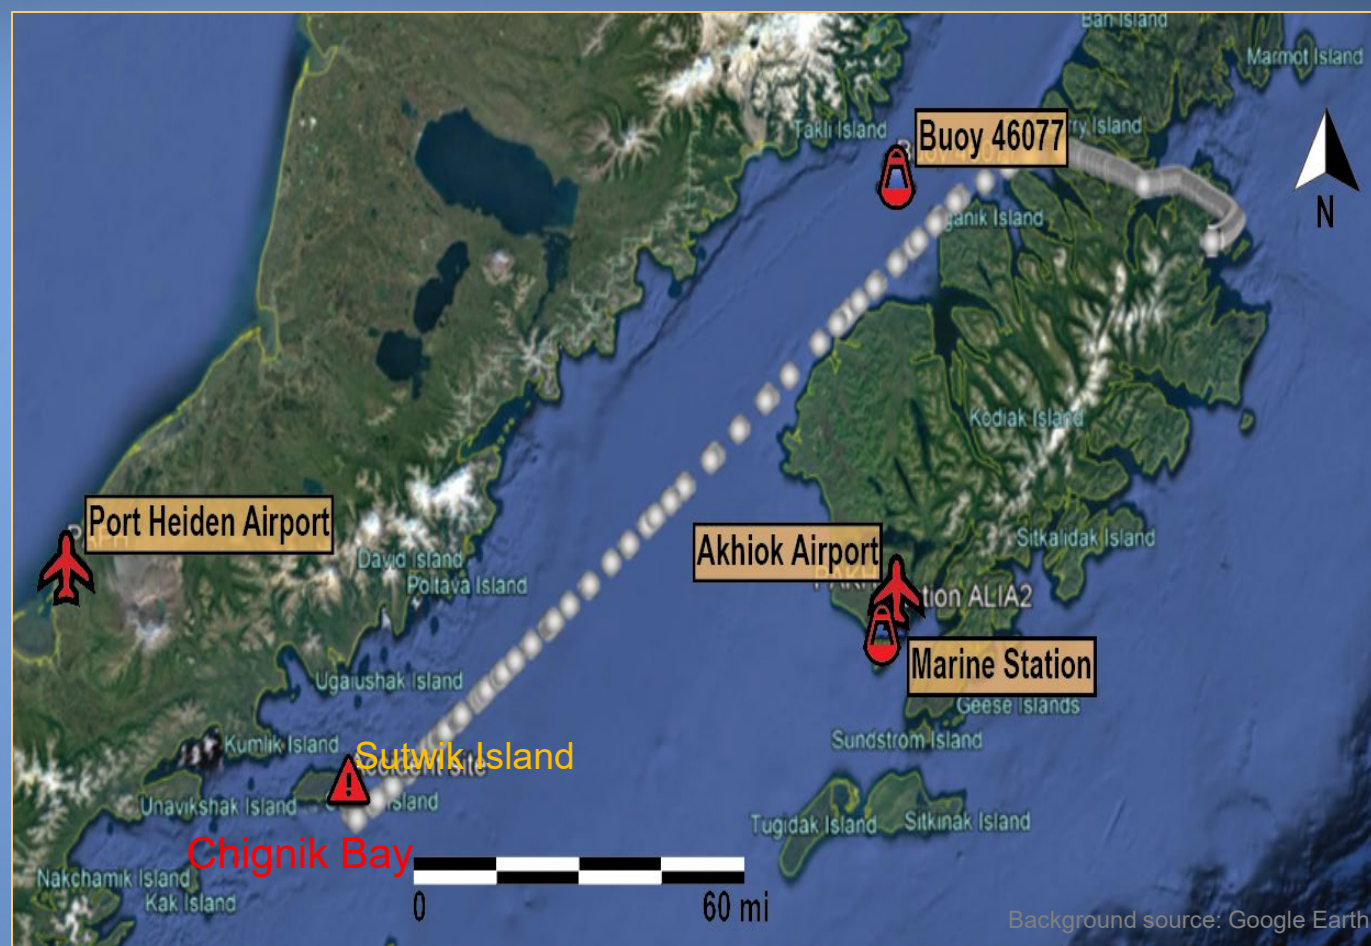
- Closest weather observation south of Alaskan Peninsula nearly 100 miles away

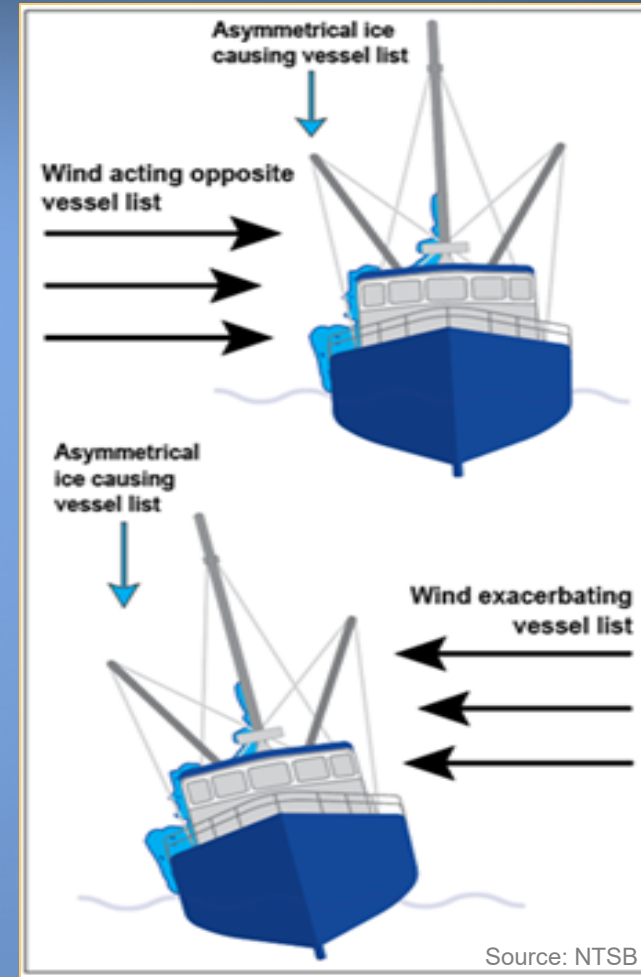
- Starboard list created by ice accumulation
- Initially wind and waves counteracted list
- Following vessel heading change, wind and waves exacerbated list
