National Transportation Safety Board

Atmos Energy Corporation
Natural Gas-Fueled Explosion
Dallas, Texas
February 23, 2018

Investigation Overview
Dallas, Texas
February 23, 2018

Examination of Gas Main

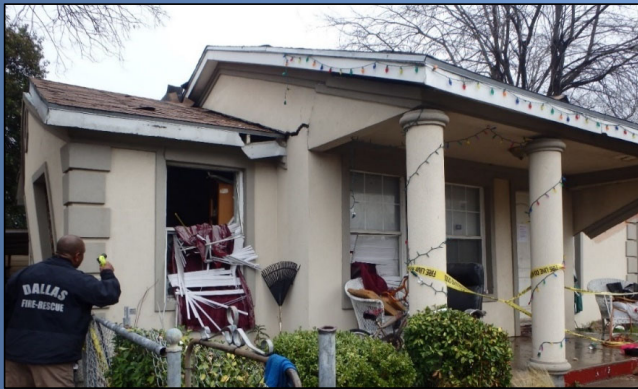
February 21, 2018 – 5:49 a.m.
Explosion and fire reported

3527 Durango Drive
One injury - second-degree burns

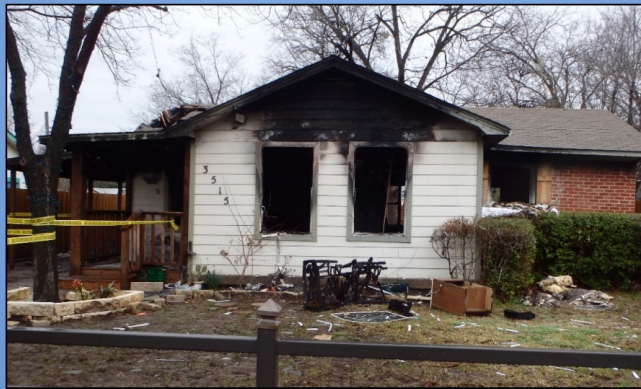
February 22, 2018 – 10:21 a.m.
Fire reported

3515 Durango Drive
One injury - second-degree burns

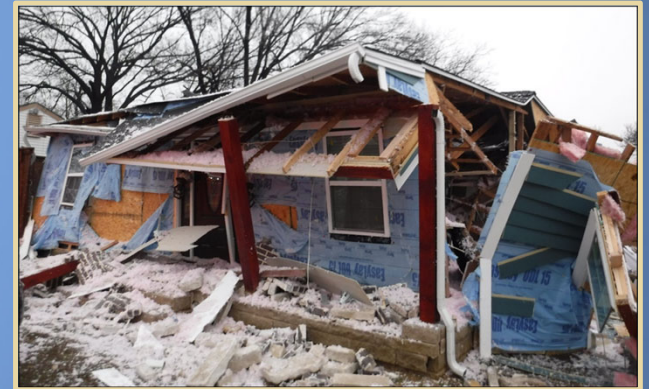
February 23, 2018 – 6:38 a.m.
Explosion reported

3534 Espanola Drive
Five injuries - one fatal

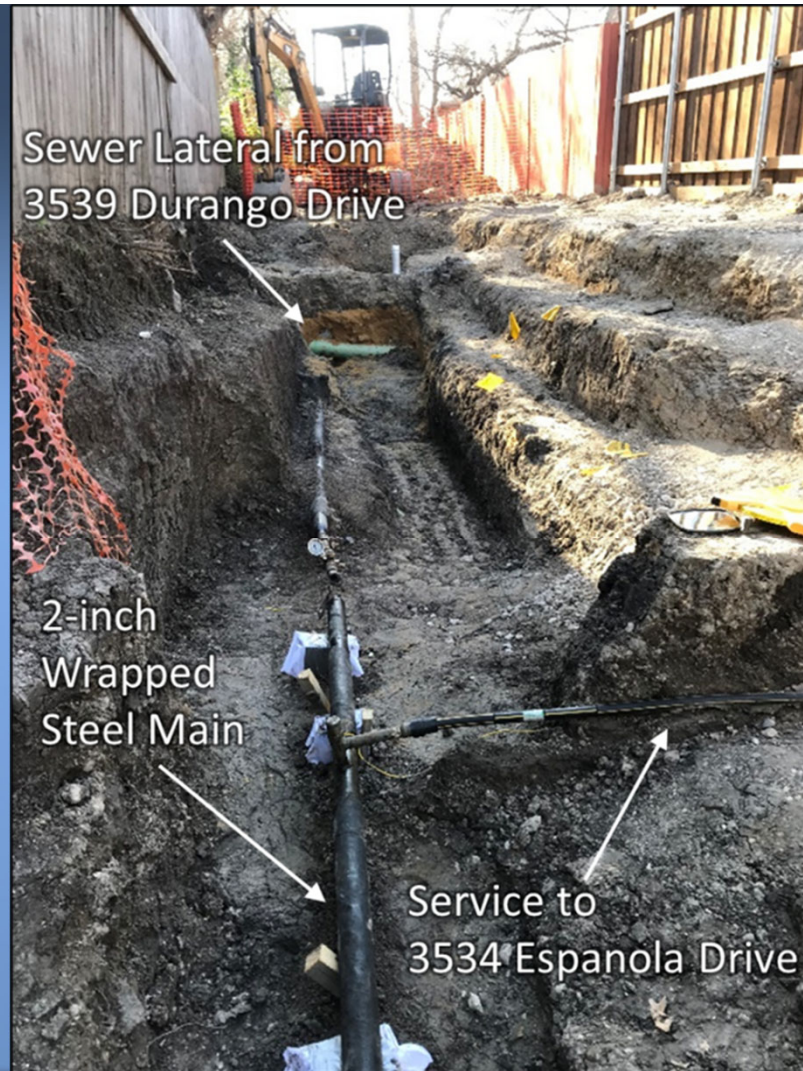
Gas Migration

- Gas indicated
 - between cracked main and explosion home
 - over sewer main
- Accumulated within home
- Ignited by an unknown source

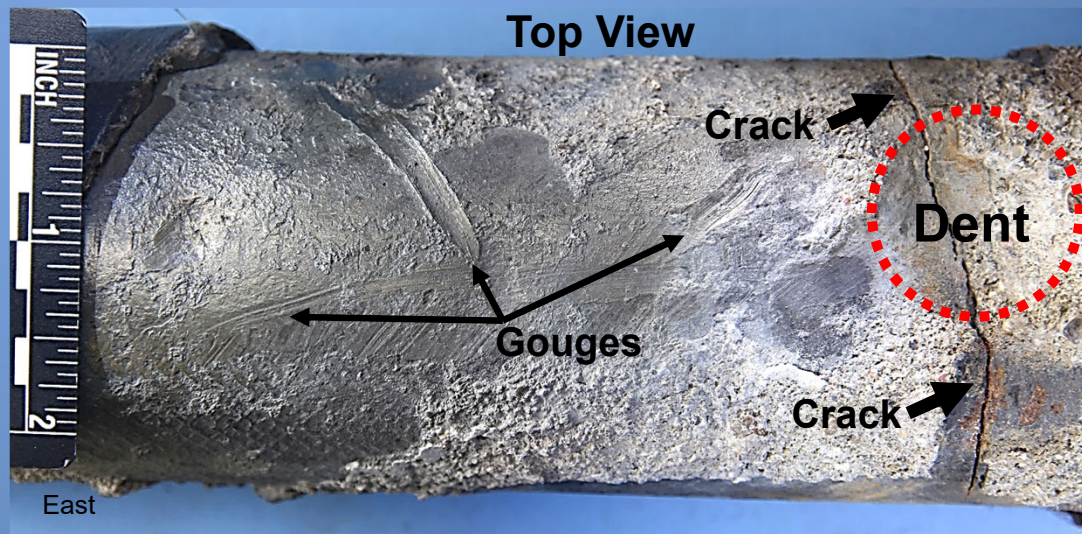
Post-cleaning

Dent and gouges

- Typical of damage from digging operation
- Consistent with those caused by excavation equipment (not from a shovel)
- Most likely resulted when sanitary sewer lateral was replaced in 1995

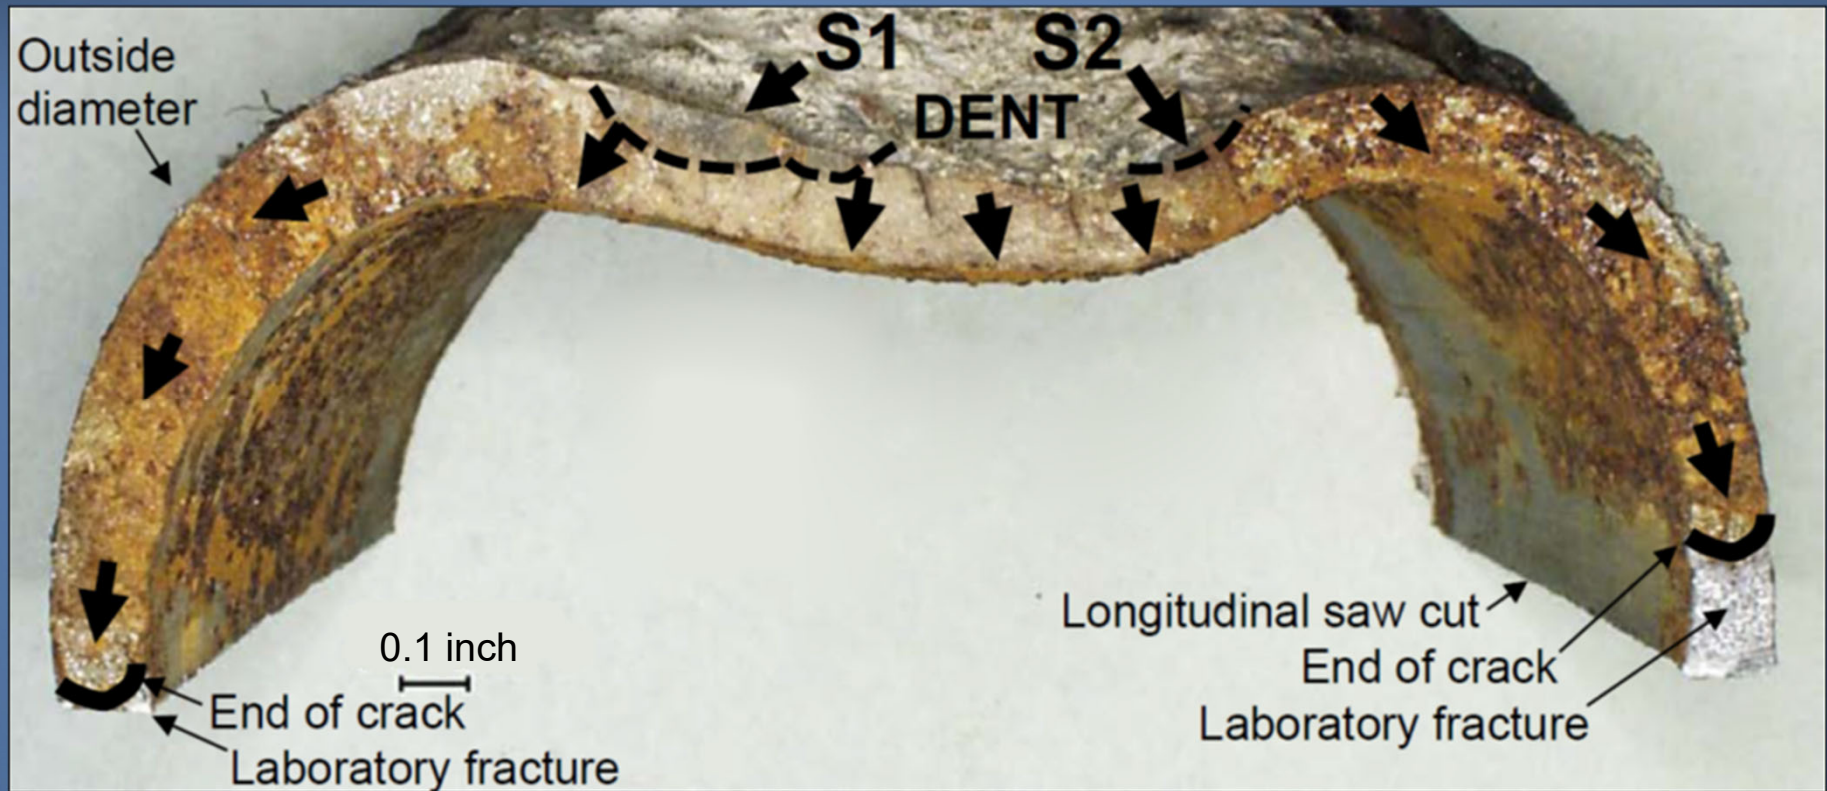
Gas Main Fracture Sequence of Events

- Fracture surface contained corrosion and calcareous deposits
- Through-wall crack was present for an extended period of time
- Fracture preceded all three fire/explosion events

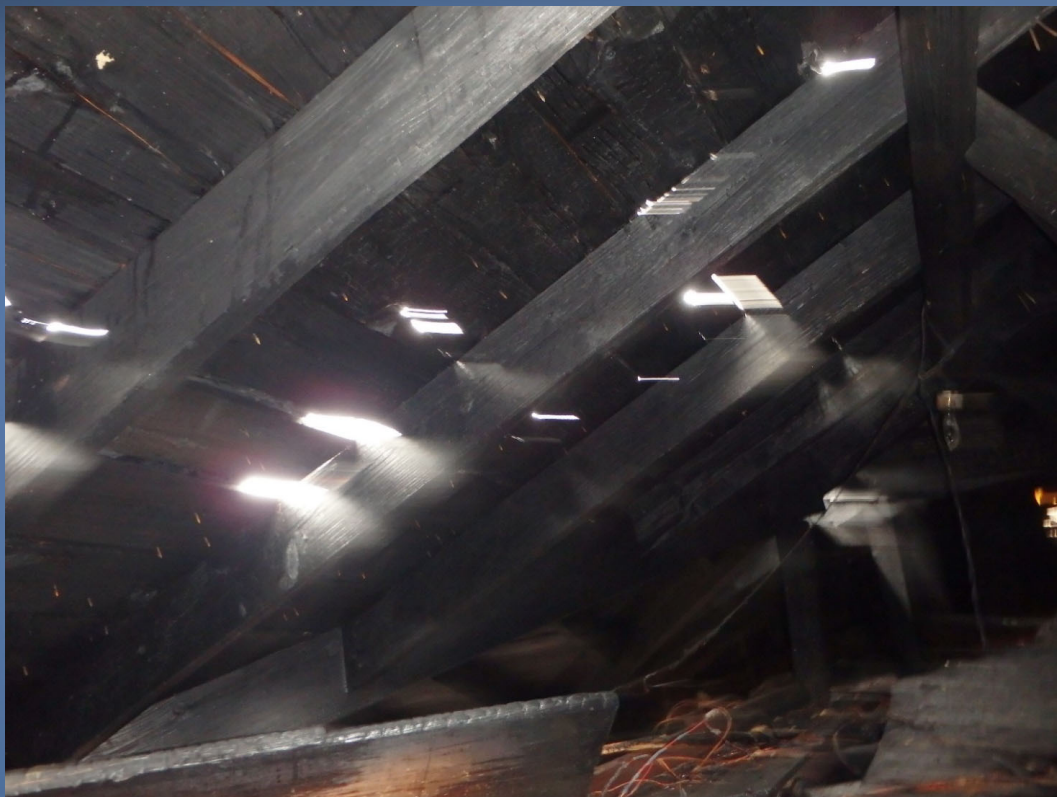
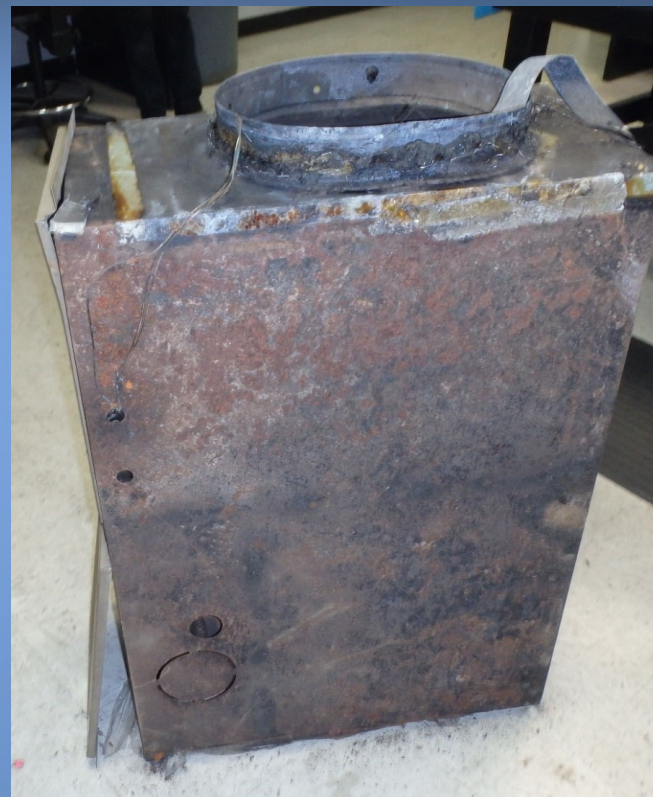
- Damage consistent with a fuel gas/air mixture explosion
- Gas entered the structure through the new addition and spread up into the attic
- Most likely source of gas was Atmos-owned gas lines
 - Gas range, hot water heater, customer piping excluded
- HVAC the most likely ignition source

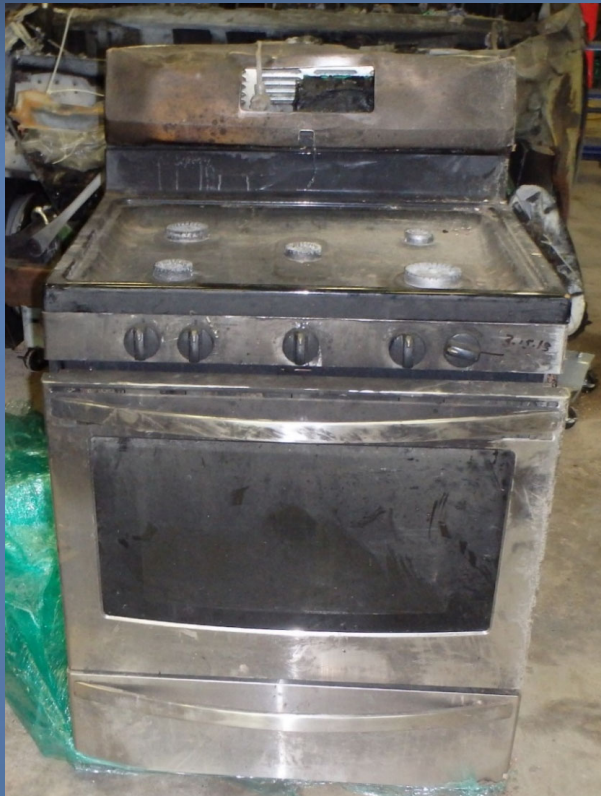
- Gas range sooted and exhibited thermal damage
- Although not tested, no obvious signs of failure or malfunction found during visual examination
- Neighbor reported similar incident

- Kitchen most likely origin of fire
- Damage not consistent with structure fire
 - Firefighting efforts not ruled out
- Exact cause of the incident could not be determined
 - Evidence that natural gas existed within the structure
 - Not all accidental causes could be excluded
