National Transportation Safety Board

Operational Factors

Initial Information

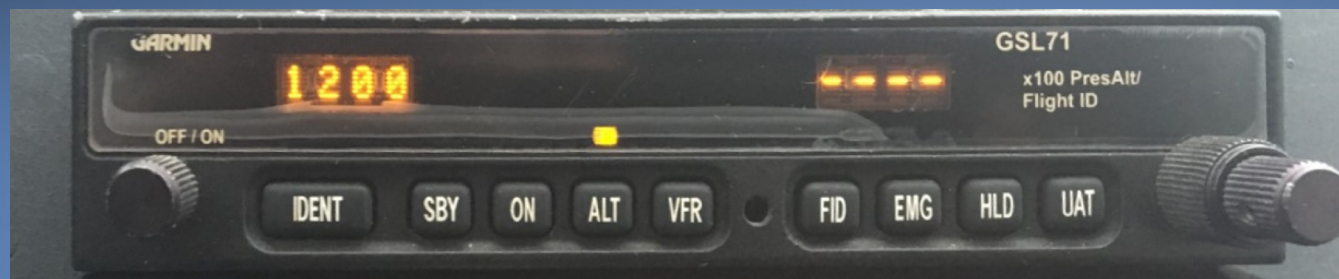
Garmin GSL 71

- Unit was OFF during the accident flight
- Unit was likely turned OFF during routine maintenance two weeks before the accident
- Unit was never subsequently turned ON
- Otter pilot unaware the unit was OFF
