Special Investigation Report on Railroad and Rail Transit Roadway Worker Protection

NTSB/SIR-14/03
PB2015-100583

NTSB/SIR-14/03
PB2015-100583
Notation 8595
Adopted September 24, 2014

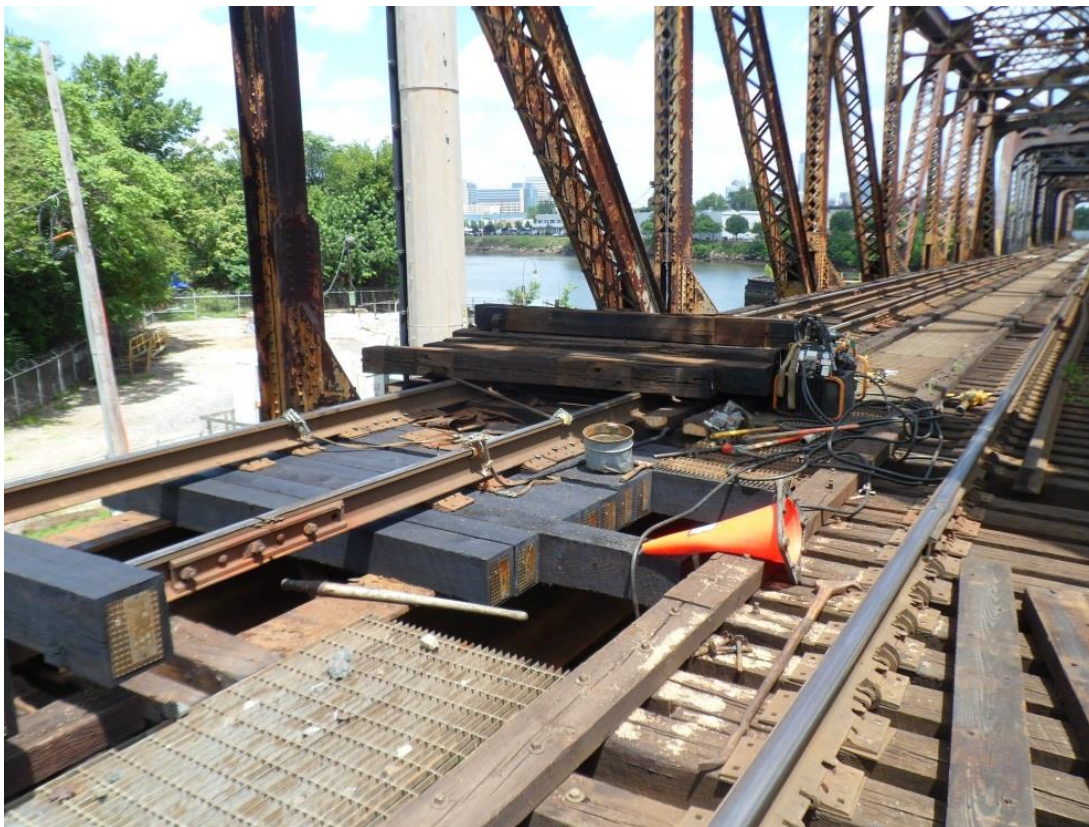
The bridge had a walkway constructed of sections of steel grating that became unsecured (loose) when a walkway support joist was cut off to facilitate timber replacement.¹³ The foreman

The foreman stated that after the joist had been cut he untied his lanyard from the rail and carried the chain saw east to put it out of the way. Members of the work crew had differing recollections of where the assistant foreman was after the joist had been cut and when they last saw him on the bridge deck: he was on track 1 between the rails, or he was on track 2 between the rails, or he was moving between the two tracks. No one on the work crew saw the assistant foreman remove his fall protection gear or untie his lanyard. One crewmember, who was sitting in the cab of the hi-rail, which was parked on the track at the end of the bridge, at the time of the accident, recalled seeing the assistant foreman reflected in the side mirror of the hi-rail. He told NTSB investigators he saw the assistant foreman walking on the center walkway toward the hi-rail, and then the assistant foreman fell through a hole in the walkway. (See figure 4.)

Figure 4. Accident location on railroad bridge with loose grating removed.

1. Ensure that the grating be kept fastened, unless immediate work requires unfastening. Once the immediate work is complete, ensure that the fastening is reapplied.
2. Ensure that when grating is left unfastened, particularly when sections of grating are shorter than 20 feet, the unfastened grating is identified by marking or signage.
3. Ensure that workers on railroad bridges can safely walk around obstacles, such as on-track equipment.
4. Employ daily safety briefings with all bridge workers of any craft who may be exposed to the hazard of unsecured grating, and specifically identify the location and nature of the unfastened grating. Such daily safety briefings should address what fall protection is being provided and remind bridge workers of the likely specific circumstances when a personal fall arrest system is required or advised.

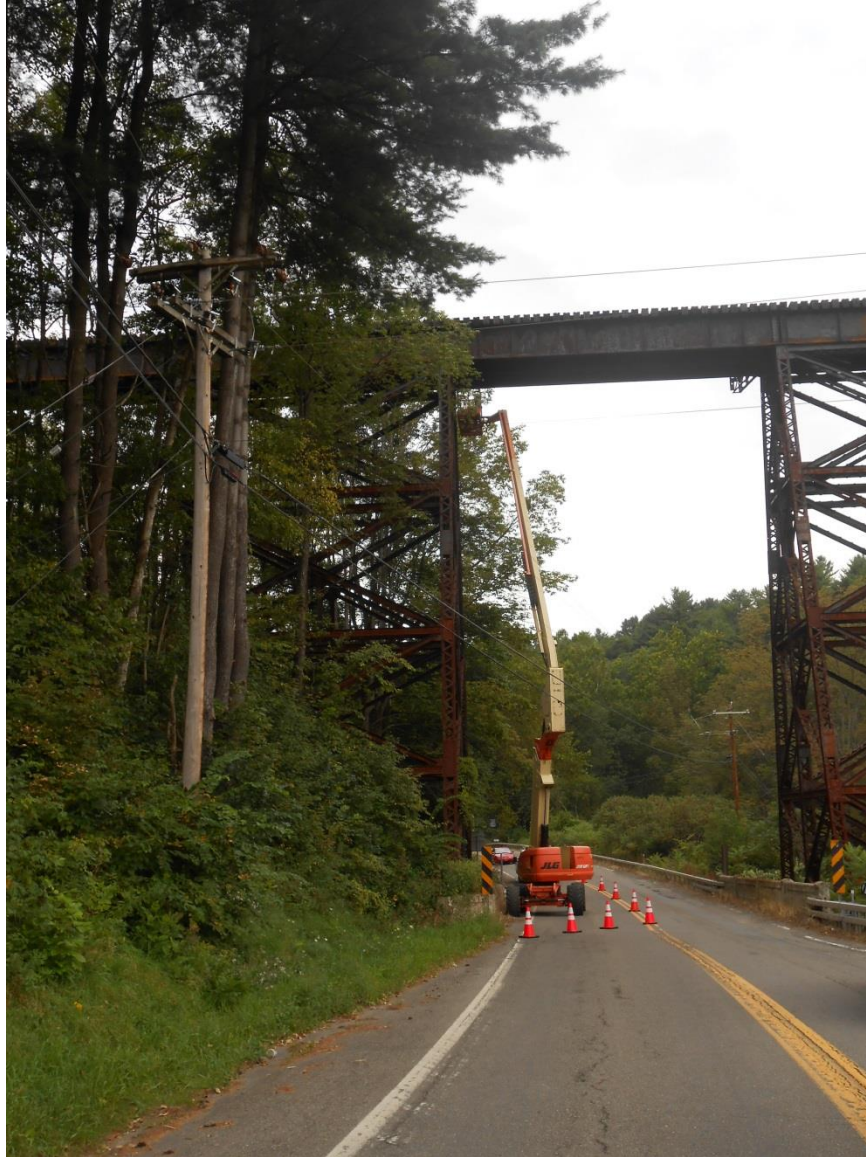
On August 26, 2013, a Canadian Pacific Railway (Canadian Pacific) Bridge and Building (B&B) assistant supervisor was fatally electrocuted while taking measurements of components of a railroad bridge about 60 feet above Highway 235 in Harpursville, New York. He was operating a telescopic boom lift from within the uninsulated bucket when the boom came into contact with an energized overhead power wire and the bucket touched the bridge support. (See figure 5.)

Figure 5. Telescopic boom lift and railroad bridge.

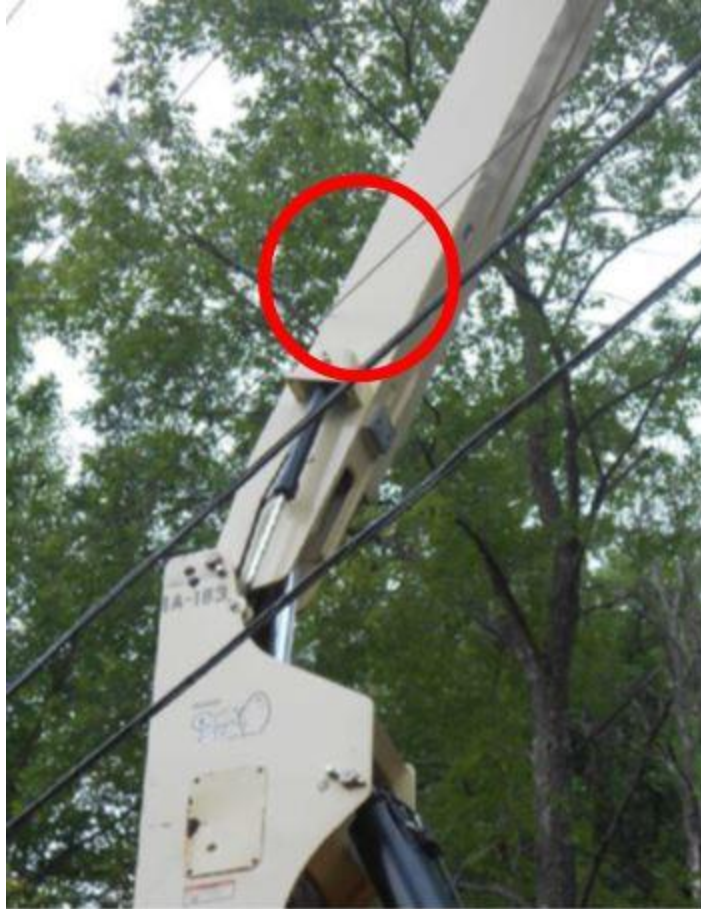
Once the lift was positioned near the highway under the bridge, the B&B assistant supervisor got in the bucket and began operating the lift, extending the boom and lifting the bucket so that he could take measurements under bridge span 9. As the bucket was elevated, the boom came near several wires situated under the bridge. The foreman said he heard the B&B supervisor tell the B&B assistant supervisor (who was operating the boom) that the boom was close to a wire. The B&B assistant supervisor asked the B&B supervisor whether that specific wire could be a tension wire or a guy wire for stabilizing the load between two poles and, if so, the boom's touching it would not be a problem. (See figure 6.)

Figure 6. Extended boom and wire.

The B&B supervisor convinced the B&B assistant supervisor that the boom was close to one of the wires, which was a live wire. They agreed to stop the job and return the bucket to the ground. As the B&B supervisor walked away to get a different perspective to view the operation, the B&B assistant supervisor moved the bucket. As he moved the bucket, the boom touched the live wire, and the B&B assistant supervisor was electrocuted about 11:15 a.m.

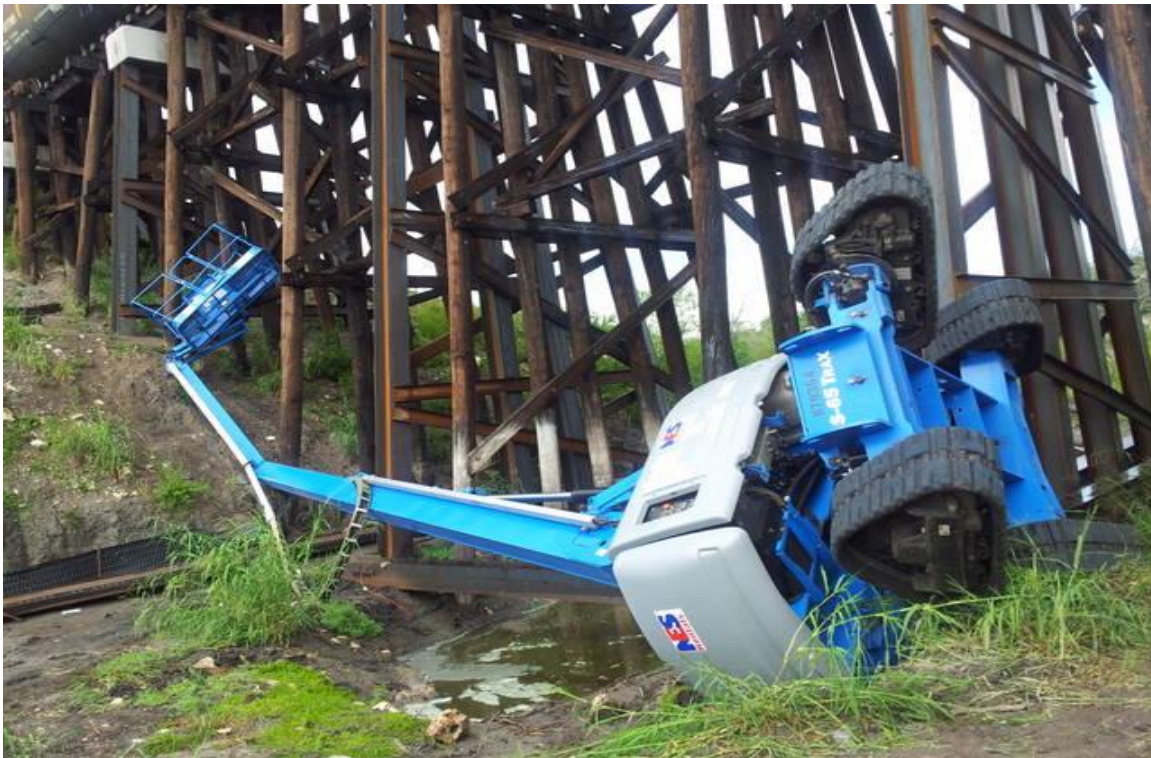
UP welder, who had been working on the bridge above the aerial lift, unhooked his fall arrest system and climbed down into the bucket to help release it from the bolt. The welders manipulated the controls from inside the bucket, attempting to release and retract the lift boom. They also tried jumping up and down in the bucket to dislodge the bucket from the bolt. At one point, the bucket suddenly came free from the bolt. The release of tension caused the bucket to drop several feet and accelerate upward unexpectedly, catapulting the second welder out of the bucket and tipping over the Trax vehicle. (See figure 7.) The first welder died, and the second welder suffered serious injuries.

Figure 7. Wreckage of S-65 Trax lift bucket.

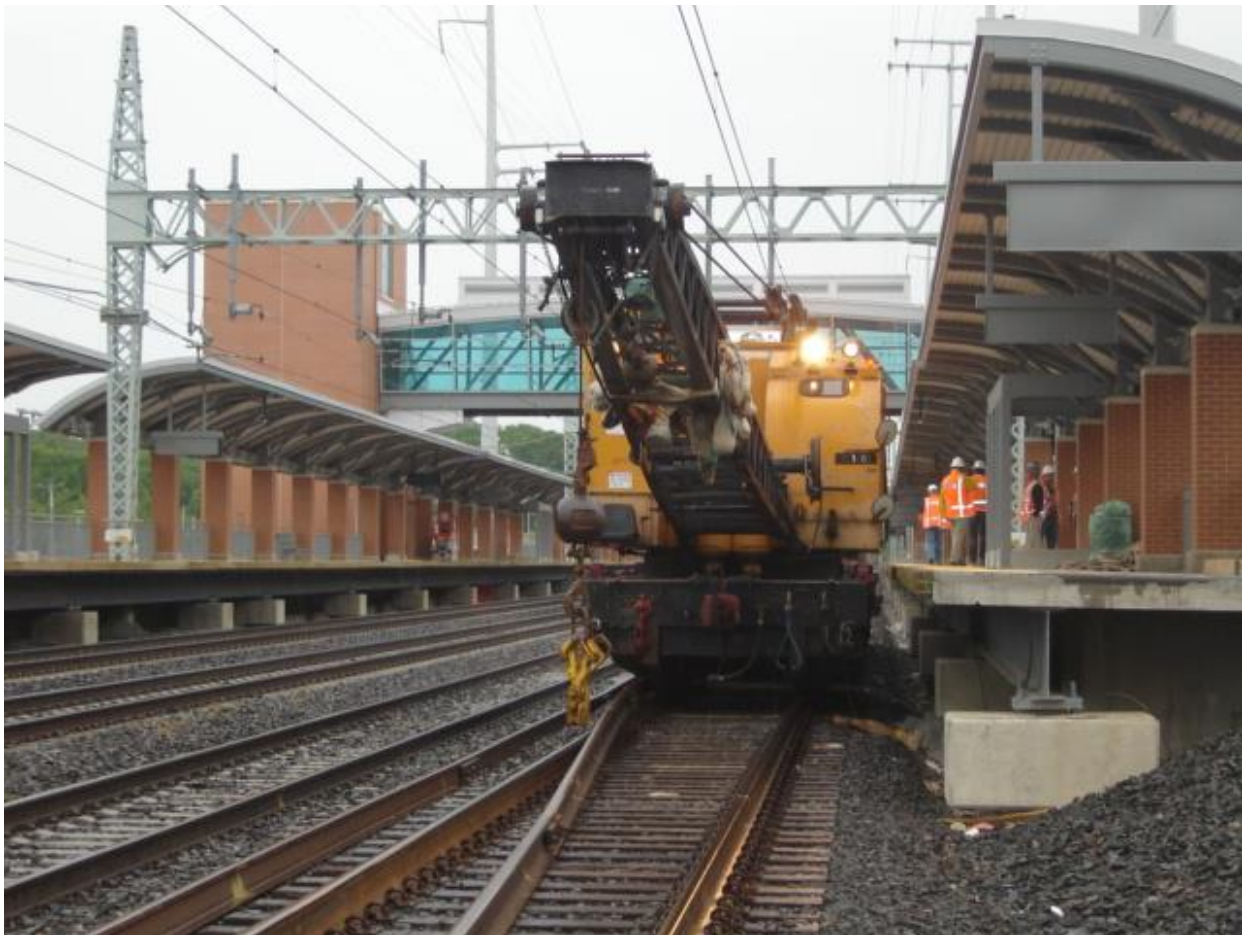
As the work was performed, the track foreman was occupying main track 1 and the crane was occupying industrial track 5. (See figure 8.) The crane operator began moving sections of rail from main track 1 to industrial track 5 when he heard the horn of a train approaching from the east. The crane operator and the track foreman continued to look to the east and observed the approaching train. The crane operator told NTSB investigators that he could not tell which track the train was on because of a curve in the tracks. He said that he returned his attention to his work because main track 1 was out of service. However, as the train neared, the crane operator realized that the train was on main track 1. He tried to warn the track foreman by yelling for him to run. The operator moved the boom clear of main track just before the train arrived; however, the track foreman did not clear the track. The train struck and killed the foreman, and it struck the rail that was draped over the north rail of main track 1; this collision with the rail knocked the remainder of the rail into the center ditch between main track 1 and industrial track 5.

Figure 8. West Haven accident location showing crane position.
