#### NATIONAL TRANSPORTATION SAFETY BOARD OFFICE OF MARINE SAFETY WASHINGTON, D.C.

# OPERATIONS GROUP FACTUAL REPORT

## 2 NTSB Accident No.: DCA15MM017

3	Accid	ent Type:	Collision	
4 5 6	Locati	on:	Houston Ship Channel, Upper Galveston Bay at buoys 89 & 90 in the vicinity of Morgan's Point. Lat 29-40.35N, Long 94-58.74 W 51.6' N	
7	Vesse	l No. 1:	Liberian-registered bulk carrier Conti Peridot	
8 9			IMO No. 9452634, Official No. 92092, 623 feet long, 106 foot beam, 32,983 gross tons, steel construction, built in 2011	
10	Owners, No. 1:		Conti Peridot Shipping Ltd.	
11	Vesse	l No. 2:	Danish-registered chemical tanker Carla Maersk	
12 13			IMO No. 9171503, Official No. 19336 ZR 1999, 599 feet long, 106 foot beam, 29289 gross tons, steel construction, built in 1999	
14	Owners No. 2:		A.P. Moller – Maersk A/S	
15	Date:		March 9, 2015	
16	Time:		12:30:45 Central Daylight Time (CDT)	
17	Injurie	es:	None	
18	Comp	lement:	25, Carla Maersk	
19			24, Conti Peridot	
20			1 Houston Pilot aboard each vessel	
21	В.	OPERATIONS	GROUP	
22		Deck Operation	ons Group Chairman

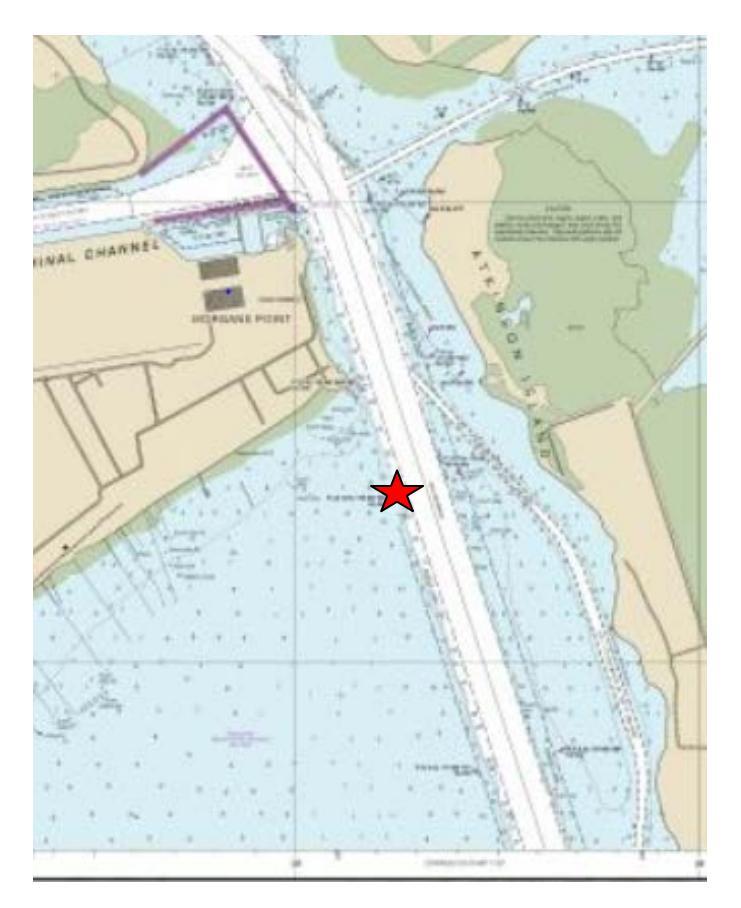
**Figure 2.** Chartlet of the Houston Ship Channel in Upper Galveston Bay including Morgan's Point and the entrance to Barbour's Cut. The red star denotes the accident site near navigation marker 89.

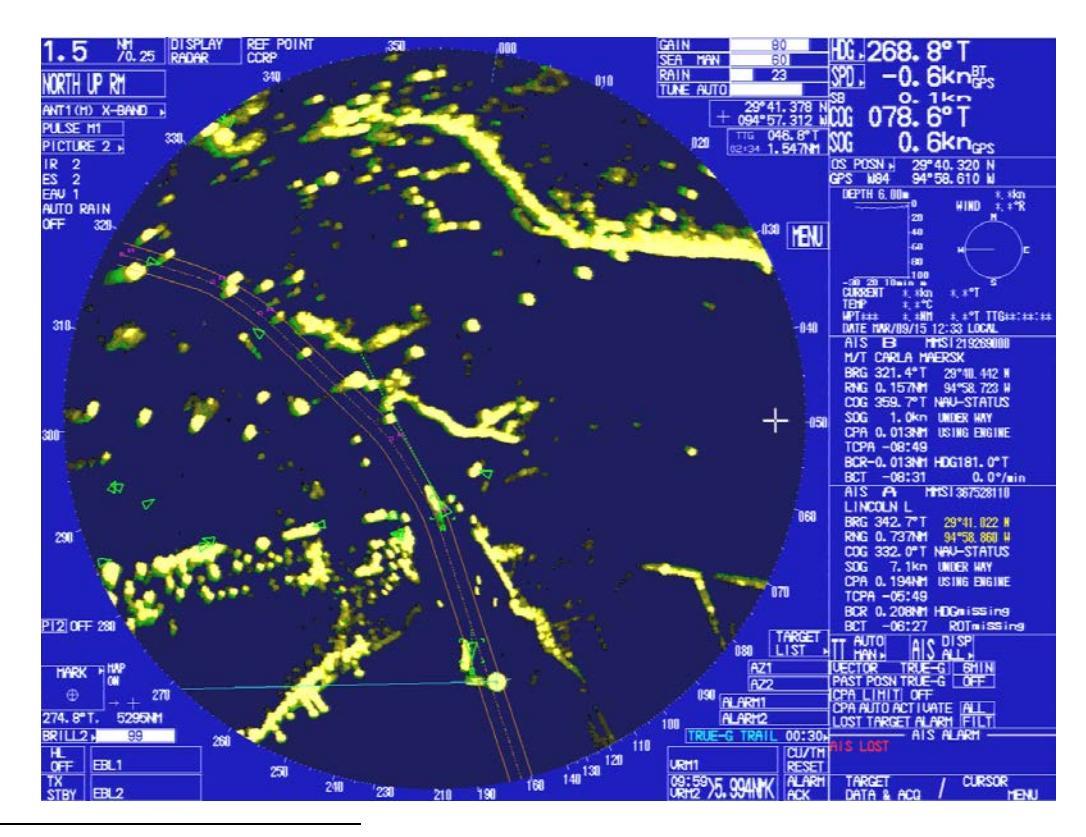
Figure 4. Radar image captured from *Conti Peridot* VDR data. At bottom of screen the collision of the two vessels is shown to the west side of the channel. The time on the image is 1231 local time. Other vessel information relative to the *Conti Peridot* is also displayed at about the moment of impact.

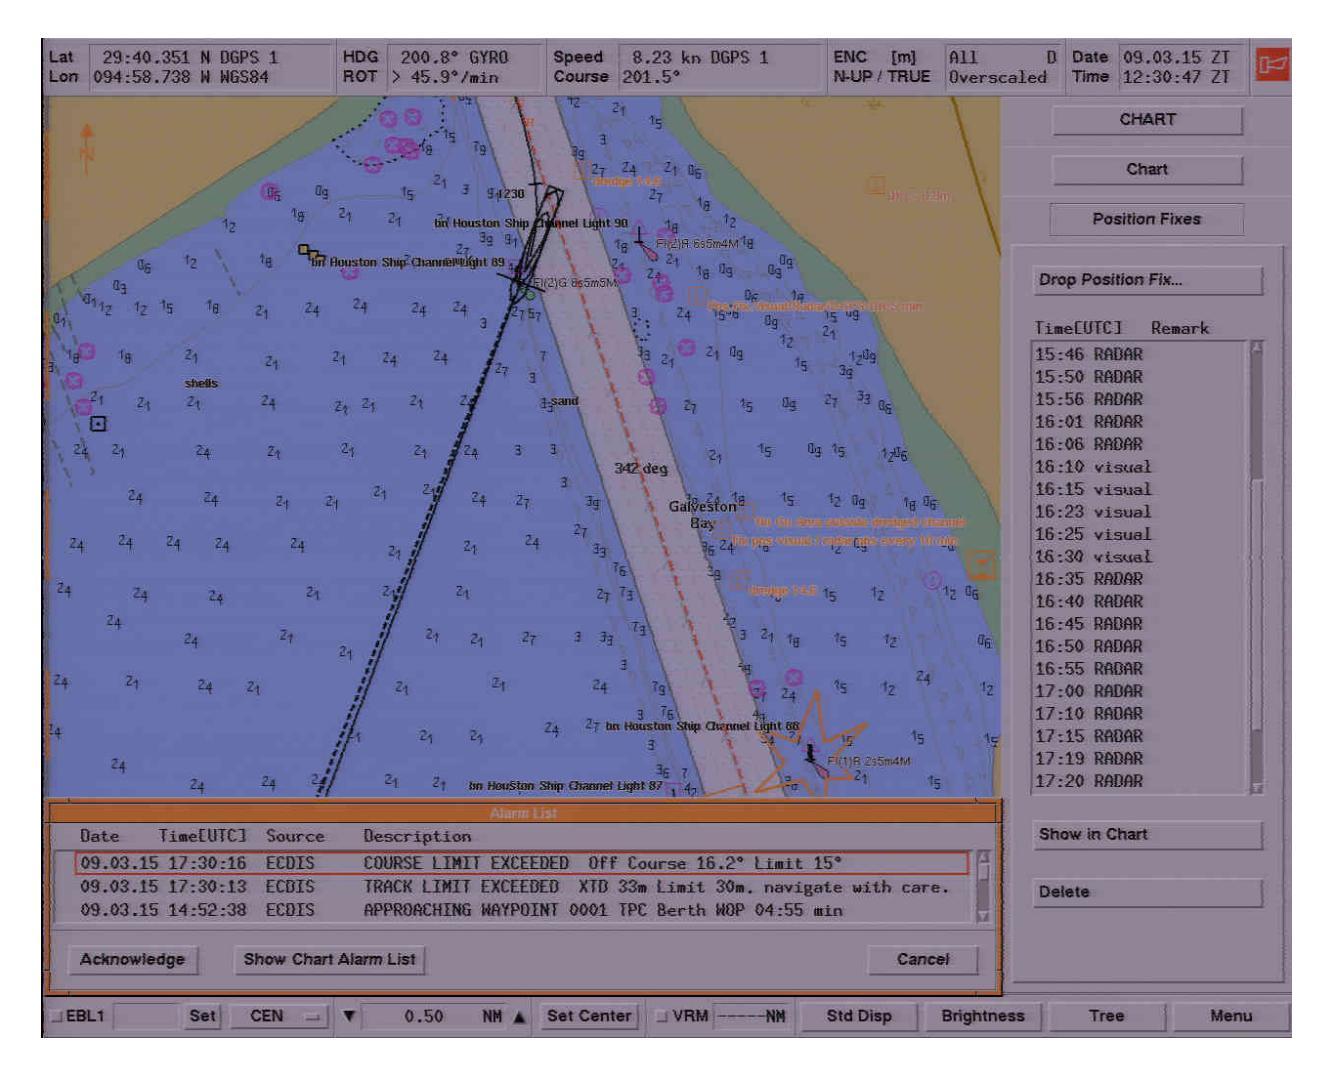
Figure 5. ECDIS (Electronic Chart Display Information System) image from Carla
 Maersk at approximate time of accident 1231. Image shows the southbound
 Carla Maersk leading off to the right and out of the channel. The image doesn't

show the Conti Peridot at the time of impact. All information displayed on the

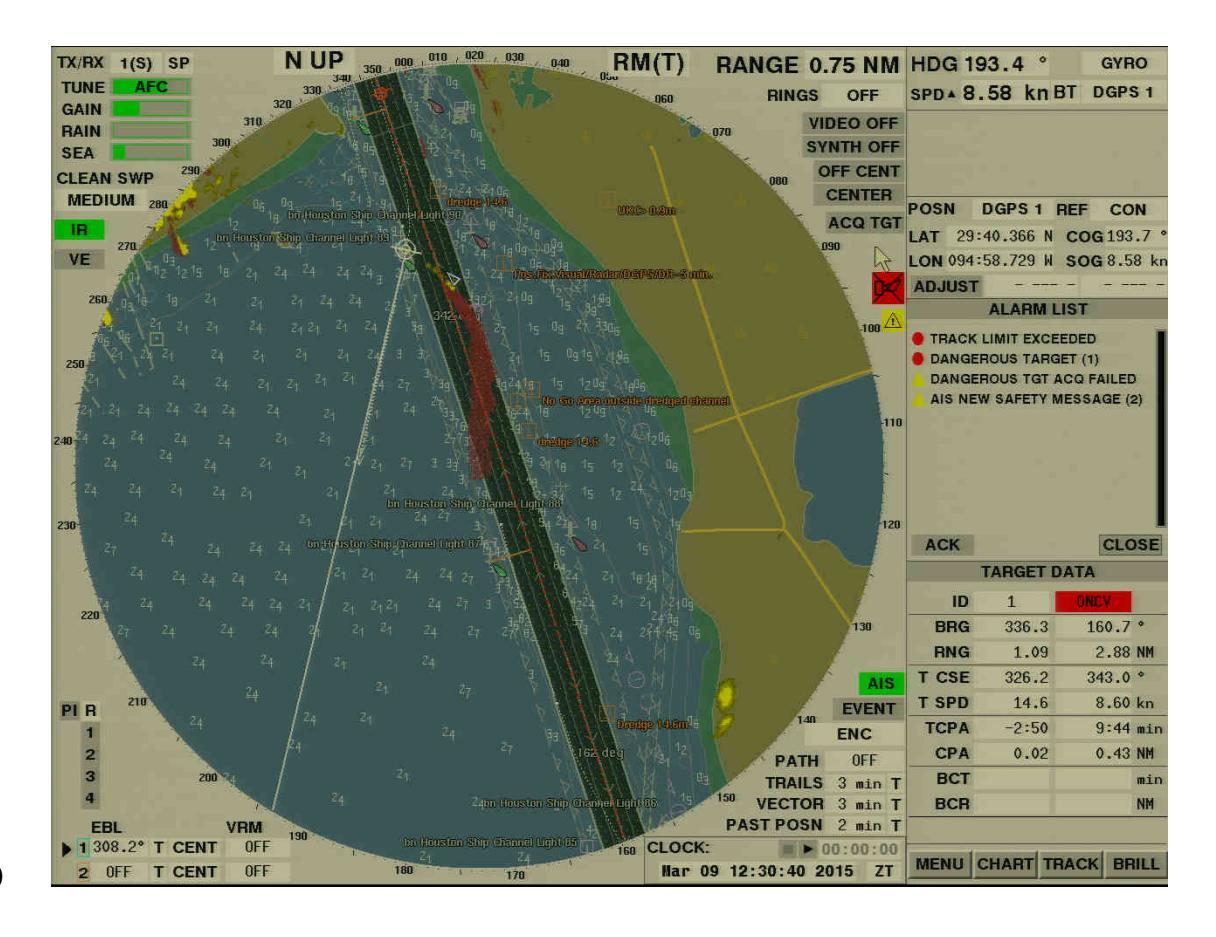
**Figure 6.** Image of *Carla Maersk* ECDIS display with radar overlay about the time of the collision. The *Carla Maersk* is to the west side of the channel at the top of the screen with the white line (cursor) extending from it to the edge of the circle. The *Conti Peridot* is seen slightly to the lower left of the *Carla Maersk* and the red "tracks" of its radar return and previous path is depicted.
