# National Transportation Safety Board

Office of Marine Safety  
Washington, D.C. 20594

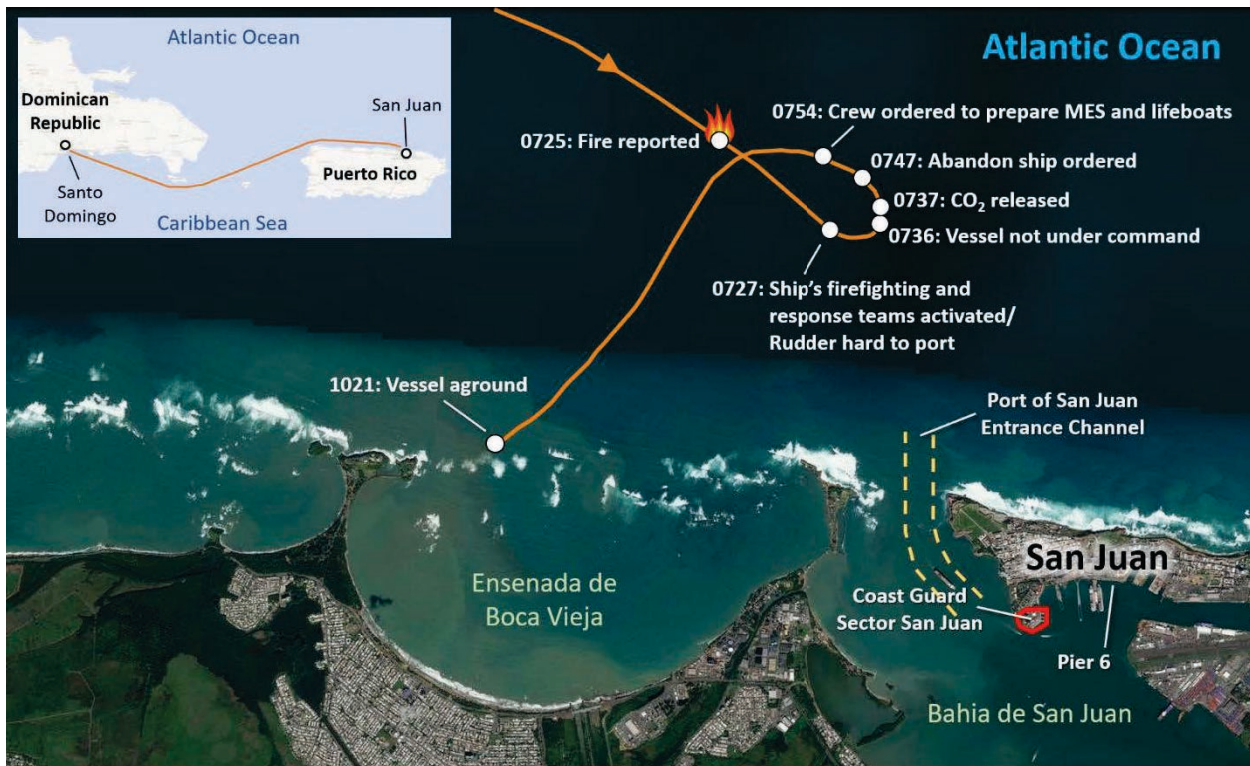
1  
2 **Figure 8. Automatic identification system (AIS) track of the *Caribbean Fantasy* and**  
3 **timeline of events. (Background by Google Earth)**

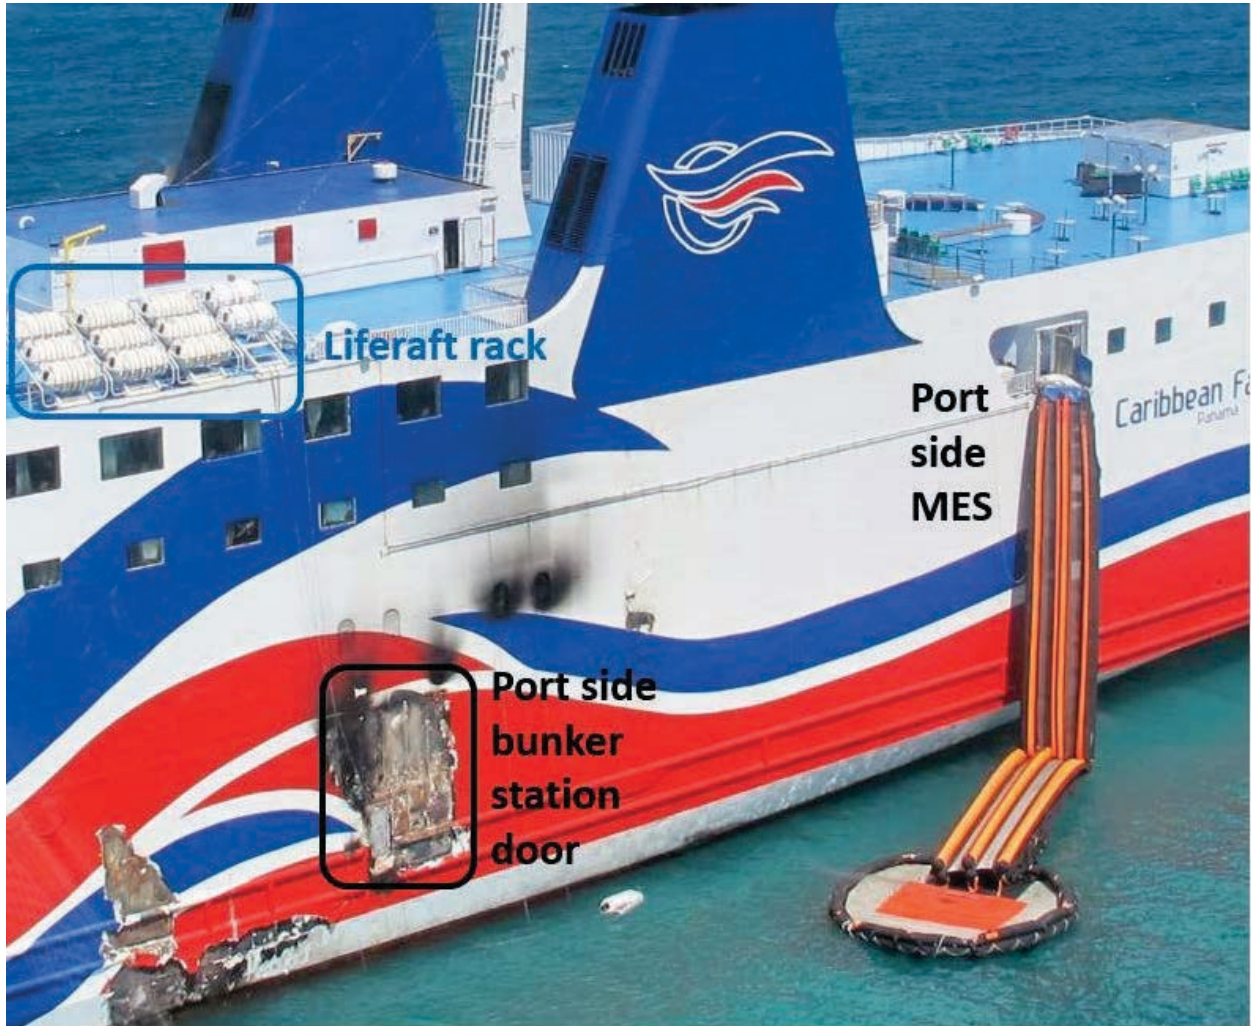
7  
8 **Figure 9. Aerial photograph of the port side of the *Caribbean Fantasy* taken on August**  
9 **19. A black rectangle highlights the location of the port side bunker station shell door.**  
10 **Note the burned paint in the surrounding area and the soot stains around some of the**  
11 **ventilation louvers. A blue rectangle outlines the main rack housing the 12 liferafts. All**  
12 **rafts remain in the rack except for one, which floats uninflated in the water. Also note the**  
13 **steep angle of the MES slide.**

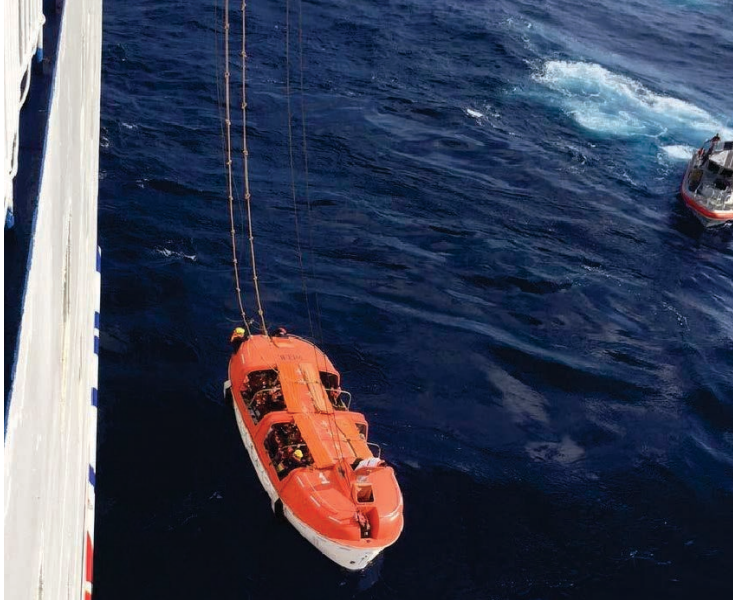
1  
2 **Figure 10. Lifeboat no. 1, at 0838 on the day of the accident, in the water and unable to**  
3 **release the release hooks. (Photo provided to Coast Guard by a *Caribbean Fantasy***  
4 **passenger)**

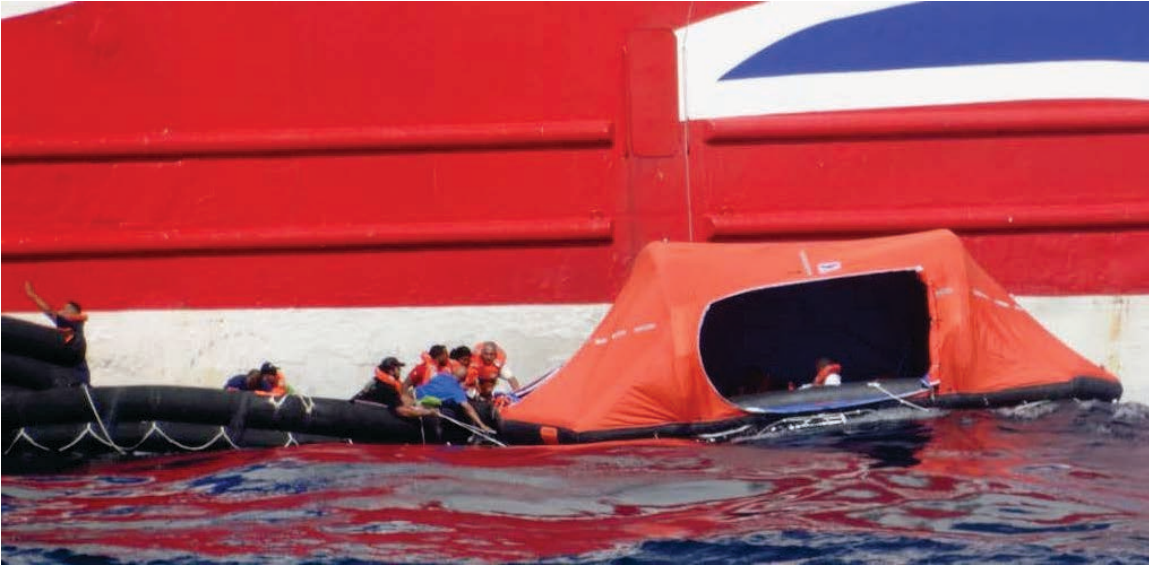
6  
7 **Figure 12. Picture of a liferaft at the starboard side MES platform with the main**  
8 **access opening facing away from the platform.**

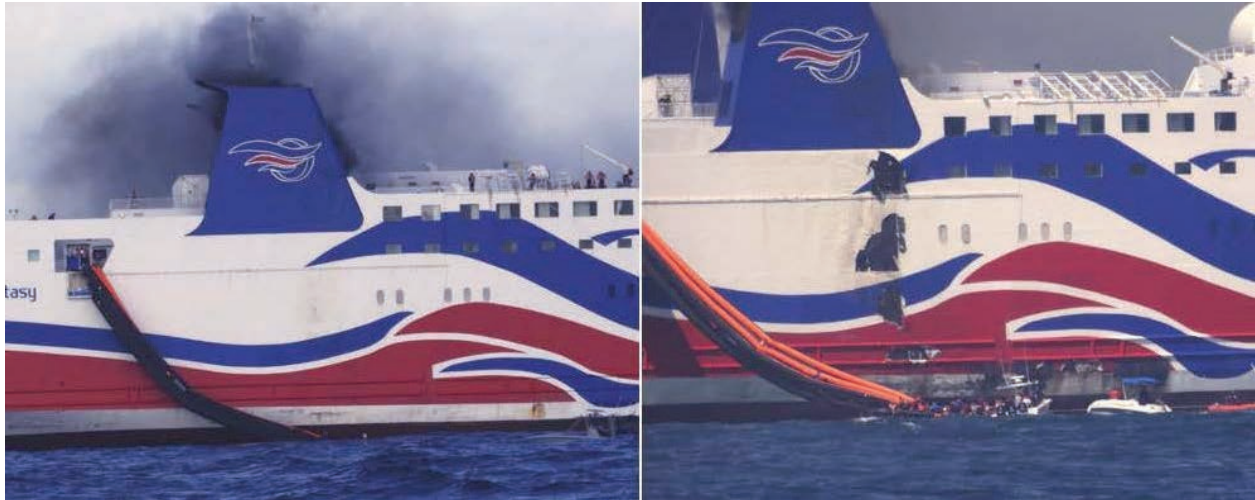
1  
2 **Figure 17. On the left, at 0853, paint is starting to blister at the water line. On the right, at**  
3 **1049, large pieces of paint are missing from the ships side extending to the stack and at**  
4 **the water line just forward of the MES slide and platform. (Photos by Coast Guard)**
