SURVEY STATEMENT NARRATIVE ANNEX

DNV GL Id No: **27084** Job Id:

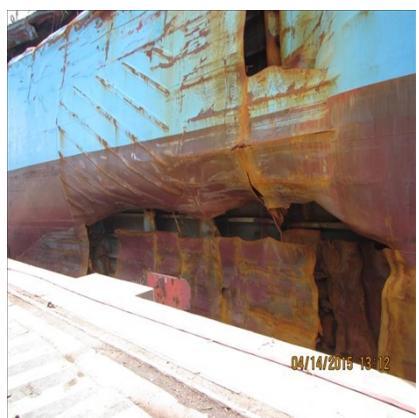
View of damage in the underwater area.

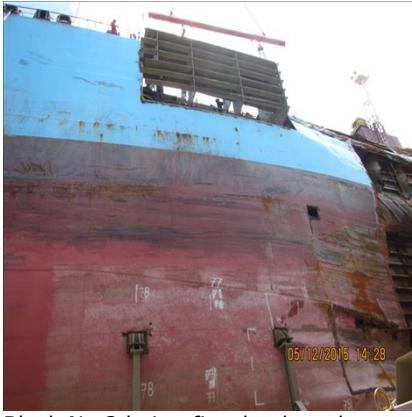
Block No.2 being fitted onboard, without the side shell plate.

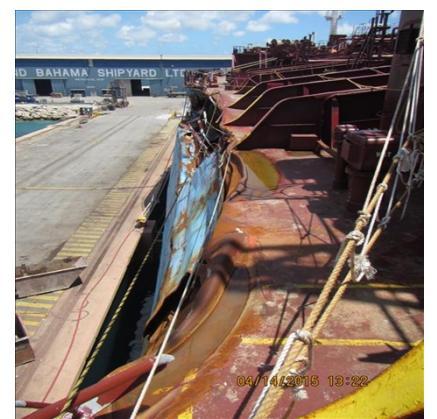
View of damage on the upper deck

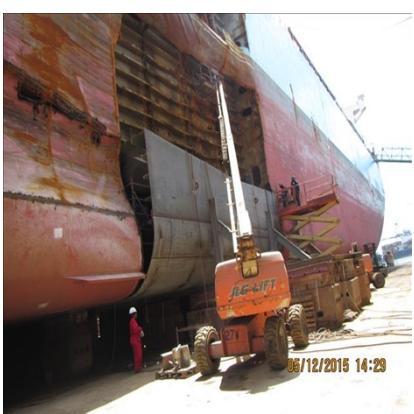
Block No.1 fitted onboard.

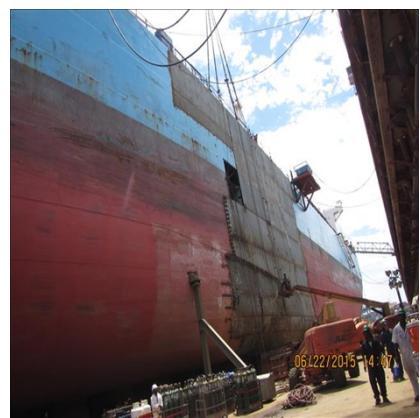
Nearing completion of repairs on 22nd of June

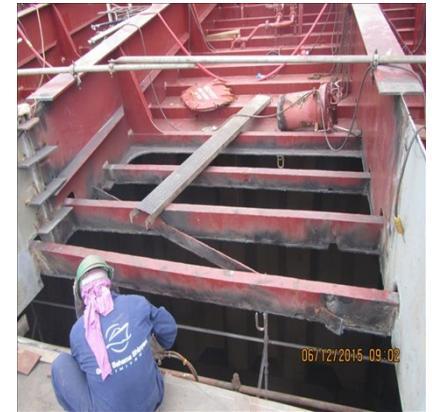
Inserts on upper deck, in way of Cargo tank No.4(P)

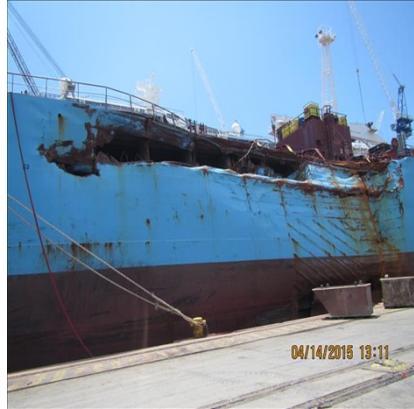
View of Side shell and partly of internals damage from the pier

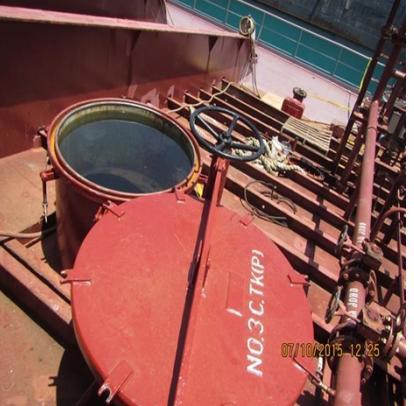
CTk 3(P) - Hydrostatic pressure test carried out on July 10th

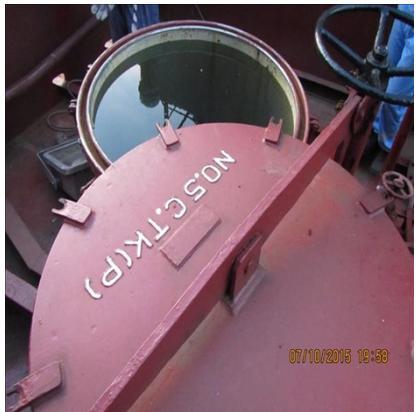
CTk 5(P) - Hydrostatic pressure test carried out on July 10th

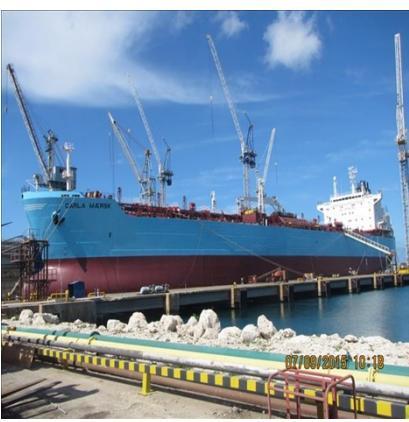
July 9th, vessel afloat.

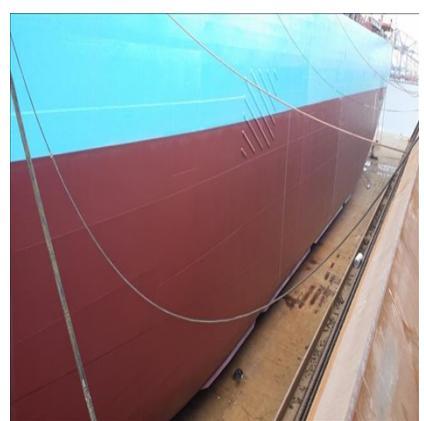
Repairs completed, July 8th.

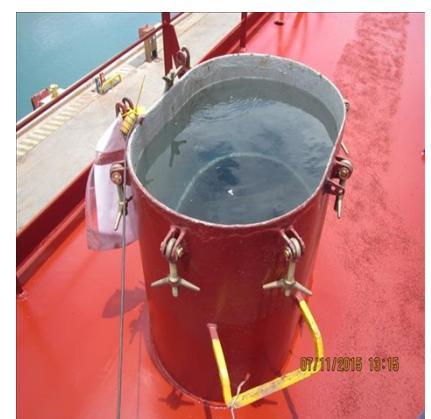
WBTk 3(P) - Hydrostatic pressure test carried out on July 11th

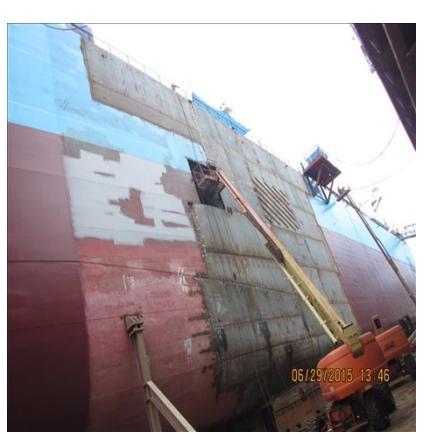
One side shell insert remaining on 29th of June for completion of steel repairs

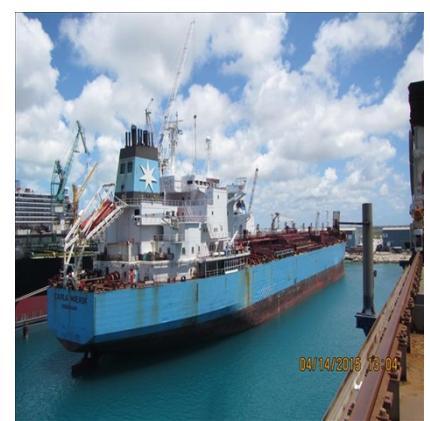
Vessel entering the shipyard premises on the 14th of April 2015

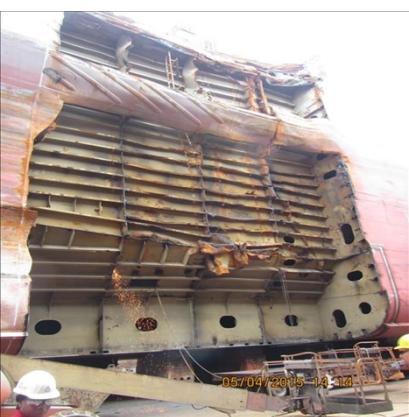
View of damage in way of WBTk No. 2(P), after removal of the damaged side shell.

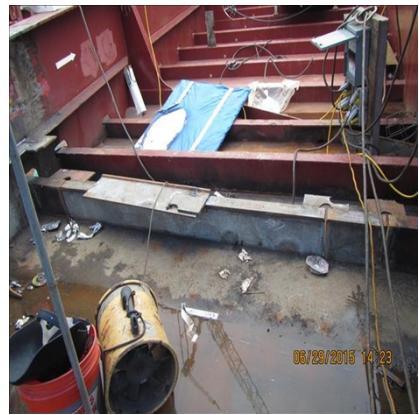
On the upper deck longitudinal stiffeners inserts - View 2

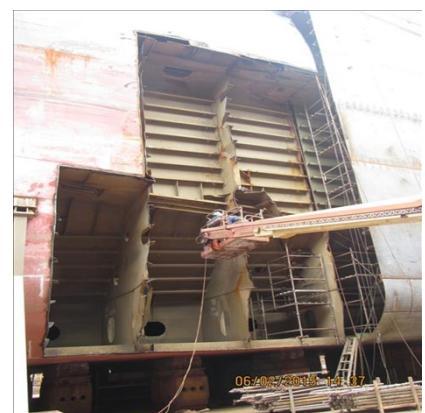
Repairs in progress.

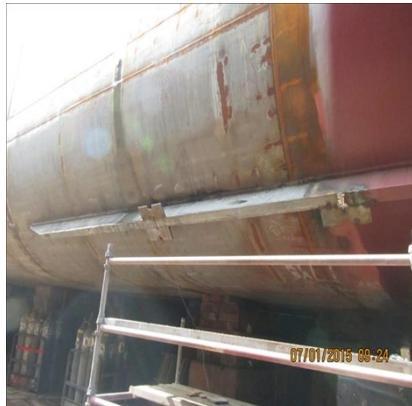
Newly fabricated bilge keel fin installed
