NATIONAL TRANSPORTATION SAFETY BOARD OFFICE OF MARINE SAFETY WASHINGTON, D.C.

HAZARDOUS MATERIALS GROUP FACTUAL REPORT

NTSB Accident No.:	DCA15MM017
Accident Type:	Collision
Location:	Houston Ship Channel (HSC), Upper Galveston Bay at buoys 89 and 90 in the vicinity of Morgan's Point.
	Lat 29-40.35N, Long 94-58.74 W 51.6' N, longitude 93° 56.4' W
Vessel No. 1:	Liberian-registered bulk carrier Conti Peridot, IMO No. 9452634
Owners No. 1:	Conti Peridot Shipping Ltd.
Vessel No. 2:	Danish-registered chemical tanker Carla Maersk, IMO No. 9171503
Owners No. 2:	A.P. Moller – Maersk A/S
Date:	March 9, 2015
Time:	12:30:45 Central Daylight Time (CDT) ¹

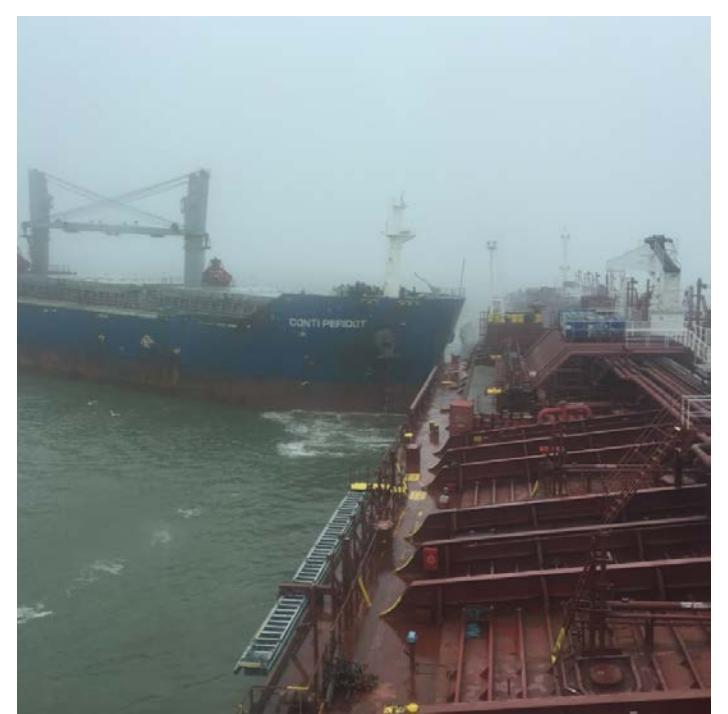
The *Carla Maersk* was struck on its port side. The impact area included port cargo tanks 3(COT3P) and 4 (COT4P) and port water ballast tanks 2 and 3. Cargo tank COT4P was breached and MTBE was discharged into the water. *Carla Maersk* crew completed emergency ballast and cargo transfer operations to correct a port list that was approximately 10 degrees.²¹

Figure 3: Collision of the Conti Peridot and the Carla Maersk.

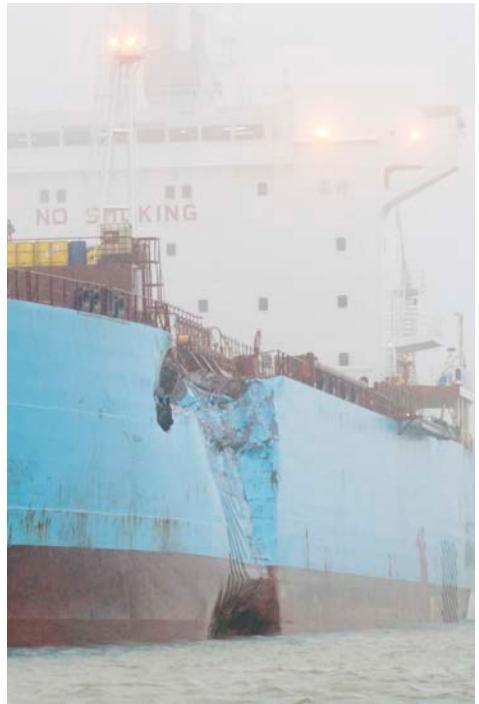
Figure 4: Carla Maersk hull damage caused by the Conti Peridot. (Courtesy of Port of Houston Authority Fire Department)

4. Following an internal inspection carried out by an ROV [remotely operated vehicle] inside Cargo Tank 4 Port, two holes were found in the inner longitudinal bulkhead in way of Fr. 71, one being of oval shape 260 x 125mm and the other of elongated shape 360 x 35mm.

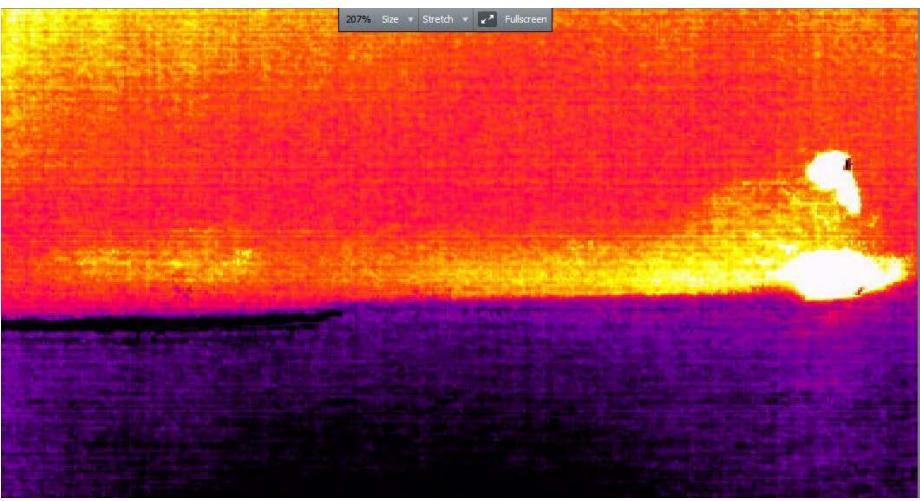
Figure 5: Thermal scan image of damage to *Carla Maersk*. The two light areas on the right-side indicate location of product flow/breach. (*Courtesy of Port of Houston Authority Fire Department*)

The thermal survey scan of the *Carla Maersk* indicated potentially two breaches. The DNV survey report of the post-collision condition of the *Carla Maersk* states:

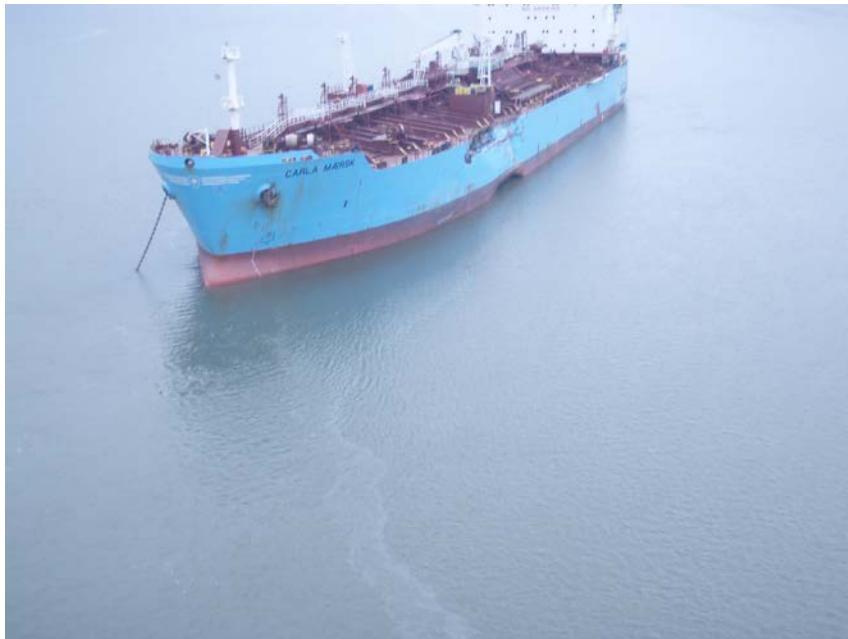
A sheen was observed on the water as a result of the rupture of hydraulic lines on the vessel. USCG small boats were on station at the border of the visual sheen edge due to MTBE flammability concerns.

Figure 6: *Carla Maersk* with sheen on the water and damage to the hull on March 10, 2015. (*Courtesy of USCG*)

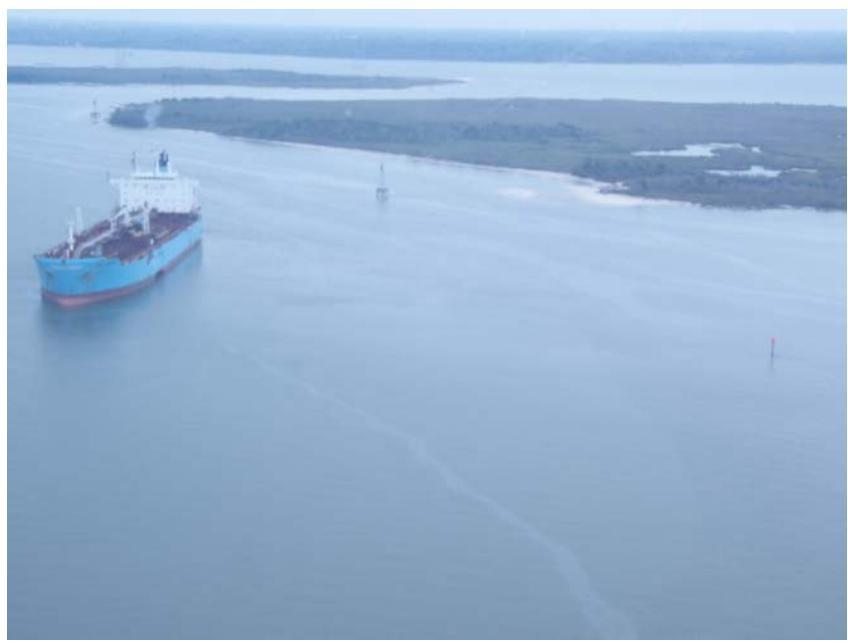
Figure 7: Carla Maersk with extended sheen on March 10, 2015. (Courtesy of USCG)

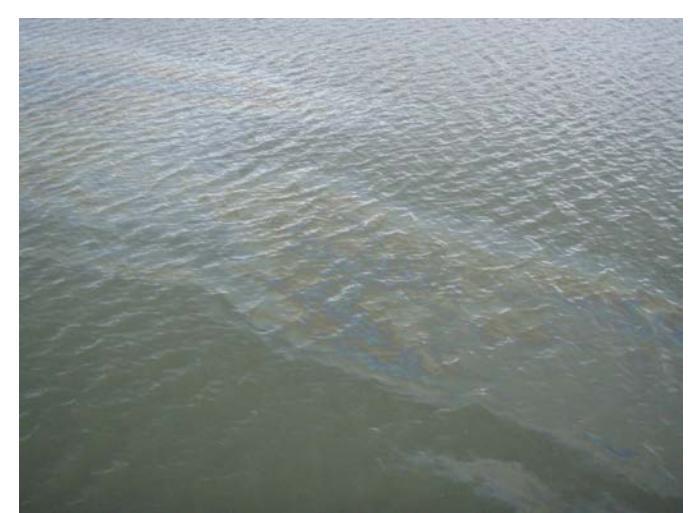
Figure 8: Sheen on water of the HSC on March 10, 2015. (*Courtesy of USCG*)

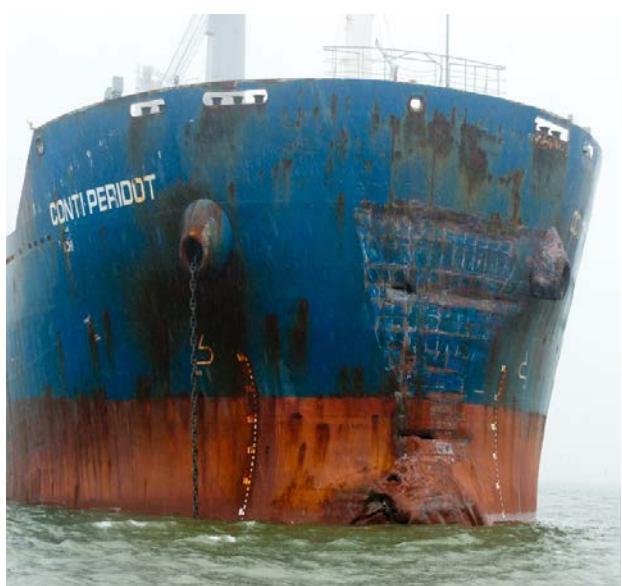
The *Conti Peridot* sustained damages primarily to the bow of the vessel. It had a crushed bulbous bow with a breach above the waterline.

Figure 9: Damage to the *Conti Peridot*. (*Courtesy of Port of Houston Authority Fire Department*)
