Service Bulletin

Document No.:	SB-EC120-111815		
Title:	Airbus EC120 Air Conditioner Compressor Drive Pulley		
Date:	20 November, 2015		
Applicability:	Airbus Helicopter model EC120 Equipped with the Air Comm Corporation AC kit no. EC120-200-1 thru -5, kit serial numbers EC120-011 and subsequent, or EC120-202-1 thru -4.		
Reference:	 FAA / STC # SR00491DE, Airbus Helicopter EC120 Air Conditioning System. ICA EC120-200M-1 		
Compliance:	Mandatory inspection upon receipt of this bulletin to be accomplished before further flight. Mandatory re-inspection each 100 flight hours subsequently.

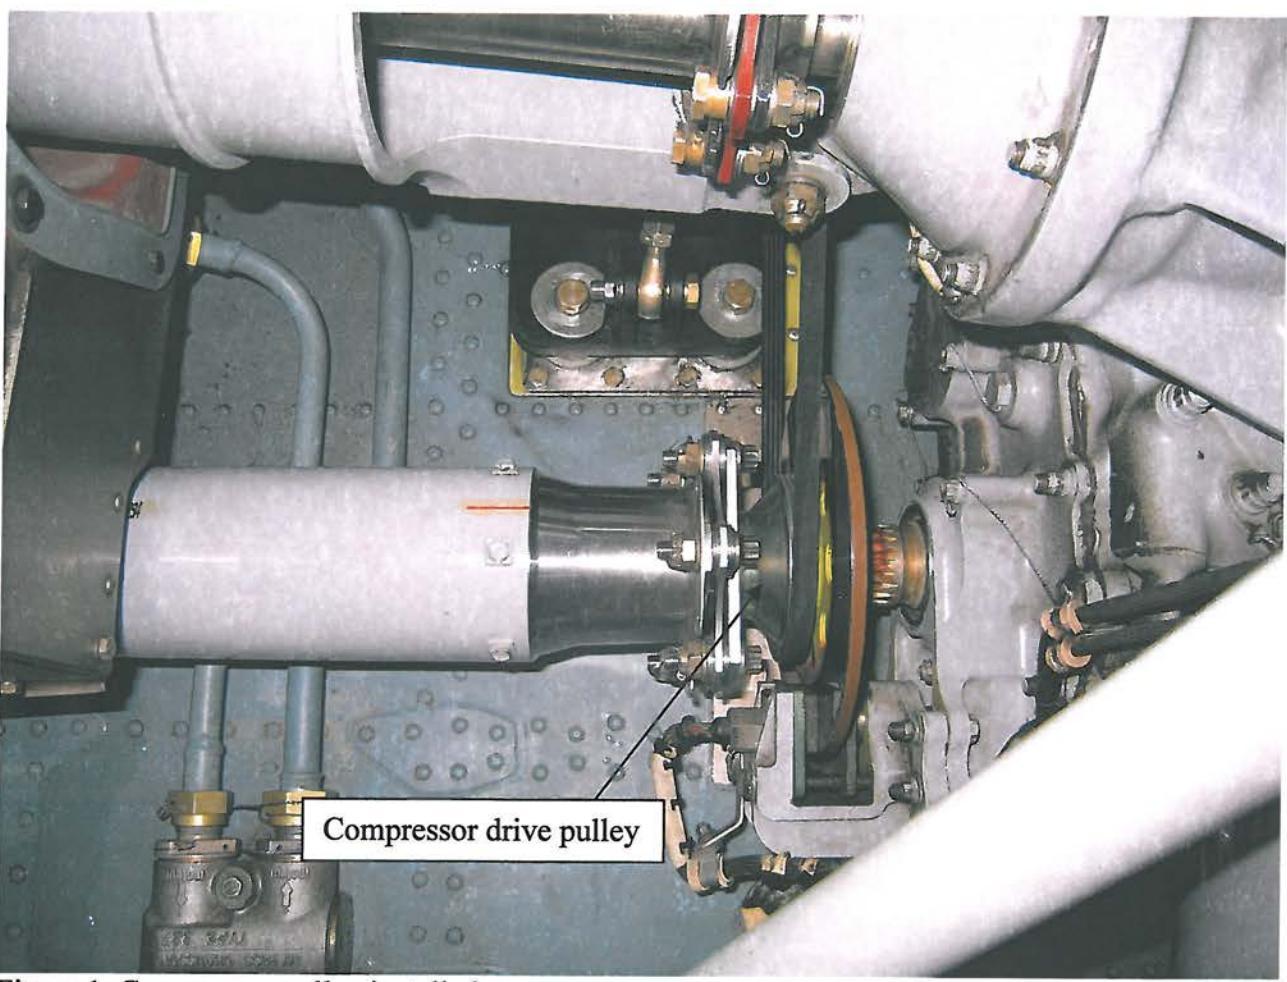
2) Remove the 3 sets of bolts, cotter pins, and nuts that secure the flange of the compressor pulley to the Thomas coupling. Slide the pulley forward on the drive shaft enough to ensure disengagement from contact with the coupling. Refer to Figure 1 below.

Figure 1. Compressor pulley installed

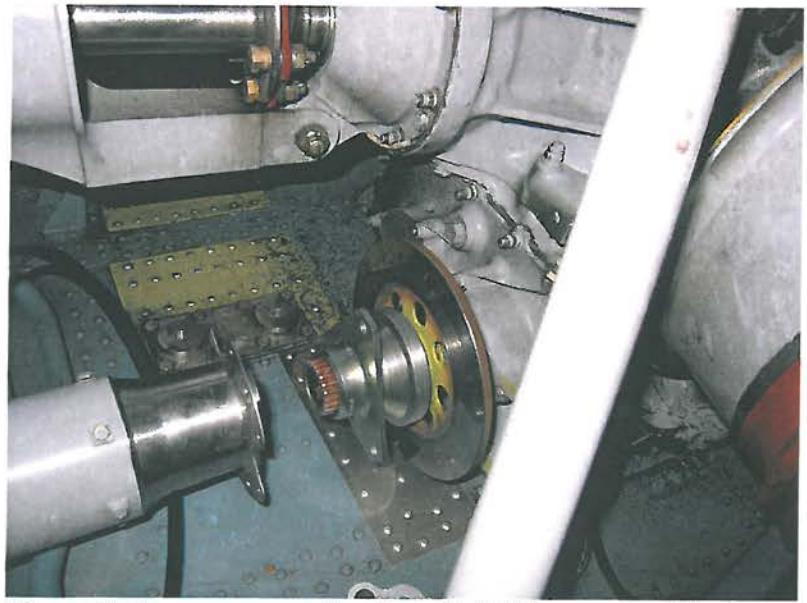
5) Except for allowable fore-aft movement of the pulley on the drive shaft splines, if any detectable motion is found (looseness of the joint), indicating wear of the splined joint, the pulley and drive shaft must be removed and replaced. Remove the Thomas coupling from the TRD shaft as shown in Figure 2. The forward tail rotor shaft must also be removed per Airbus service instructions in order to gain enough clearance to remove the pulley. Remove the pulley and contact ACC for a replacement. Contact Airbus for a replacement drive shaft and instructions for replacement procedures. Report the findings including the information in the list below to ACC per the information provided in section B.

Figure 2. Compressor pulley installed, Thomas coupling removed
