# AIRFRAME ACCIDENT REPORT

## **CEN16LA312**

8/8/16 Hickory Ridge, AR

AT-502B manufactured in 2001 502B-0634 N634LA

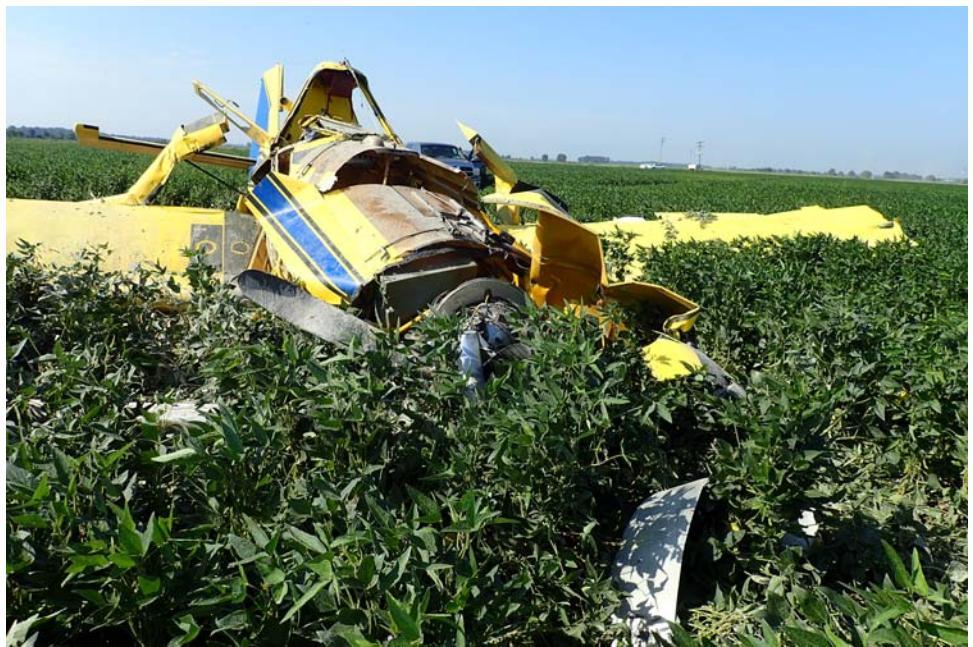
The aircraft was located in the soybean field in an upright position with the fuselage oriented on a northerly heading. The wings remained attached to the fuselage in their normal location,

Air Tractor, Inc. ID # CEN16LA312 but were heavily damaged. The fuselage structure forward of the cockpit remained in its normal orientation, but was heavily damaged. The aft fuselage and empennage were generally undamaged.

Wreckage viewed from the front right

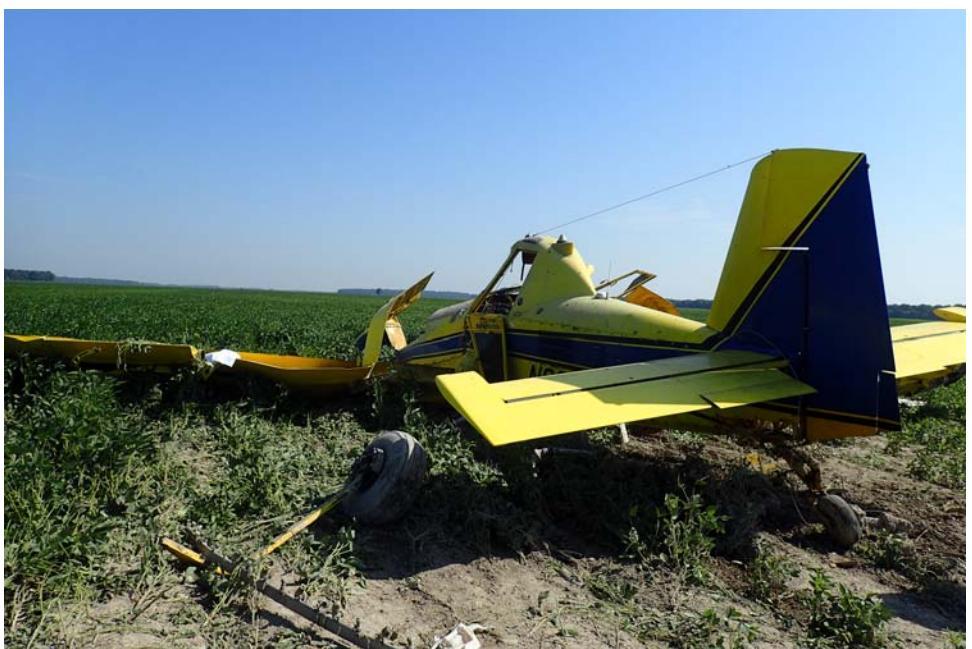
A long length (several hundred feet) of 3/8 galvanized electrical cable was loosely wrapped around the empennage and tail gear and trailed out from the aircraft toward the southeast and then arcing around toward the east and then the northeast. No definitive wire strike marks were noted on aircraft leading edge surfaces.

Wreckage viewed from the rear left

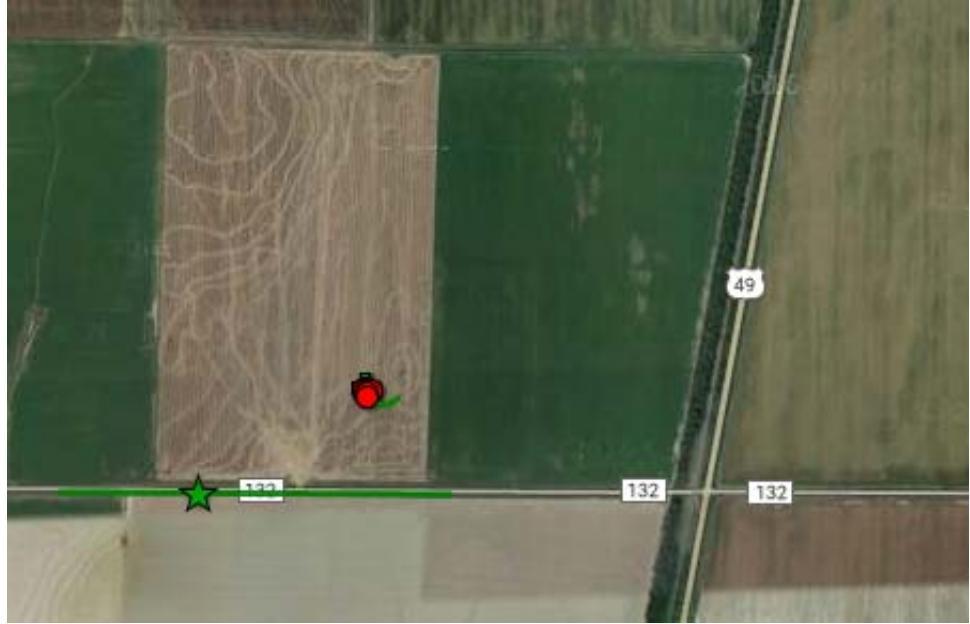
Upon arrival at the scene, it was noted that the aircraft was located in a soybean field to the north of County Road 132. A set of rural power distribution lines ran along the south edge of the road. It was reported by Trooper Ziegenhorn that the aircraft had been treating a field to the south of County Road 132, was travelling north, failed to climb over the wires, and contacted the top three wires of these distribution lines. By the time of arrival on scene, the distribution wires had been repaired.

Google Maps view with wreckage location (red) and location of broken wires (green star)

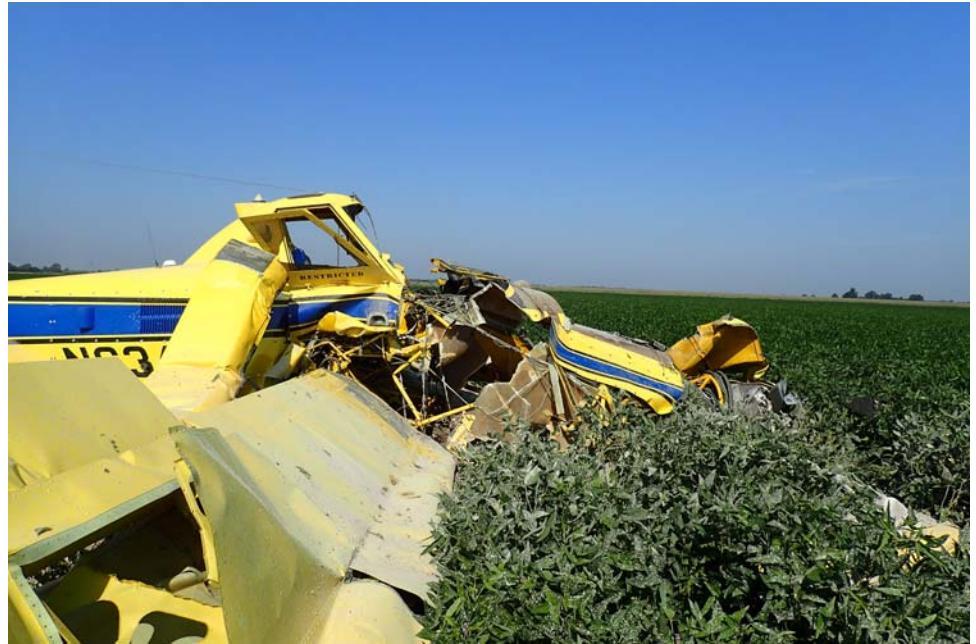
The main landing gear springs had separated from the fuselage. The lower forward fuselage structure (including the main landing gear attachments and the wing attach structure) had dug into the soil, causing this part of the structure to begin to "roll up" under the fuselage. This resulted in both of the wings to assume a significant nose-down angle compared to their normal relationship with the fuselage. This rolling of the fuselage is a fairly common occurrence in Air Tractor aircraft and helps dissipate the impact energy of the crash.

View from right wingtip showing the wing rolled under the fuselage

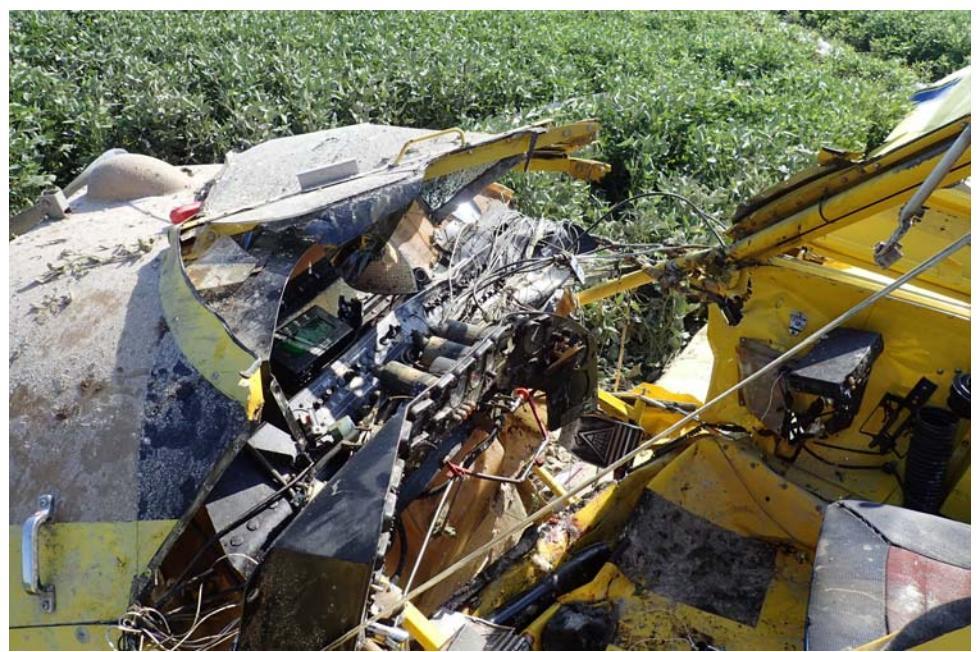
**Instrument Panels and Windshield**

The cockpit overturn structure was intact and there was no evidence of any external intrusions to the cockpit envelope. The windshield structure was detached at its upper support and remained attached to its lower support on the top of the hopper. This lower attach point was displaced forward approximately 3 feet due to the separation of the fuselage structure. There were no wire strike marks found on the windshield structure and there was no damage to the windshield wiper.

The upper and lower instrument panels had been displaced forward with the hopper. The righthand side of the lower instrument panel exhibited crush damage from the aft (cockpit) side.

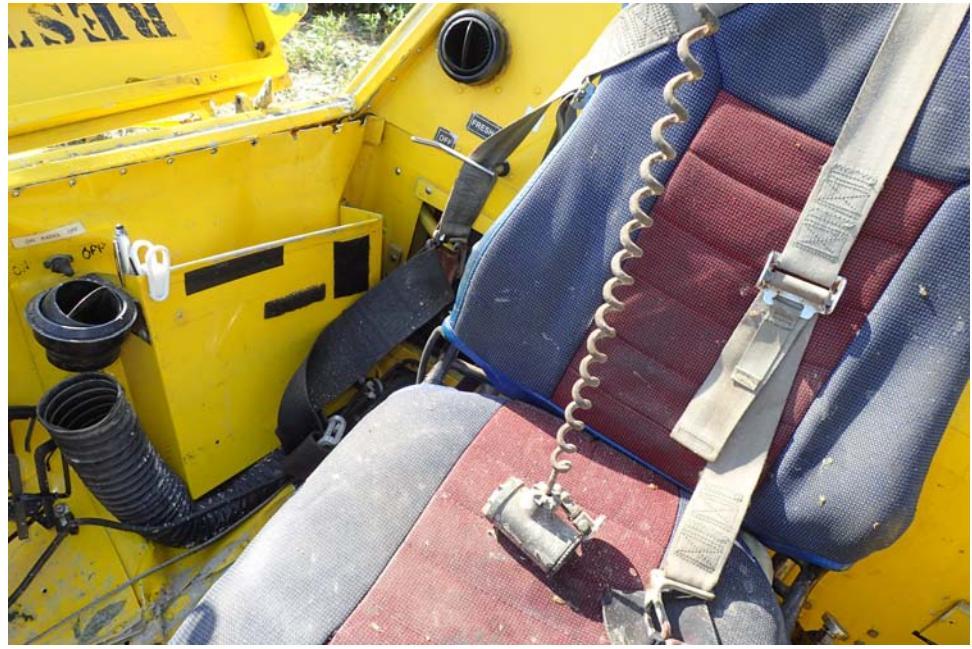
The interior of the cockpit was examined. The pilot's restraints were unbuckled and did not show any signs of failure or overstress. The shoulder harnesses were significantly sunbleached and deteriorated. The vertical rails that support the seat were undamaged.

View of Pilot's seat belts and shoulder harness

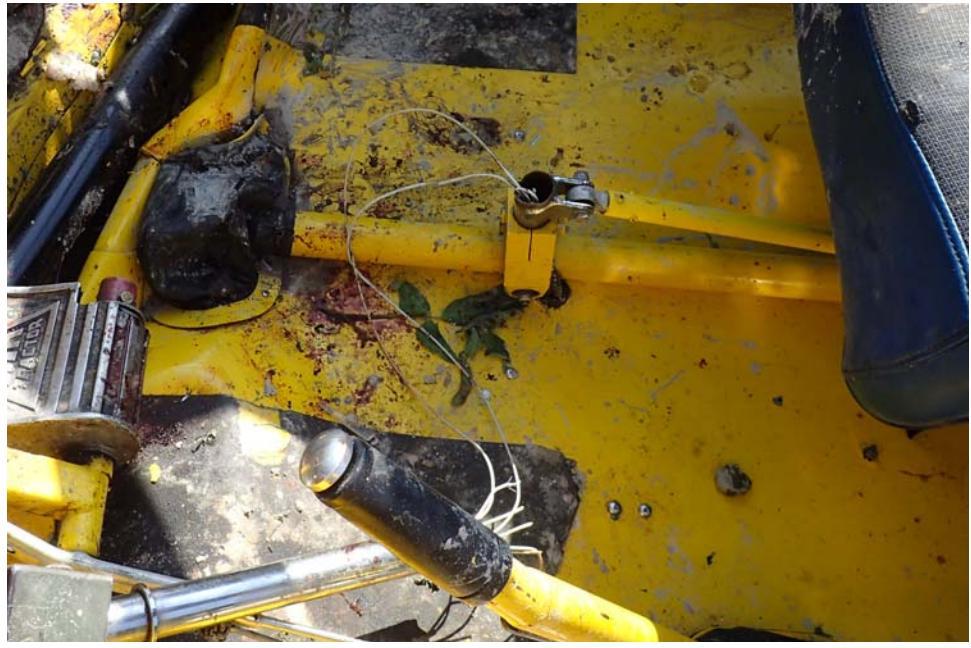
The pilot's control stick was separated from its pivot point just above the attachment of the elevator pushrod. The separated surface was consistent with a bending/shear fracture in the forward direction. This is consistent with the stick being forced forward beyond its limit.

View of control stick separation (wires remain connecting stick to base)

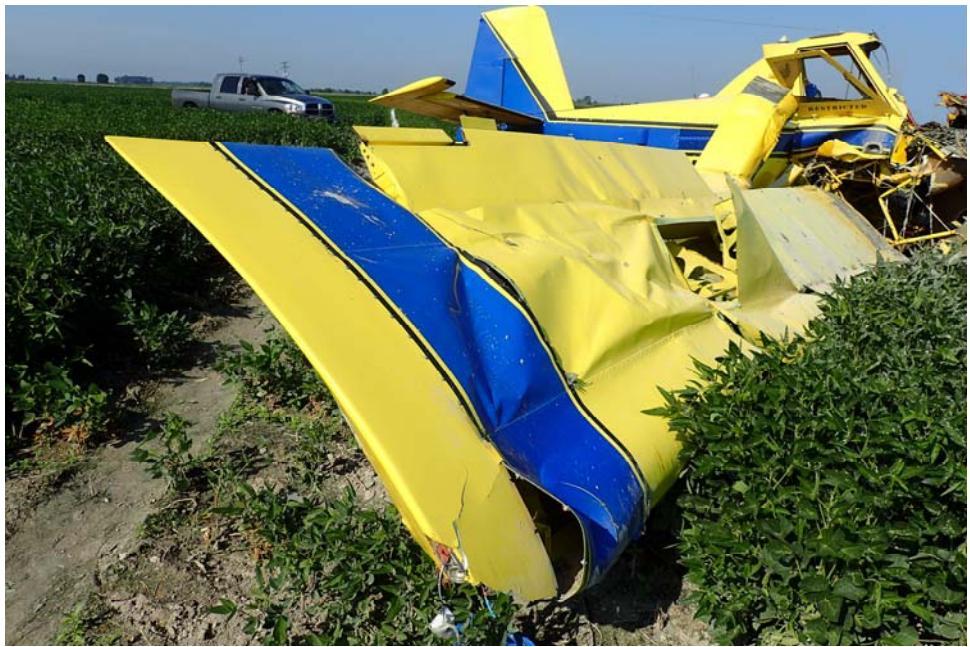
**Right wing**

Both wings exhibited significant damage and chordwise scratching to the bottom sides of the wings. Leading edge damage was moderate and both wings received approximately the same level of damage. The largest wing damage was outboard of the fuel tank area. Both wing fuel tanks and the fuselage header tank were ruptured. It was unknown how much fuel was onboard at the time of the accident.

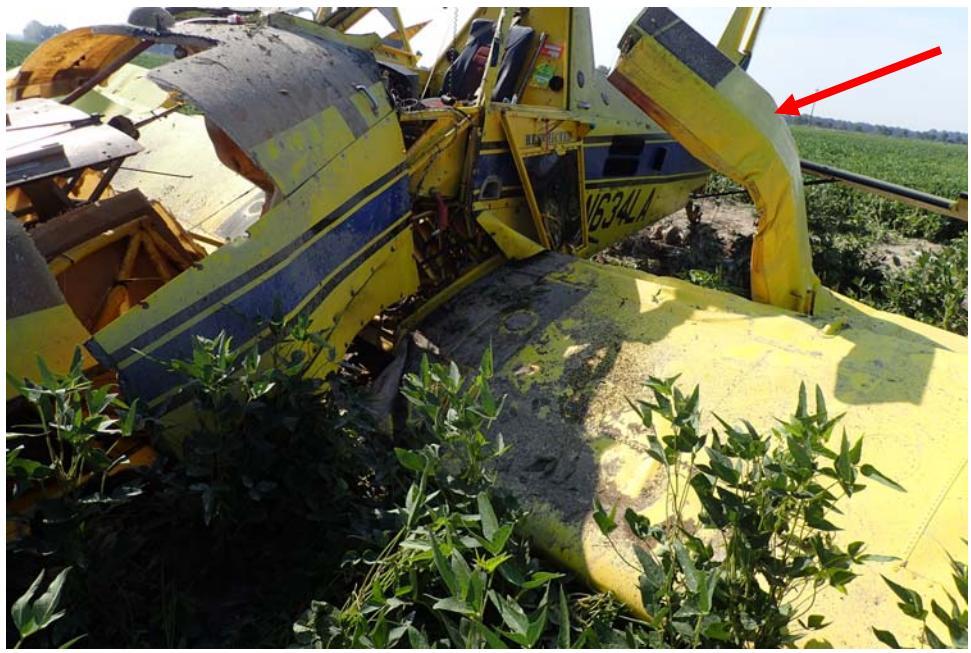
Both ailerons remained intact and installed in their proper placement on the wings. The ailerons received light damage. The flaps remained installed in their proper placement on the wings. Both inboard ends of the flaps were curled up significantly higher than the wings. This damage was most likely caused by the separation of the main landing gear and their impact with the flaps. The radius of deformation on the bottom of each flap is generally the same shape as the main landing gear tires.

Detail of lefthand flap curled up on inboard end

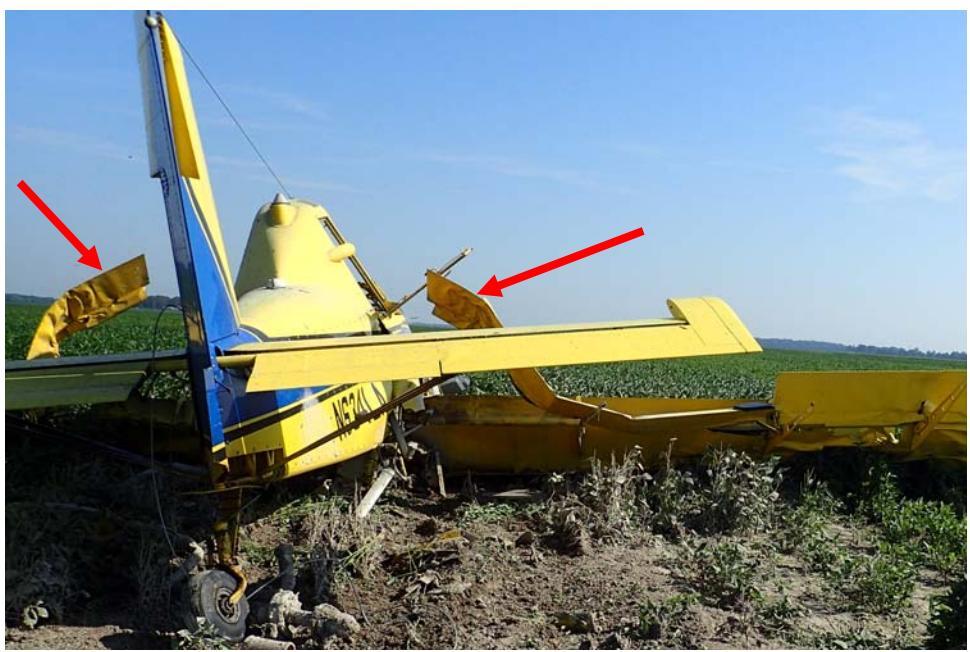
View from behind of flap damage

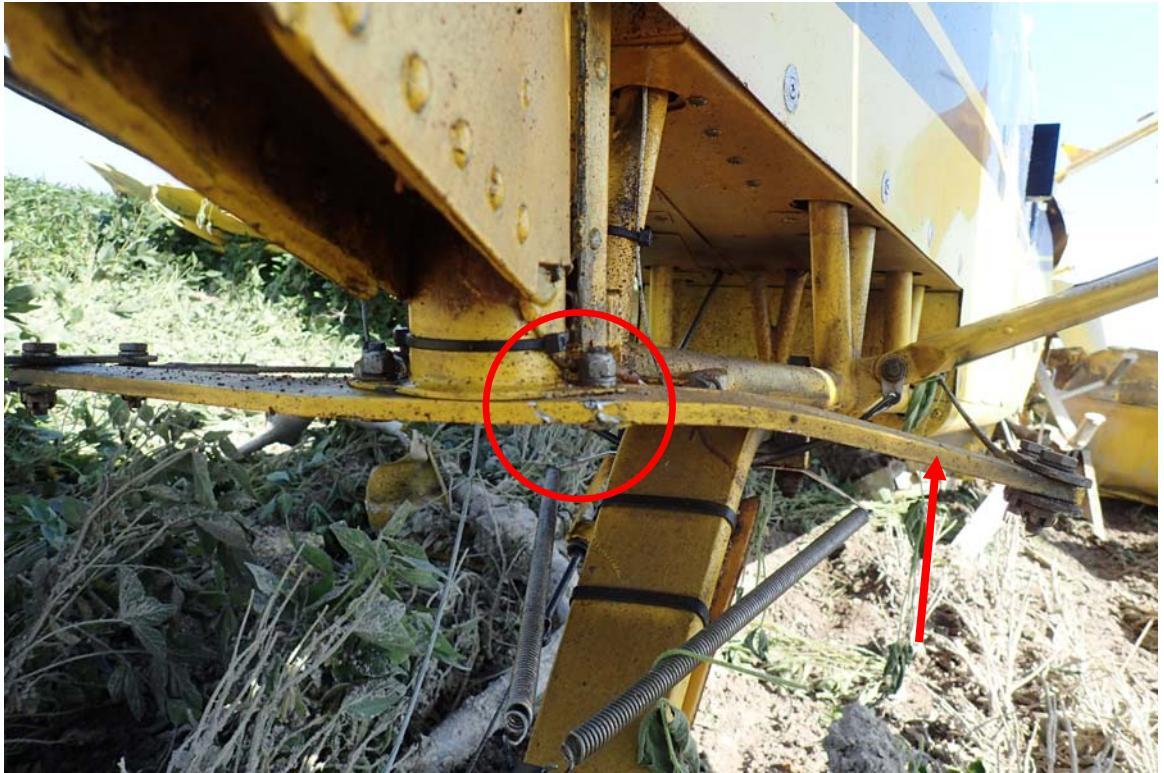
No wire strike marks were noted on any of the leading edges or tips of any empennage surface. The only damage noted on the empennage was to the rudder control horn located at the bottom of the rudder. The righthand side of the horn was bent downward approximately 10 degrees and there were some fresh impact marks on the aft side of the horn. The cause of this damage is unknown.

Impact marks (circled) and deformed rudder horn (arrow)

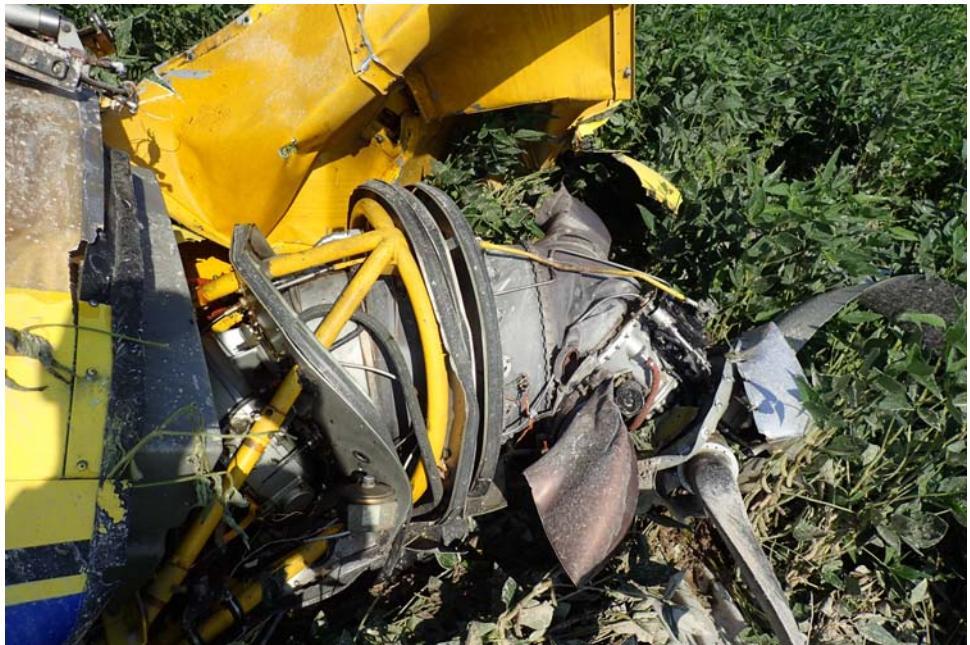
The engine was confirmed to be a PT6A-34AG engine serial number PCE-PH0230. The engine exhibited significant impact damage. The engine exhaust duct was crushed with the reduction gearbox being angled toward the right. One of the propeller blades was found with a nick in the leading edge.

Engine wreckage
