### NATIONAL TRANSPORTATION SAFETY BOARD

## AIR TRAFFIC CONTROL FACTUAL REPORT

ERA14FA112

Location:Bellevue, TennesseeDate/Time:Monday, February 3, 2014, 1656, central standard time (CST)<br/>Monday, February 3, 2014, 2256 coordinated universal time (UTC)Airplane:N840V, a Gulfstream Commander 690C

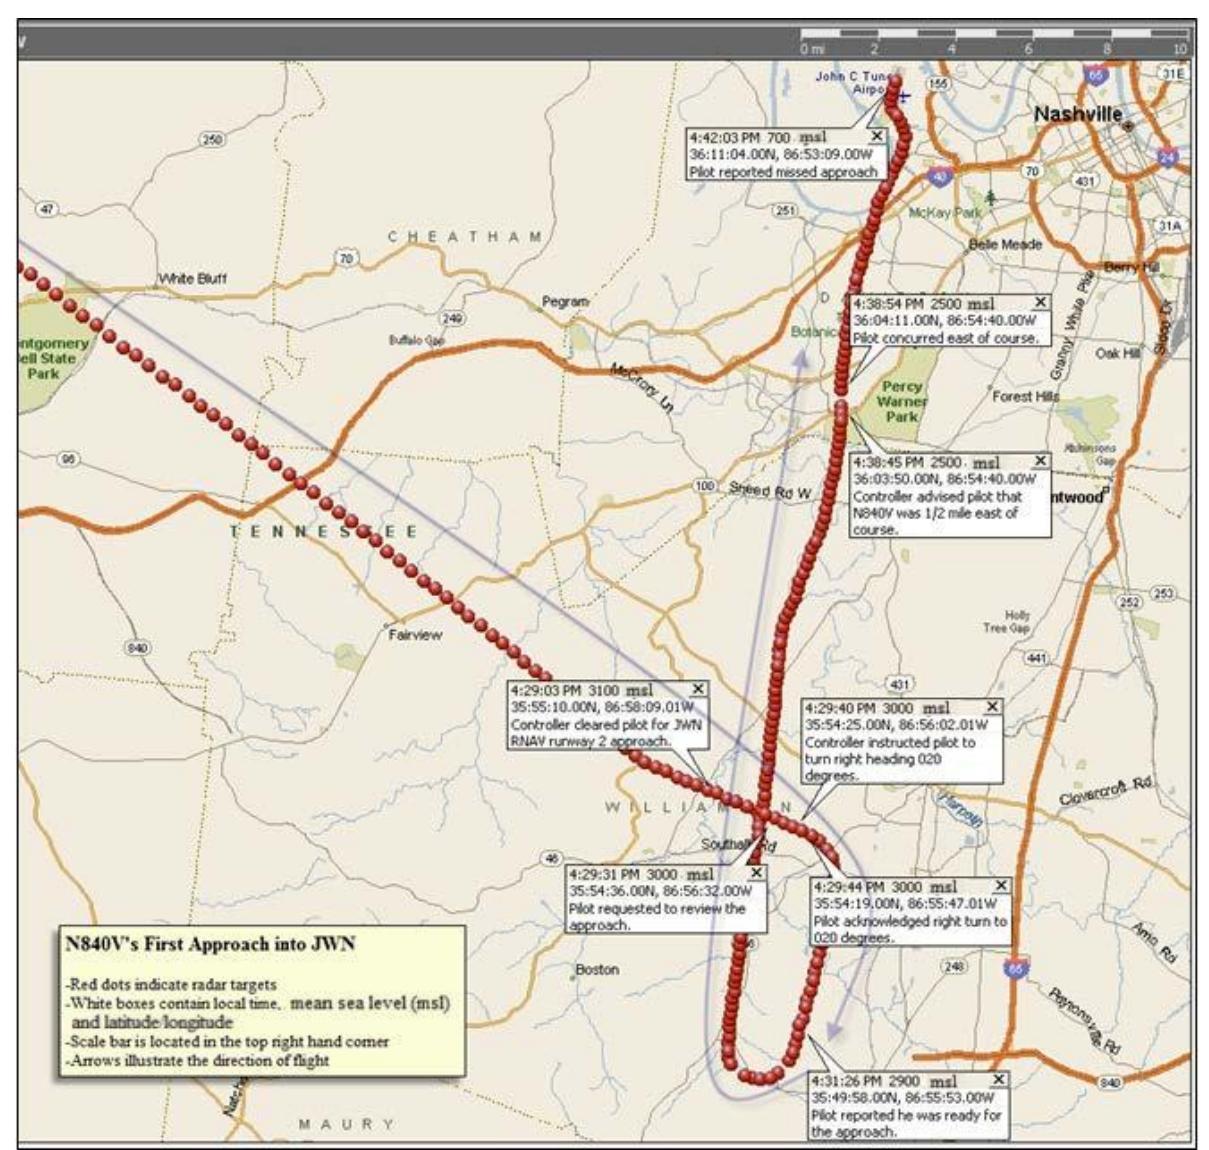
About 1638, the DRW controller advised the pilot, "we're showing you about a half a mile to the east of the uh approach, change to advisory frequency approved, radar service terminated, report your cancellation in the air this frequency, on the ground one two four point five five." The pilot requested that the controller repeat that transmission. The DRW OJTI controller informed the pilot that his airplane was about a half mile east of the final approach course, and explained "that's why we were asking if you were showing yourself established on the uh approach." The pilot responded, "That's correct I'm a little east of course." The DRW OJTI controller advised N840V that radar services were terminated and instructed the pilot to report canceling his IFR when he landed. Figure 1 illustrates N840V's flight path for the first approach into JWN.

Figure 1. Flight path of N840V's first approach into JWN.

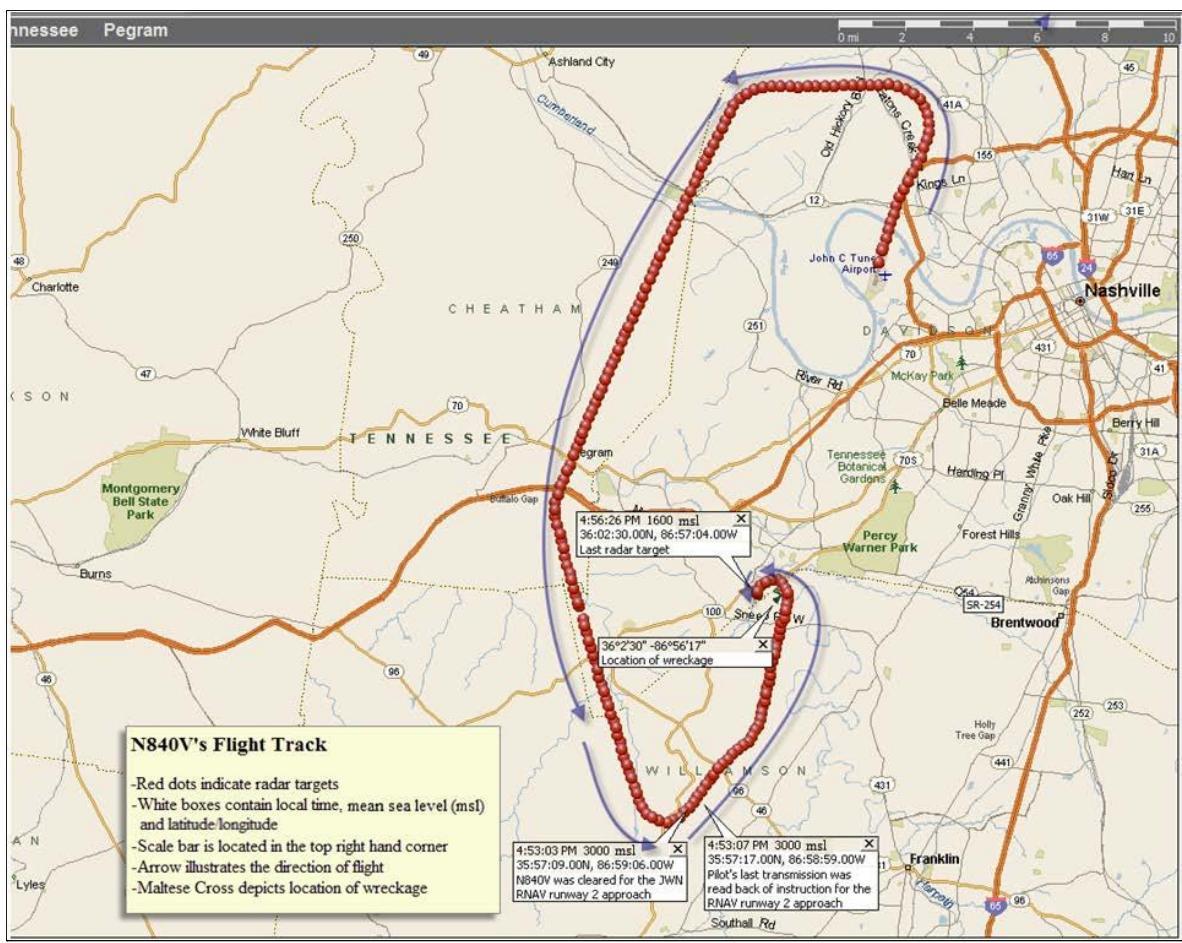
The DRW controller made several more attempts to contact the pilot. There were no further transmissions from the pilot of N840V. Figure 2 shows N840V's flight path after the missed approach at JWN, until the time of the accident.

Figure 2. N840V's flight path subsequent to missed approach at JWN.
