NATIONAL TRANSPORTATION SAFETY BOARD

Aircraft Performance - Addendum #1

Addendum to Group Chairman's Aircraft Performance Study by John O'Callaghan

Location:	Sixty miles South of Nantucket, MA	
Date:	October 31, 1999	
Time:	0150 Eastern Standard Time (EST)	
Flight:	EgyptAir Flight 990	
Aircraft:	Boeing 767-366ER, Registration SU-GAP	
NTSB#:	DCA00MA006

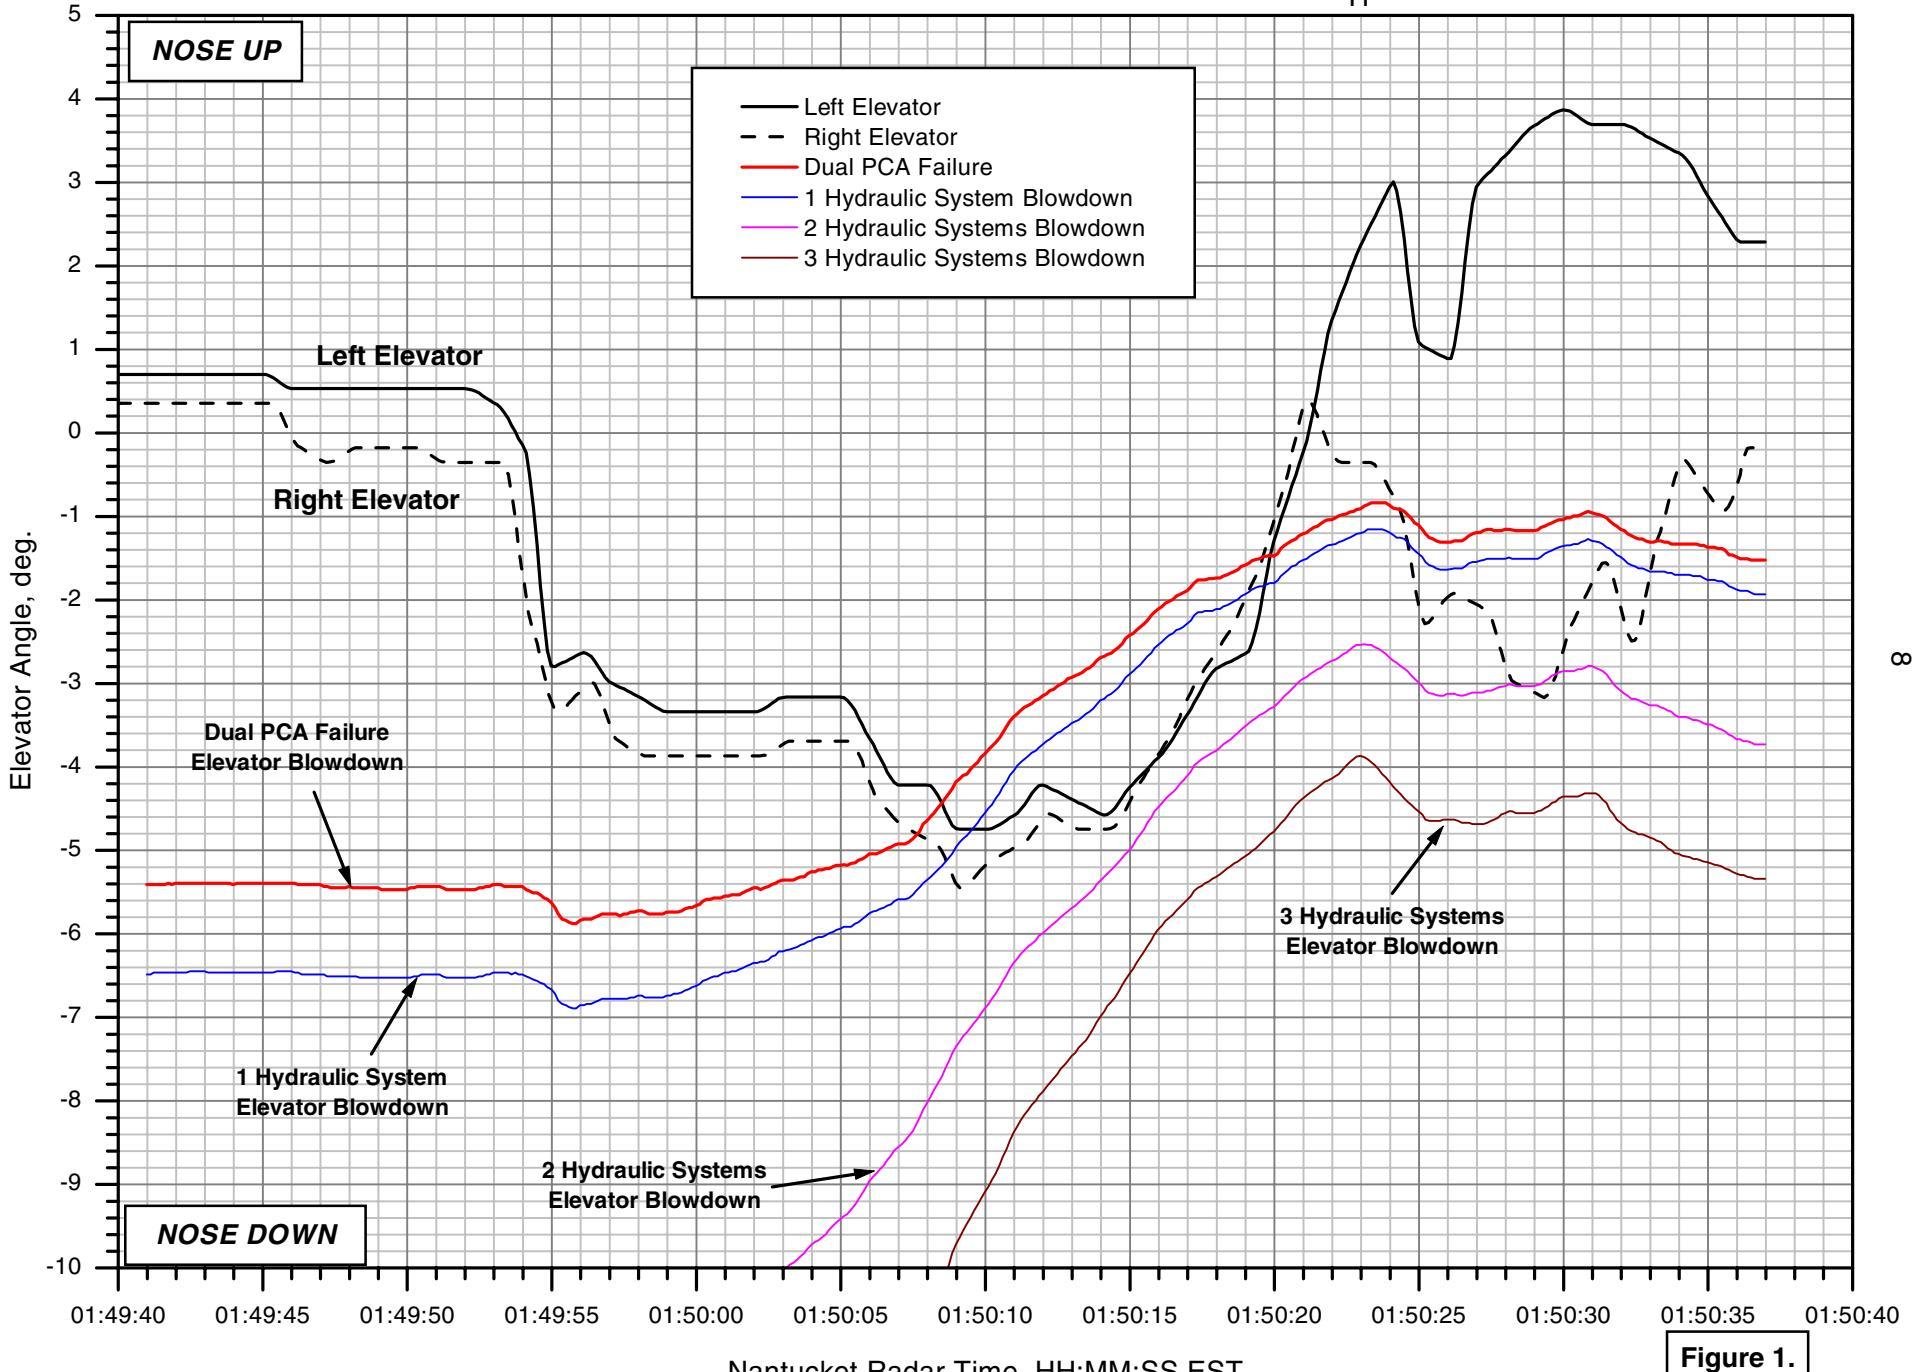
John O'Callaghan Senior Aerospace Engineer April 19, 2000 EgyptAir 990 Elevator Blowdown Angles

The solutions for δ_e with n = 0.78, 1, 2, and 3 are shown in Figure 1. These solutions are the blowdown angles corresponding to the Dual PCA Failure and various hydraulic systems turned off. The elevator positions recorded on the DFDR are also shown in Figure 1. The elevator blowdown angle is primarily dependent on the dynamic pressure, decreasing as dynamic pressure increases. Changes in angle of attack produce oscillations about the general trend set by the increasing dynamic pressure. Nonlinear Mach effects become more pronounced after about 01:50:07, where the Mach number is increasing through 0.86 and the slope of the blowdown curves increases abruptly. The extrapolated C_H data provided by Boeing indicates that the C_H for a given δ_e deflection starts to increase significantly above Mach 0.86, and at Mach 0.98 reaches over twice its Mach 0.8 value for some values of δ_e and α_H .

The Addendum also presents the elevator blowdown angles corresponding to different numbers of hydraulic systems powered on and off, and to a Dual Elevator PCA Failure scenario. The blowdown angles are estimated using extrapolated, non-linear elevator hinge moment data. The results of the calculations are shown in Figure 1.
