National Transportation Safety Board

Airplane Performance Study Addendum

Specialist's Report Addendum Timothy Burtch

Location: Lubbock, TX Date: January 27, 2009 Time: 1037 GMT (437 CDT) Airplane: ATR-42-320, N902FX NTSB Accident Number: CEN09MA142

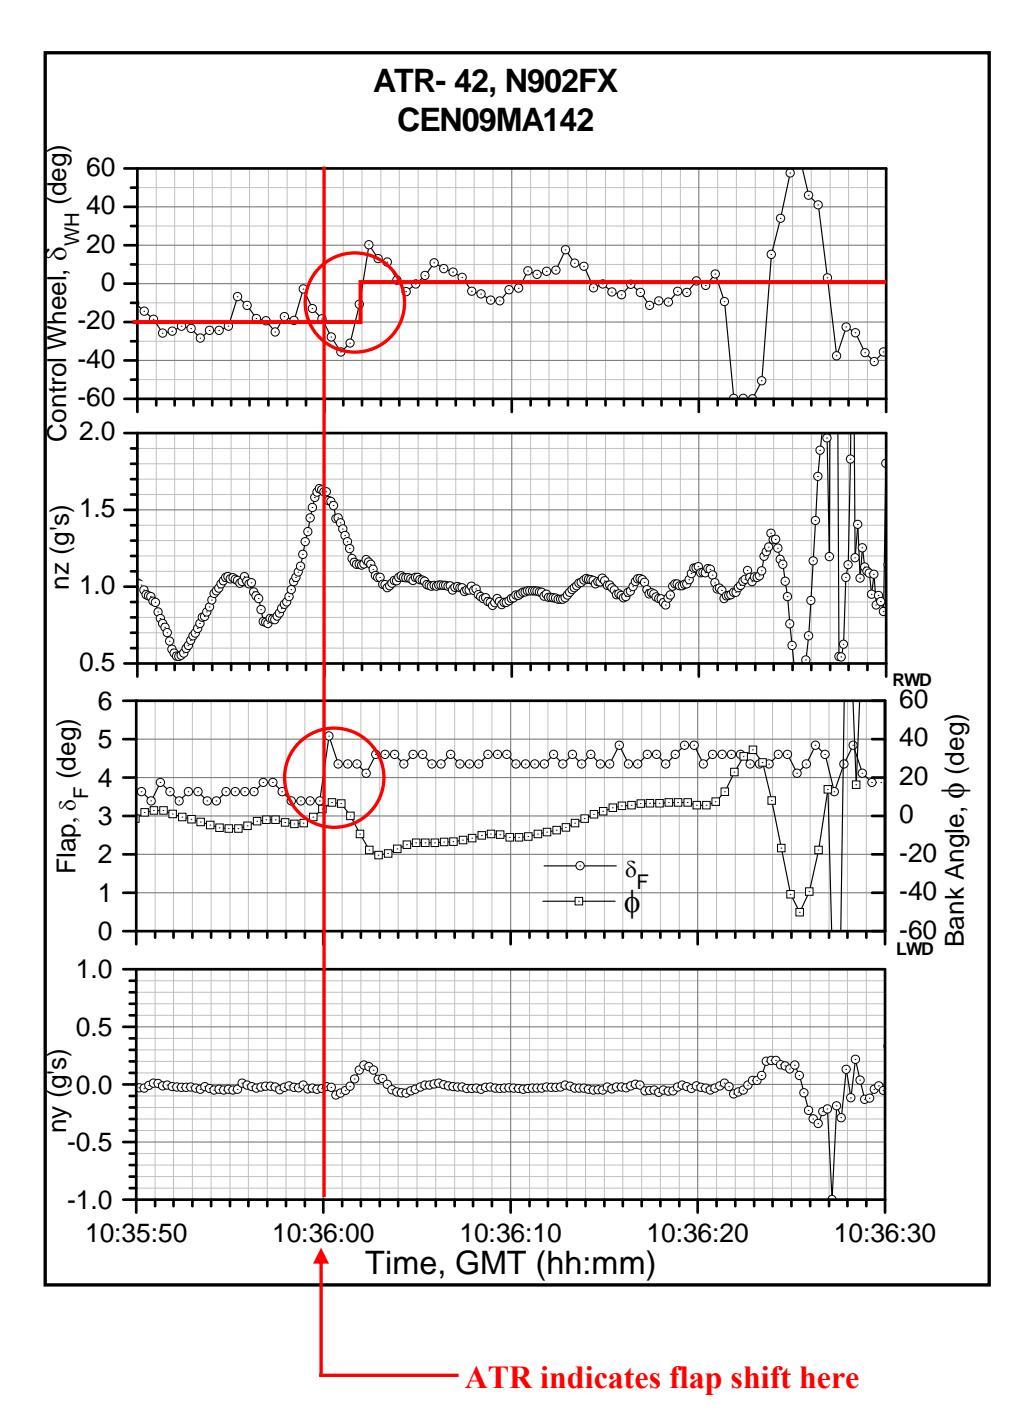
According to ATR and based on airplane performance, simulation results, and FDR data, the left flaps retracted from an actual position of 8-10 degrees to approximately 4.5 degrees. The right flaps, on the other hand, extended to approximately 4.5 degrees. At this point, all four flaps were symmetrically extended to 4.5 degrees, and the captain's control input to counteract the flap asymmetry was no longer required. See the configuration change reflected in the shift in control wheel position around 1036:00 noted in Figure 1.

Time histories of the FDR wheel position, average flap position, and the resulting vertical and lateral accelerations are shown in Figure 1. Additional information regarding the flap system is provided in the Airworthiness Group Factual Report Addendum 2.

Figure 1. Flap Shift at 10:36:00, About the Same Time as Pilot Input

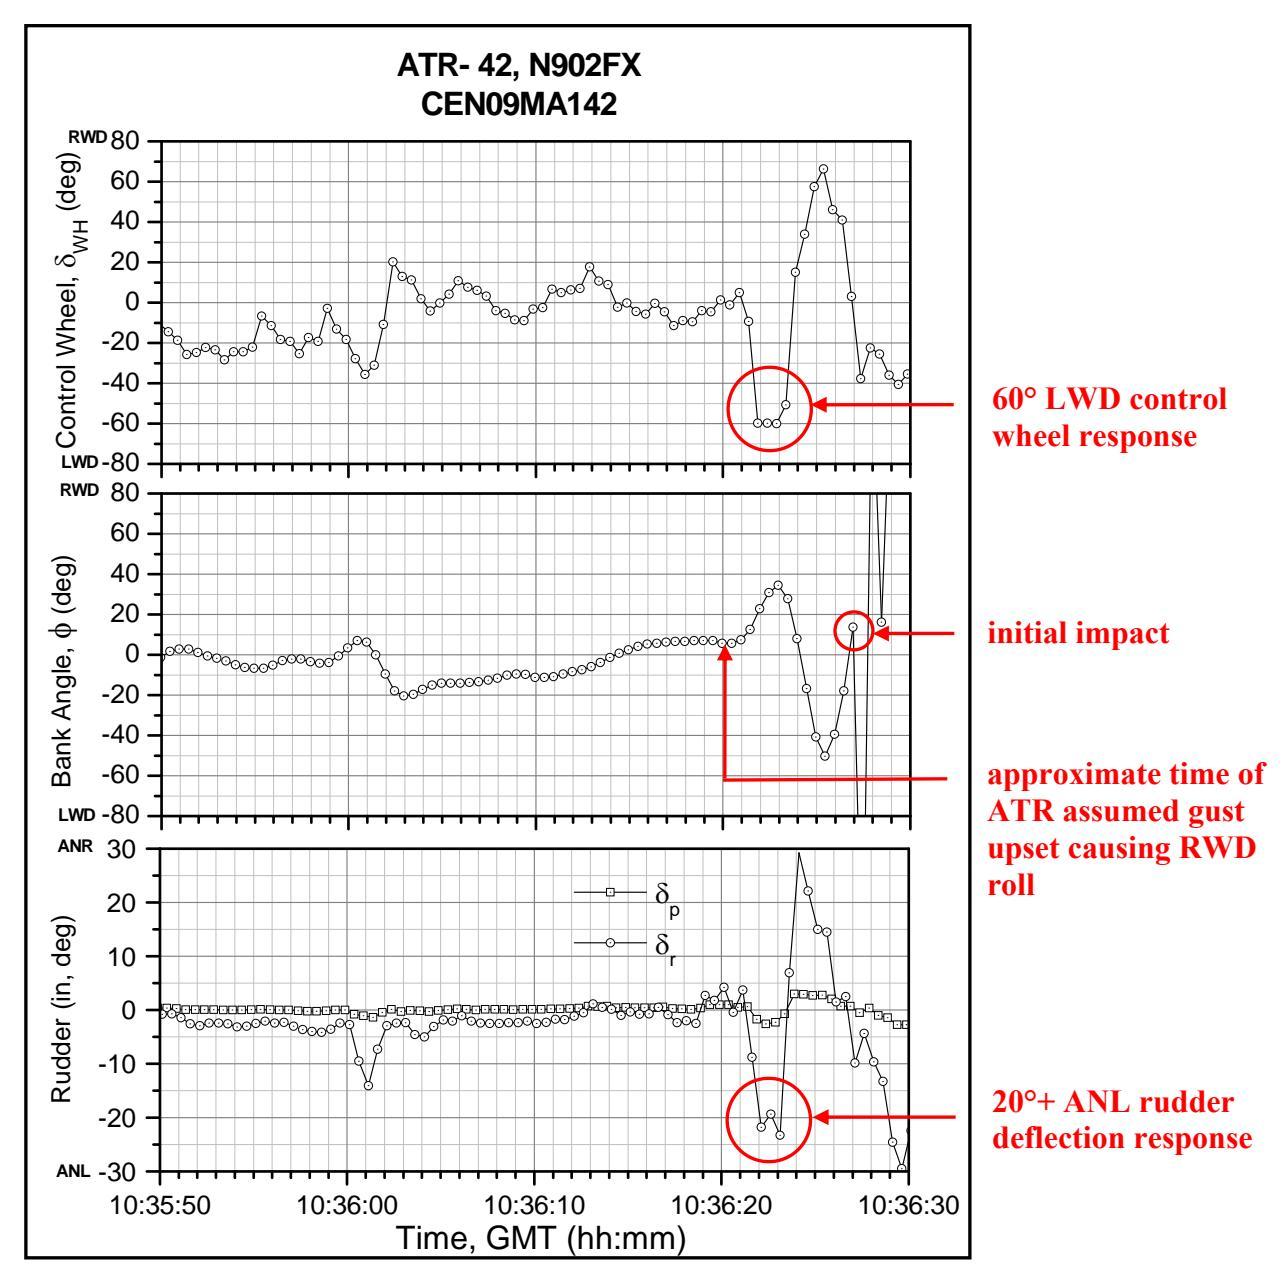
In addition to the new flap position information, the possibility of a gust encounter during the final seconds of Empire 8284's approach was introduced by ATR during the NTSB's November 18-19, 2010 visit to Toulouse. At 1036:20, the FDR data indicate that the accident airplane began rolling right at approximately 14 degrees/second without input from the pilot. See Figure 2.

While the precise effect of rudder pedal, sideslip, and wind gusts on the ATR-42 lateral / directional dynamics would require ATR-42 simulation model data, the 35 degree right bank shown in Figure 2 does not appear to be the result of a wind gust. The NTSB considered two other potential sources for the uncommanded roll: a second flap asymmetry and a wing stall.

Figure 2. ATR Assumed Gust Upset at 1036:21 and the Recorded Pilot Response

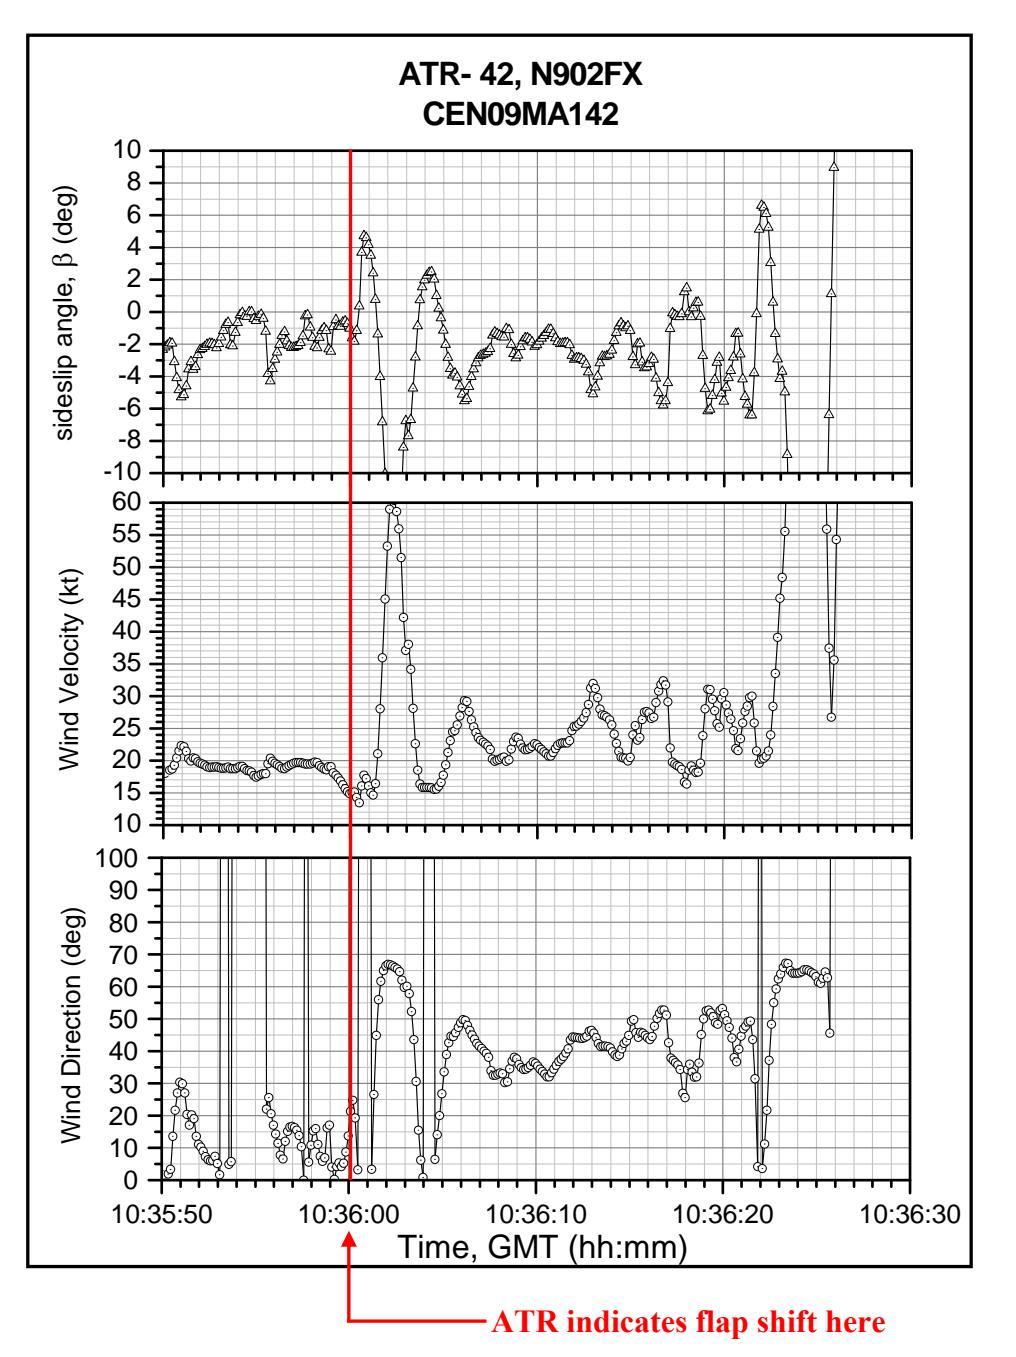
Figure 3 shows the estimated sideslip angle based on the lateral acceleration and rudder deflection recorded on the FDR. Sideslip angle does induce airplane roll, and the calculated sideslip does fluctuate $\pm 2^{\circ}$ around a mean of about -2° in the seconds before the 35 degree roll upset. However, the small sideslip angles are consistent with the small rudder input that the captain was carrying during most of the approach, likely due to the quartering tailwind. See the rudder deflection in Figure 2. The large 8° to 10° change in sideslip at 10:36:01 corresponds to the 112 lb pedal force input made by the captain and, as previously discussed, is about the time the flaps returned to a symmetric configuration.

Figure 3 also includes the wind speed and wind direction calculated for the final seconds of Empire flight 8284. Figure 4 is a table of the recorded Automated Surface Observing System (ASOS) one minute wind data around the time of the accident. Each one minute report in the table represents the average wind over the previous two minutes using a five second sampling period (i.e., 24 samples in two minutes). The average winds are recorded 10 meters above the ground or 32.8 ft agl. The ASOS report closest to the accident is for 1036:00 and was a 13 kt average wind with a peak wind of 15 kt (and is highlighted in yellow). This is very close to the NTSB estimate of 15 kt from 021° shown in Figure 3 at 1036:00. It should also be noted that "a gust" requires a fluctuation of at least 10 kt to be reported at all by the airport. There were no gust reports around the time of the accident. ATR assumed a 15 kt gust lasting three seconds in their analysis.

Figure 3. Sideslip and Wind Estimated from FDR Accelerometer Measurements

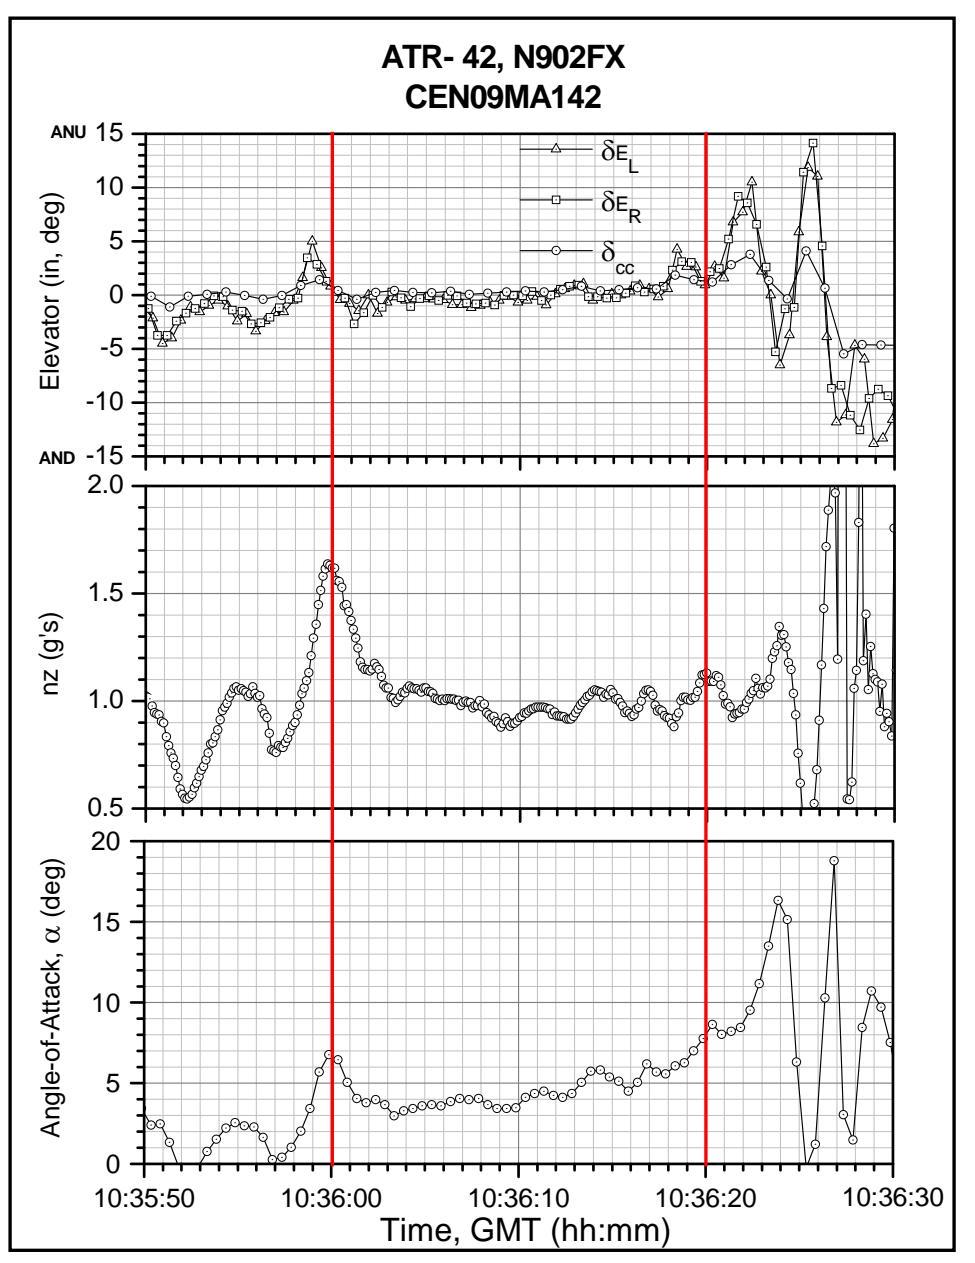
As can be seen in Figure 5, the amount of load factor that results for a given change in angle-ofattack (which is proportional to lift) appears to be diminished when a comparison is made between the load factor peak around 1036:00 (from an elevator input that peaked at 10:35:59) and the load factor peak around 1036:20 (from an elevator input that peaked just beyond 10:36:18). This reduction can be the result of a wing that is approaching a stalled condition and, because of the separated air flow, is no longer able to effectively generate lift. ATR also identified an asymmetric loss of lift as a potential source of the uncommanded roll during the accident flight.

Figure 5. Vertical Load Factor with AOA

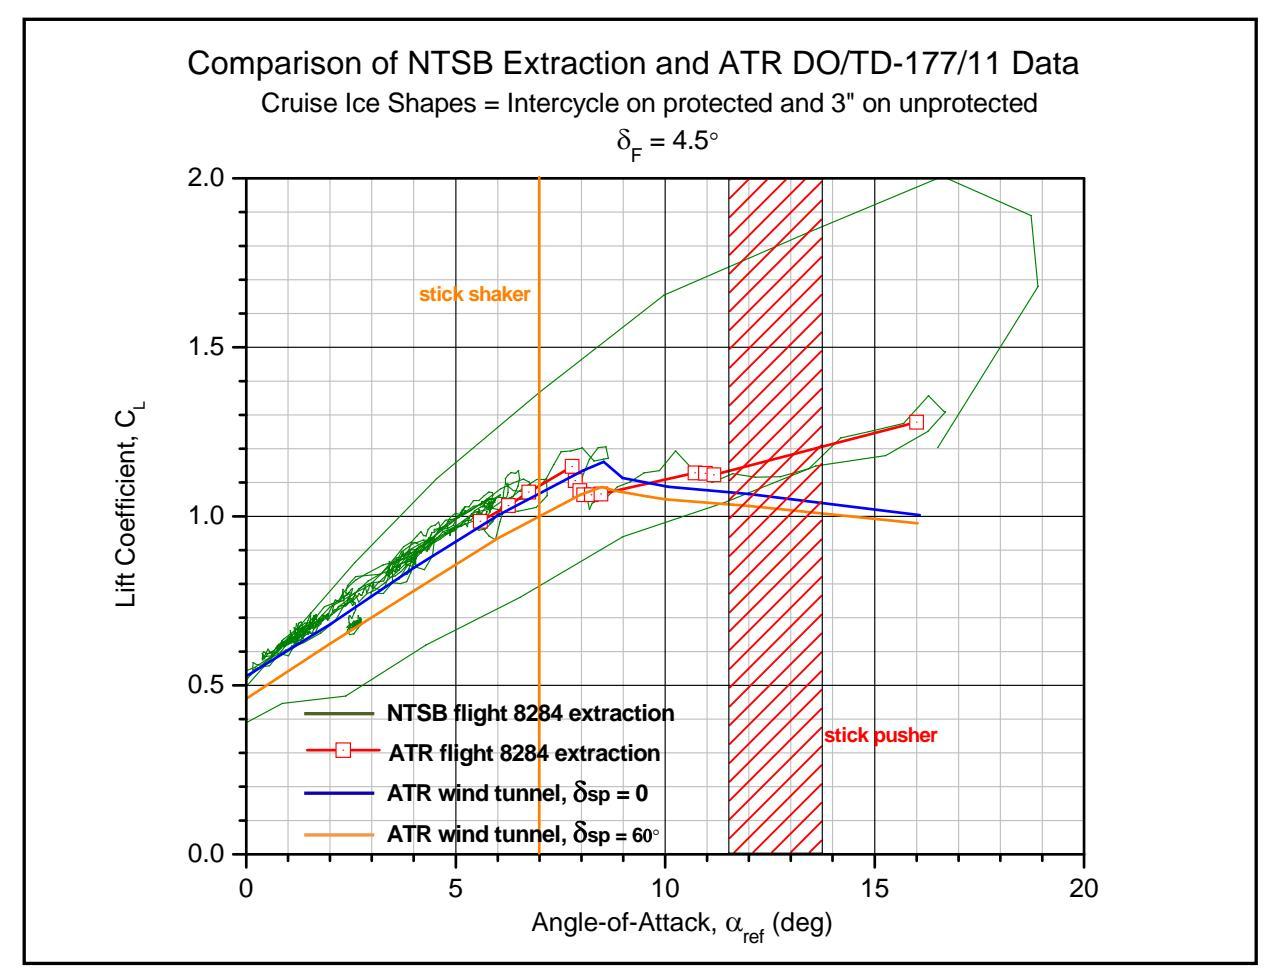
The lift coefficient for the accident approach was extracted using primarily the FDR accelerometer, angular rates, and angle-of-attack data to look for the presence of a stall. In addition, airplane geometry, mass properties, and engine thrust were required and were either obtained from ATR or estimated. Figure 8 shows the NTSB's estimated lift coefficient based on FDR data (green). Figure 8 also includes ATR's estimated lift coefficient for flight 8284 including the effect of the captain's full roll spoiler input beyond stick shaker at 7.8 degrees angle-of-attack (red). Finally, Figure 8 has wind tunnel lift coefficient data for the ATR-42 with "cruise ice"⁶ shapes with and without full roll spoiler (blue and orange, respectively).

Figure 8 shows the lift coefficient extraction for the accident and lift coefficient data from the original ice certification program. However, every ice encounter produces unique accretions. It is therefore not possible to draw conclusions about the actual ice accretion on Empire 8284 beyond stating that the NTSB's extracted lift data looks similar to ATR's "cruise ice" lift data for angles-of-attacks slightly greater than stick shaker. Small variances in the height and location of the ice accretion can have large effects in the stall region of the lift curve.

Figure 8. Comparison of NTSB and ATR Extracted Lift Coefficient for Empire flight 8284

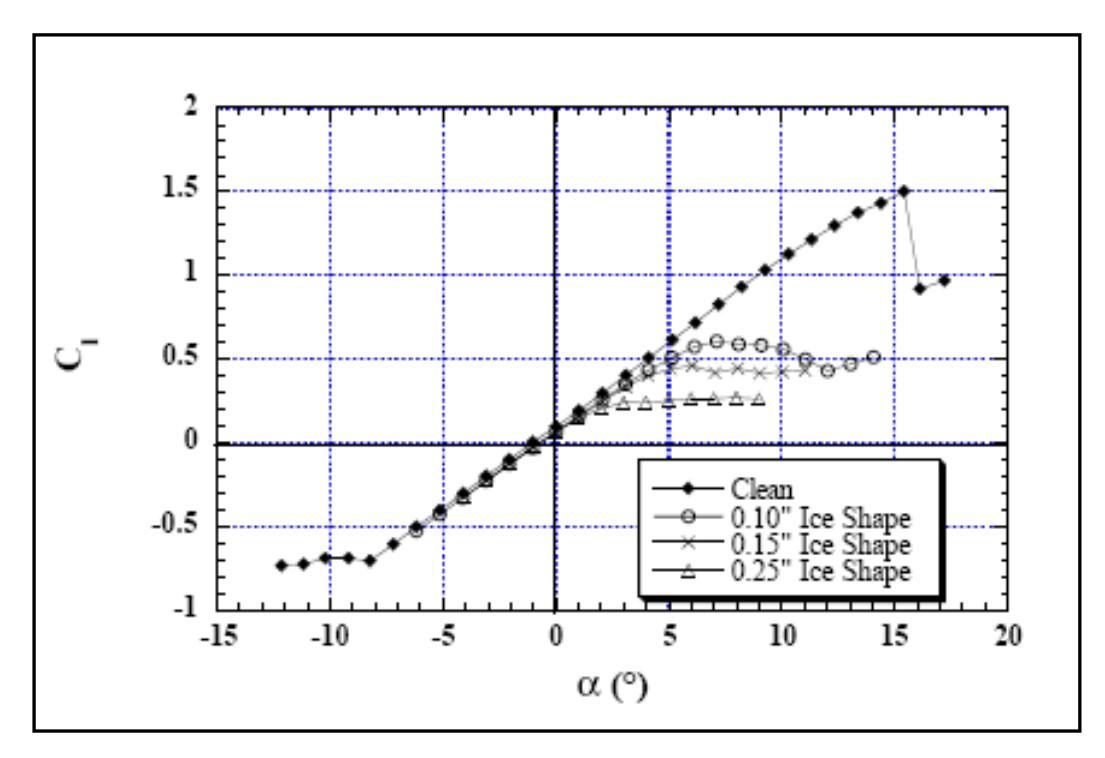
The Federal Aviation Administration's Office of Aviation Research published the effects of such variances for a NACA 230 series airfoil (vs. the NACA 430 series on the ATR-42) in its final report, "Effects of Large-Droplet Ice Accretion on Airfoil and Wing Aerodynamics and Control" (DOT/FAA/AR-00/14). Figure 9 contains excerpts from the report which show that the linear portion of the lift curve does not vary greatly with ice shape; however, the maximum lift

Figure 9(a). Effect of Simulated Ice Shapes on Lift Coefficient for NACA 230 Series Airfoil

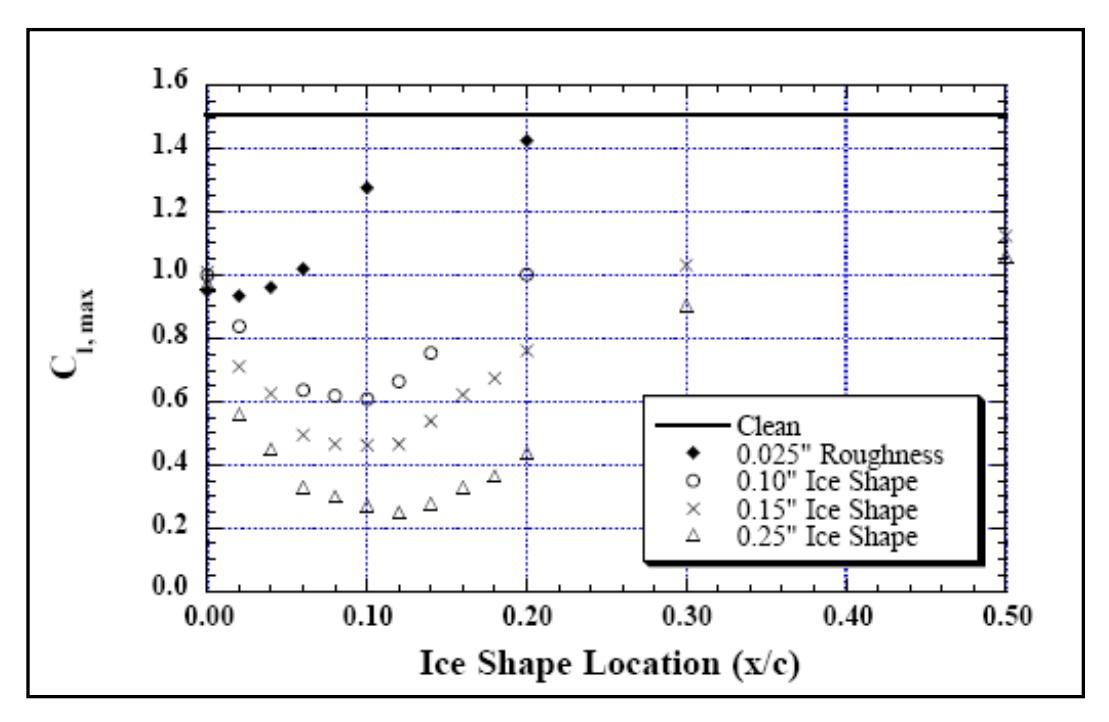
Figure 9(b). Effect of Simulated Ice Shapes on C_{Lmax} for NACA 230 Series Airfoil

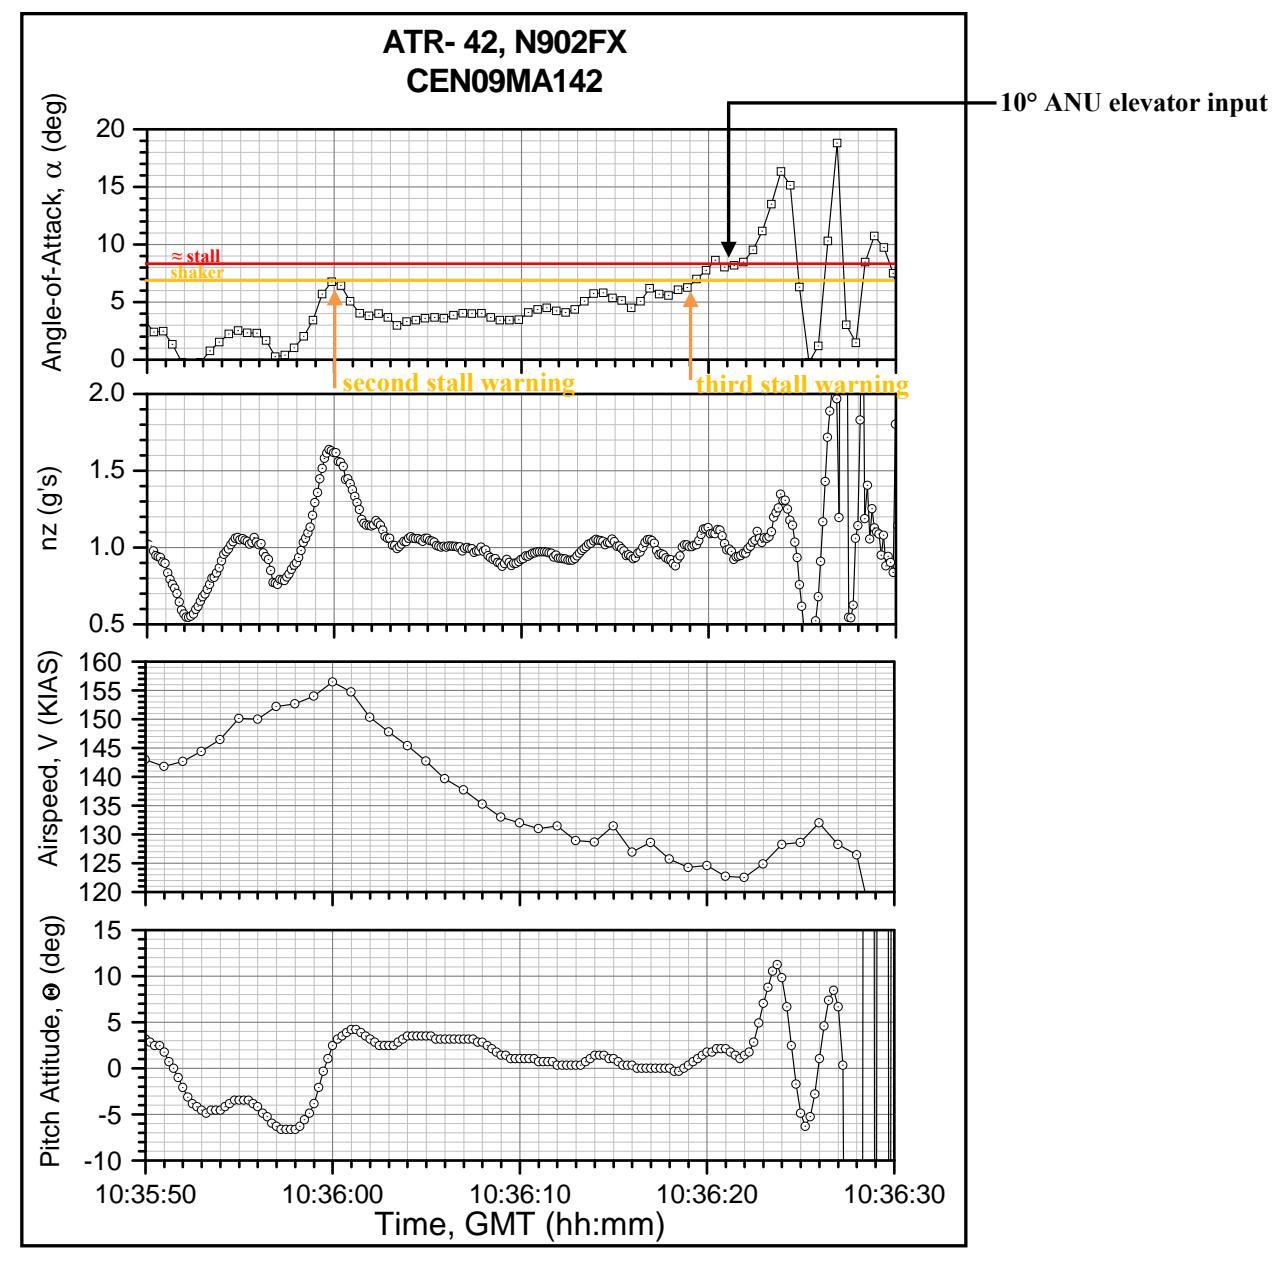
The NTSB lift extraction highlights the fact that Empire flight 8284 had very little stall margin remaining as the captain started increasing torque to over 95% and the elevator started increasing to over 10 degrees airplane-nose-up at approximately 1036:18 and 1036:21, respectively (see Figures 10 and 11). Stick shaker AOA had already been exceeded. Without roll input from the pilot, the airplane began to roll right at 1036:20 about the same time it reached an AOA of 8.6 degrees. In response, the pilot started inputting maximum left-wing-down (LWD) control wheel around 1036:21 and reached 60 degrees of wheel about a second later. Rudder deflection reached approximately 22 degree airplane-nose-left (ANL) at the same time. At 1036:23, two seconds after the captain's LWD wheel input, the airplane reached a 35-degree right-wing-down (RWD) bank angle. There was approximately a one second delay in the airplane's bank angle response to the captain's LWD command. The airplane was at an altitude of about 114 ft above the ground at 1036:23.

Based on the NTSB's lift coefficient extraction, the gradient of load factor with angle-of-attack, $\Delta nz/\Delta \alpha$, and the airplane's response to the captain's inputs, it is likely that the airplane stalled at approximately 1036:20, just prior to reaching 8 degrees angle-of-attack. The uncommanded roll at 1036:20 is consistent with an accelerated stall. The captain's aileron input at 1036:21 likely exacerbated the RWD roll, and the airplane reached a maximum 35° RWD bank before the right roll was arrested and the airplane began rolling left.

Figure 10. Final Stall Warning at 10:36:19

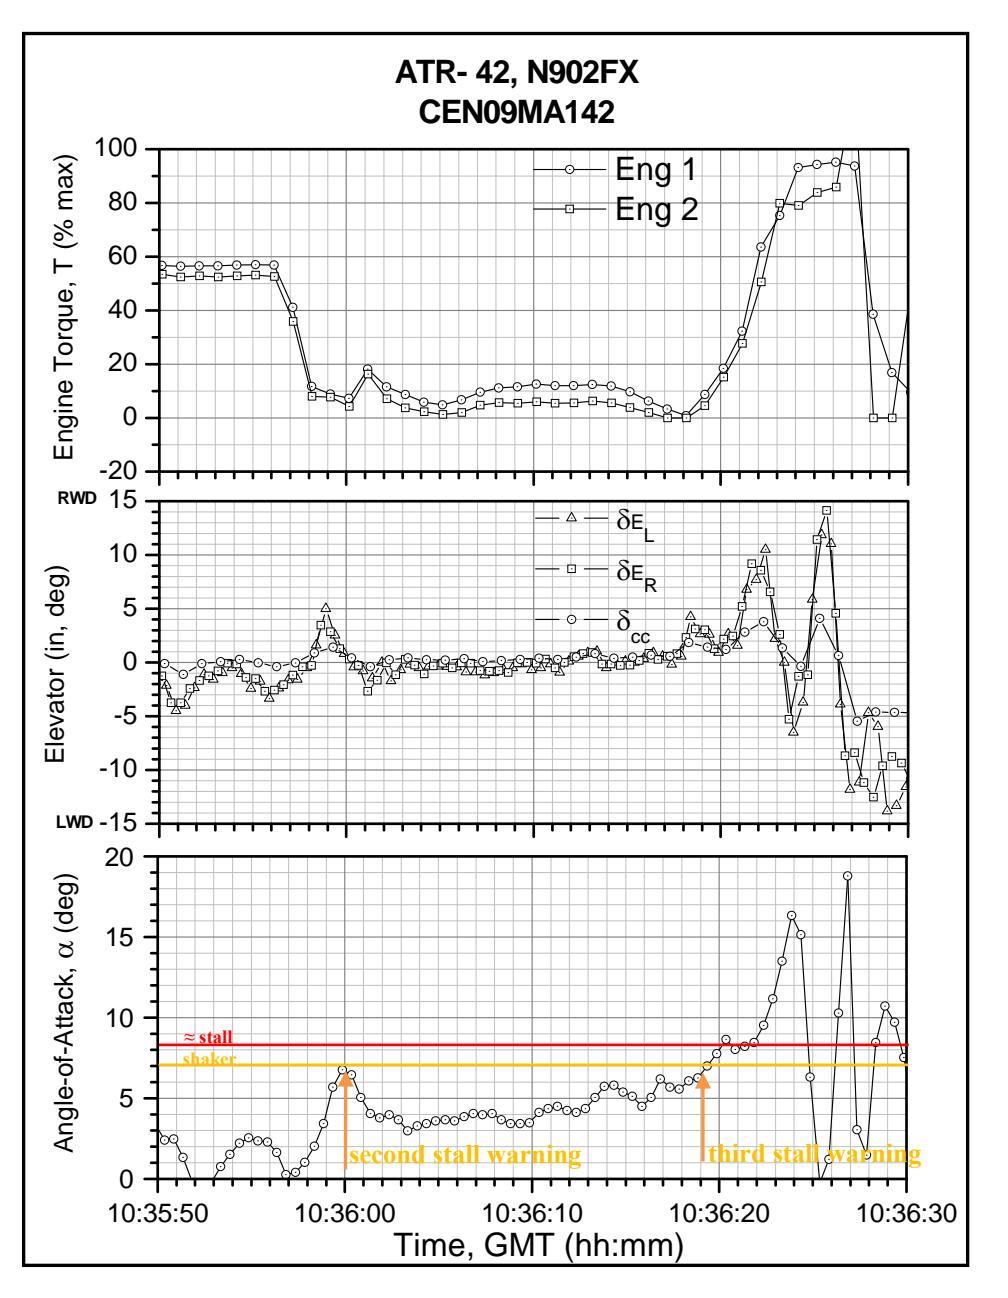
Figure 11. Final Stall Warning at 10:36:19
