National Transportation Safety Board

Airplane Performance Study

Specialist's Report of Investigation Timothy Burtch

Location:	Denver, CO
Date:	December 20, 2008
Time:	0018 GMT (6:18 pm MST)
Airplane:	Boeing B-737-500, N18611
NTSB Number:	DCA09MA021

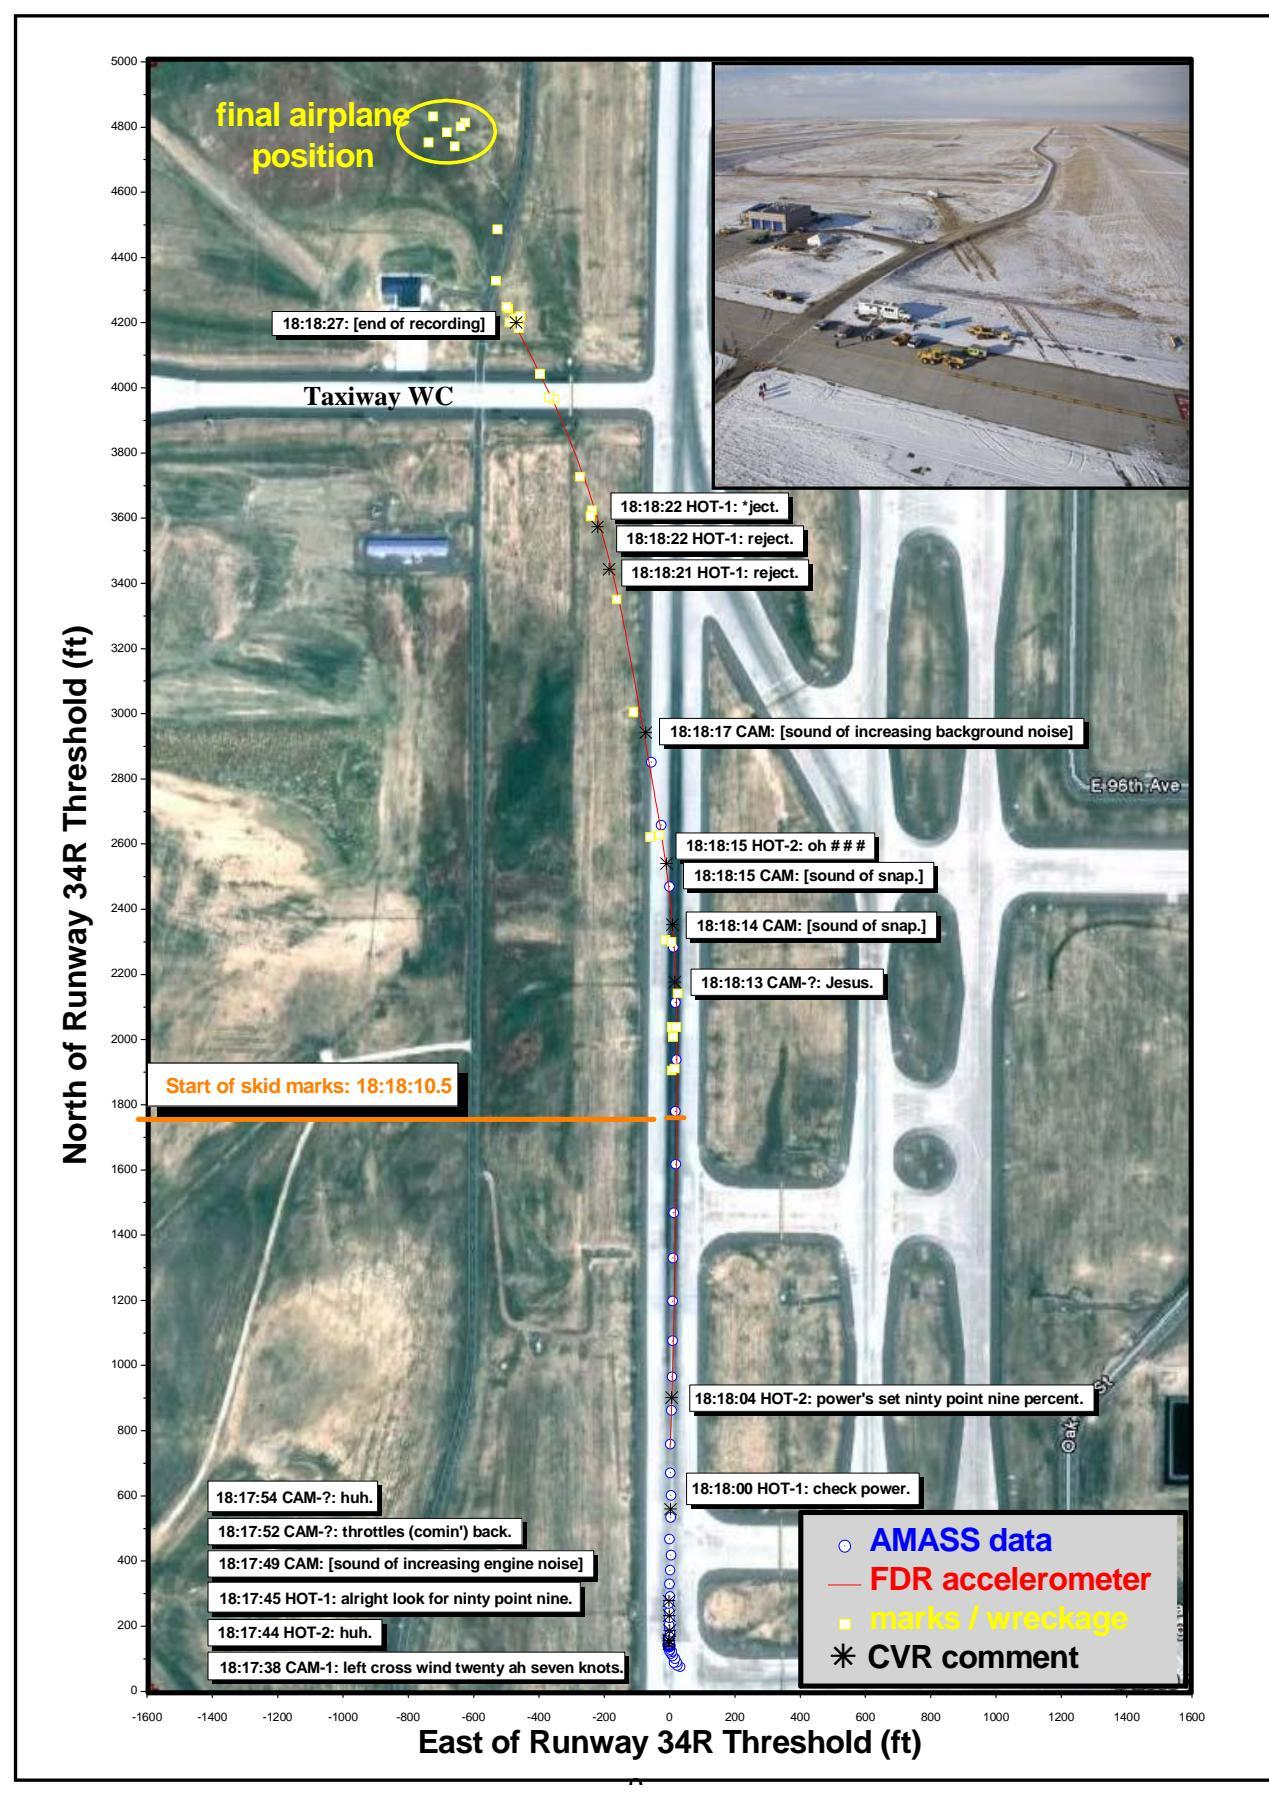
Figure 1: Accident Scene Overlay Including Ground Path and CVR Comments

The FDR integration is shown in red in Figure 1. It was necessary to perform an integration because the position data recorded on the FDR lacked the precision to accurately place the airplane on the runway. The AMASS data, on the other hand, is accurate and is recorded every second at Denver International Airport. However, AMASS position for Flight#1404 does not exist beyond the point the airplane departed the runway. An integration was required for an accurate ground track beyond the AMASS range and up until the FDR stopped recording. In addition to providing a ground track for the accident airplane, integrating the FDR accelerometer data also provided the proper context for the cockpit voice recorder (CVR) comments and a set of accelerometer biases for the wind extraction effort. The CVR comments are show in yellow in Figure 1. The wind extraction is discussed below.

³ The pilot reported after the accident that he was concerned about the airplane rolling over the embankment adjacent the runway and that he added RWD aileron to help prevent this from happening. However, the AMASS data and FDR integration in Figure 1 show that the airplane was still close to the runway centerline when the RWD wheel was introduced by the pilot at about 18:18:13.

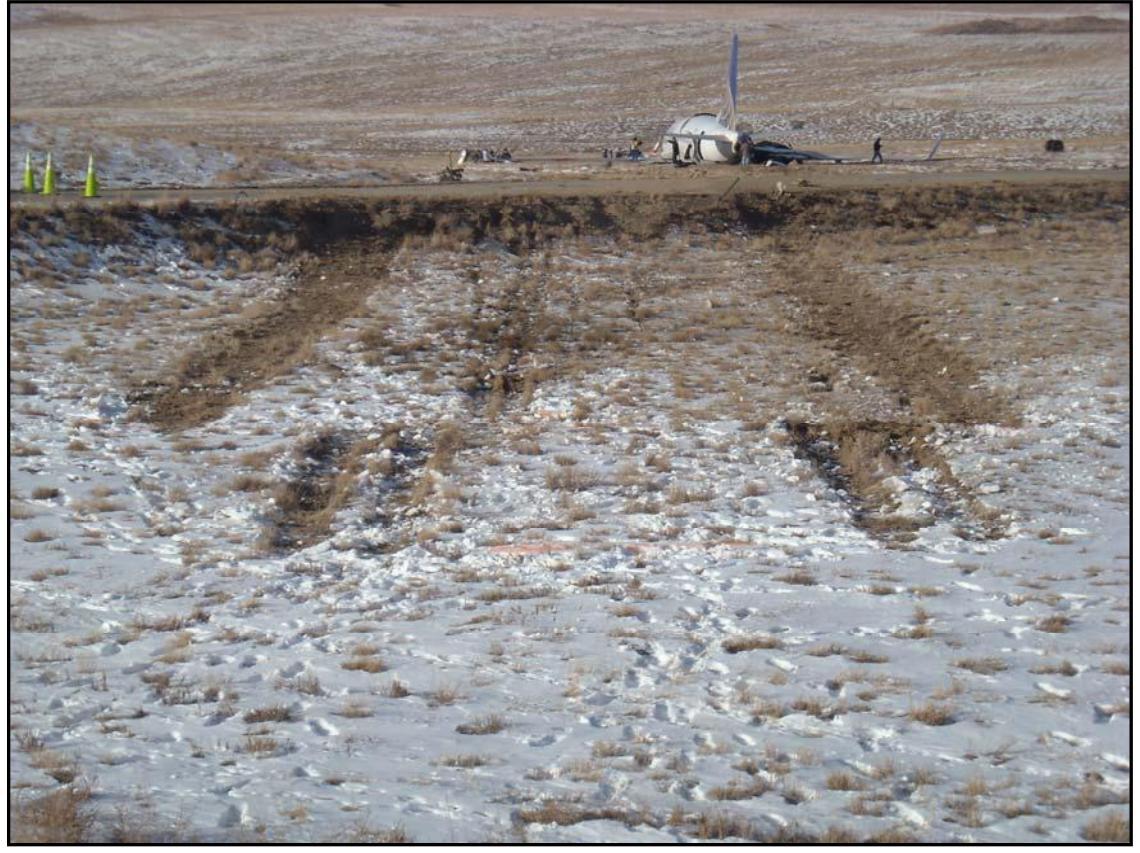
Figure 2a: Gear and Engine Nacelle Tracks Appear North of Taxiway WC

Select data from the FDR are plotted in Figures 3 through 9. Figure 3 contains the pilot inputs throughout the take-off roll, the excursion through the grass adjacent runway 34R, and the crossing of Taxiway WC. The data end when the airplane was just north of Taxiway WC. This point approximately corresponds with a 3g spike in vertical load factor recorded on the FDR and likely resulted from a drop-off north of Taxiway WC. According to on-scene witness marks, this is also the point where the airplane lost both main landing gear and began to slide on its engine nacelles. See the inset in Figure 1 and Figure 2.

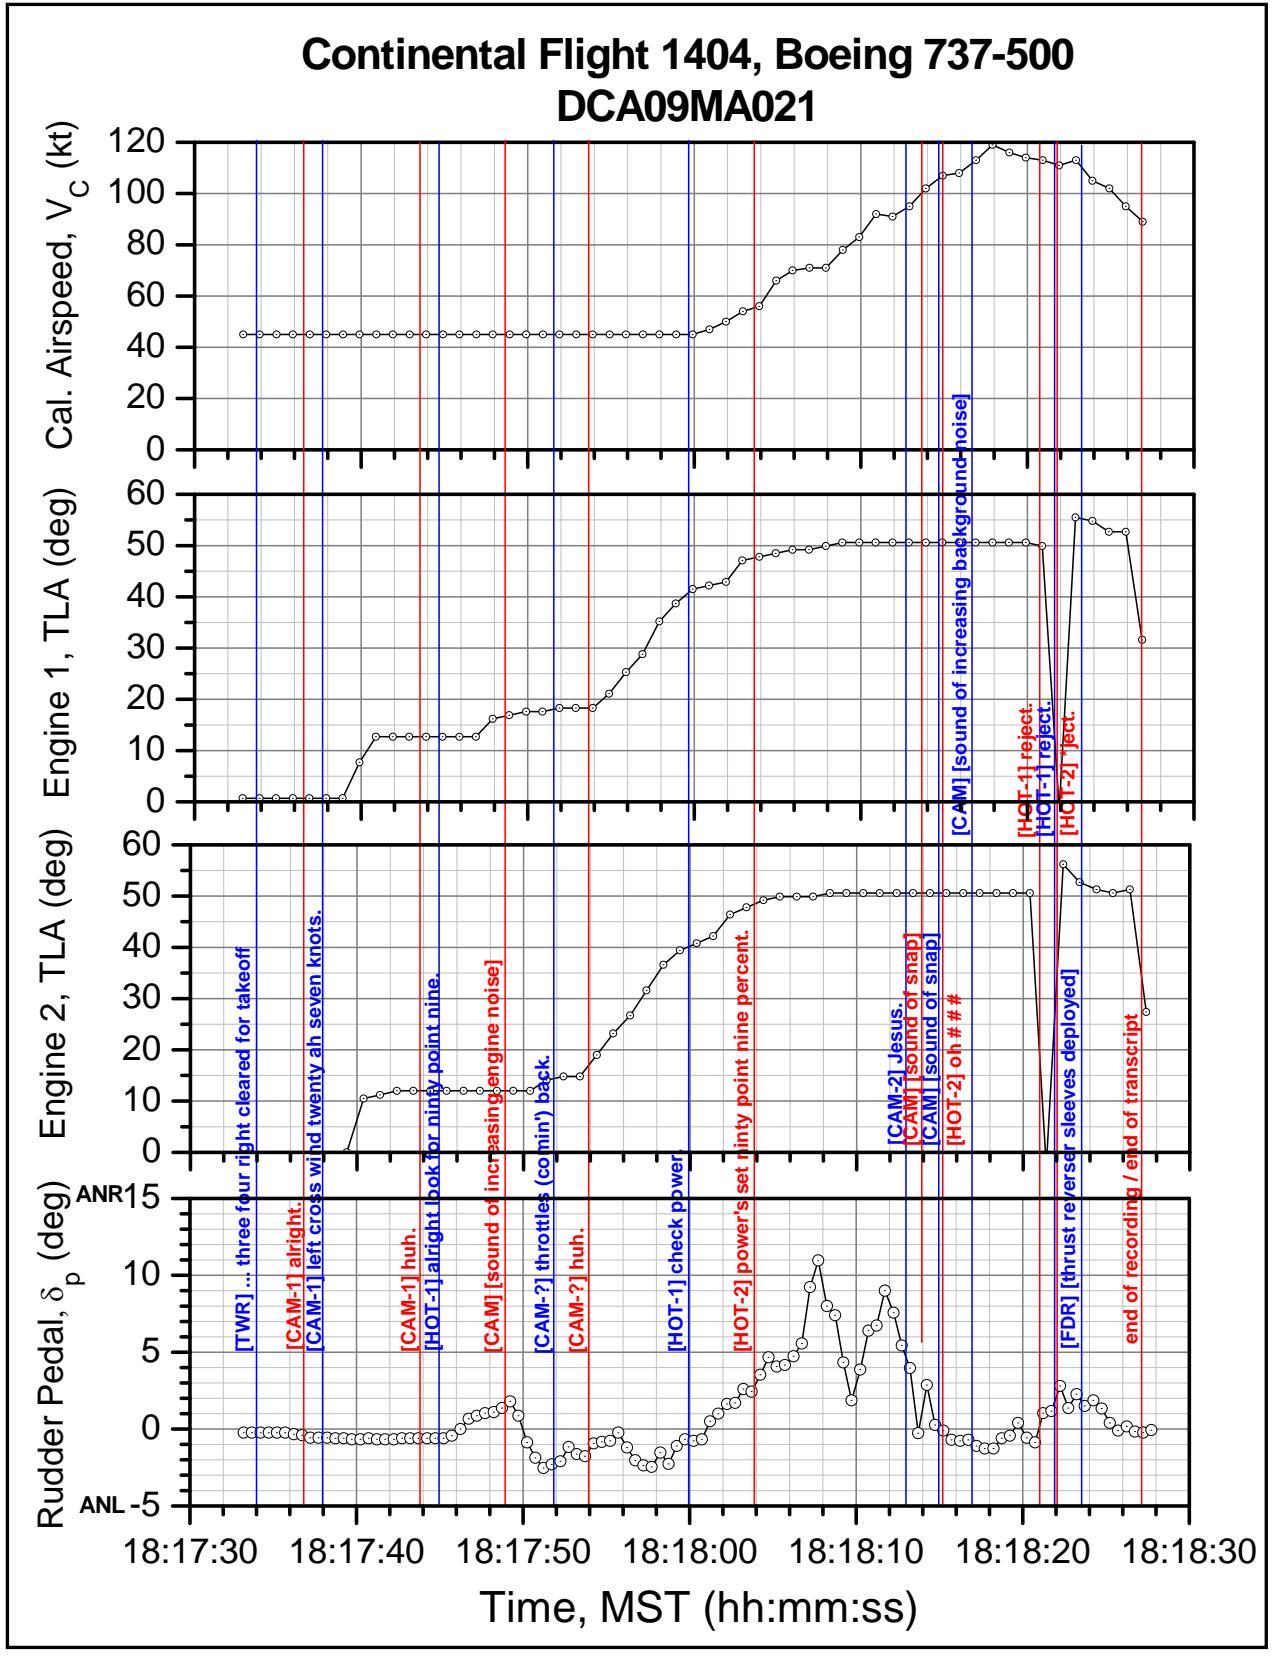
Figure 4: Engine Operation

Figure 4 includes FDR parameters for the engines. Engine performance was normal for take-off until just after the airplane departed the runway¹ and before the Captain made the call to reject the take-off at 18:18:21MST. (All times are MST unless otherwise noted.) As shown in the figure, the airplane departed the runway at approximately 110 kt calibrated airspeed (KCAS) and reached a maximum airspeed of 120 kt KCAS². The airplane decelerated to about 90 KCAS before the FDR stopped recording just north of Taxiway WC at 18:18:27.

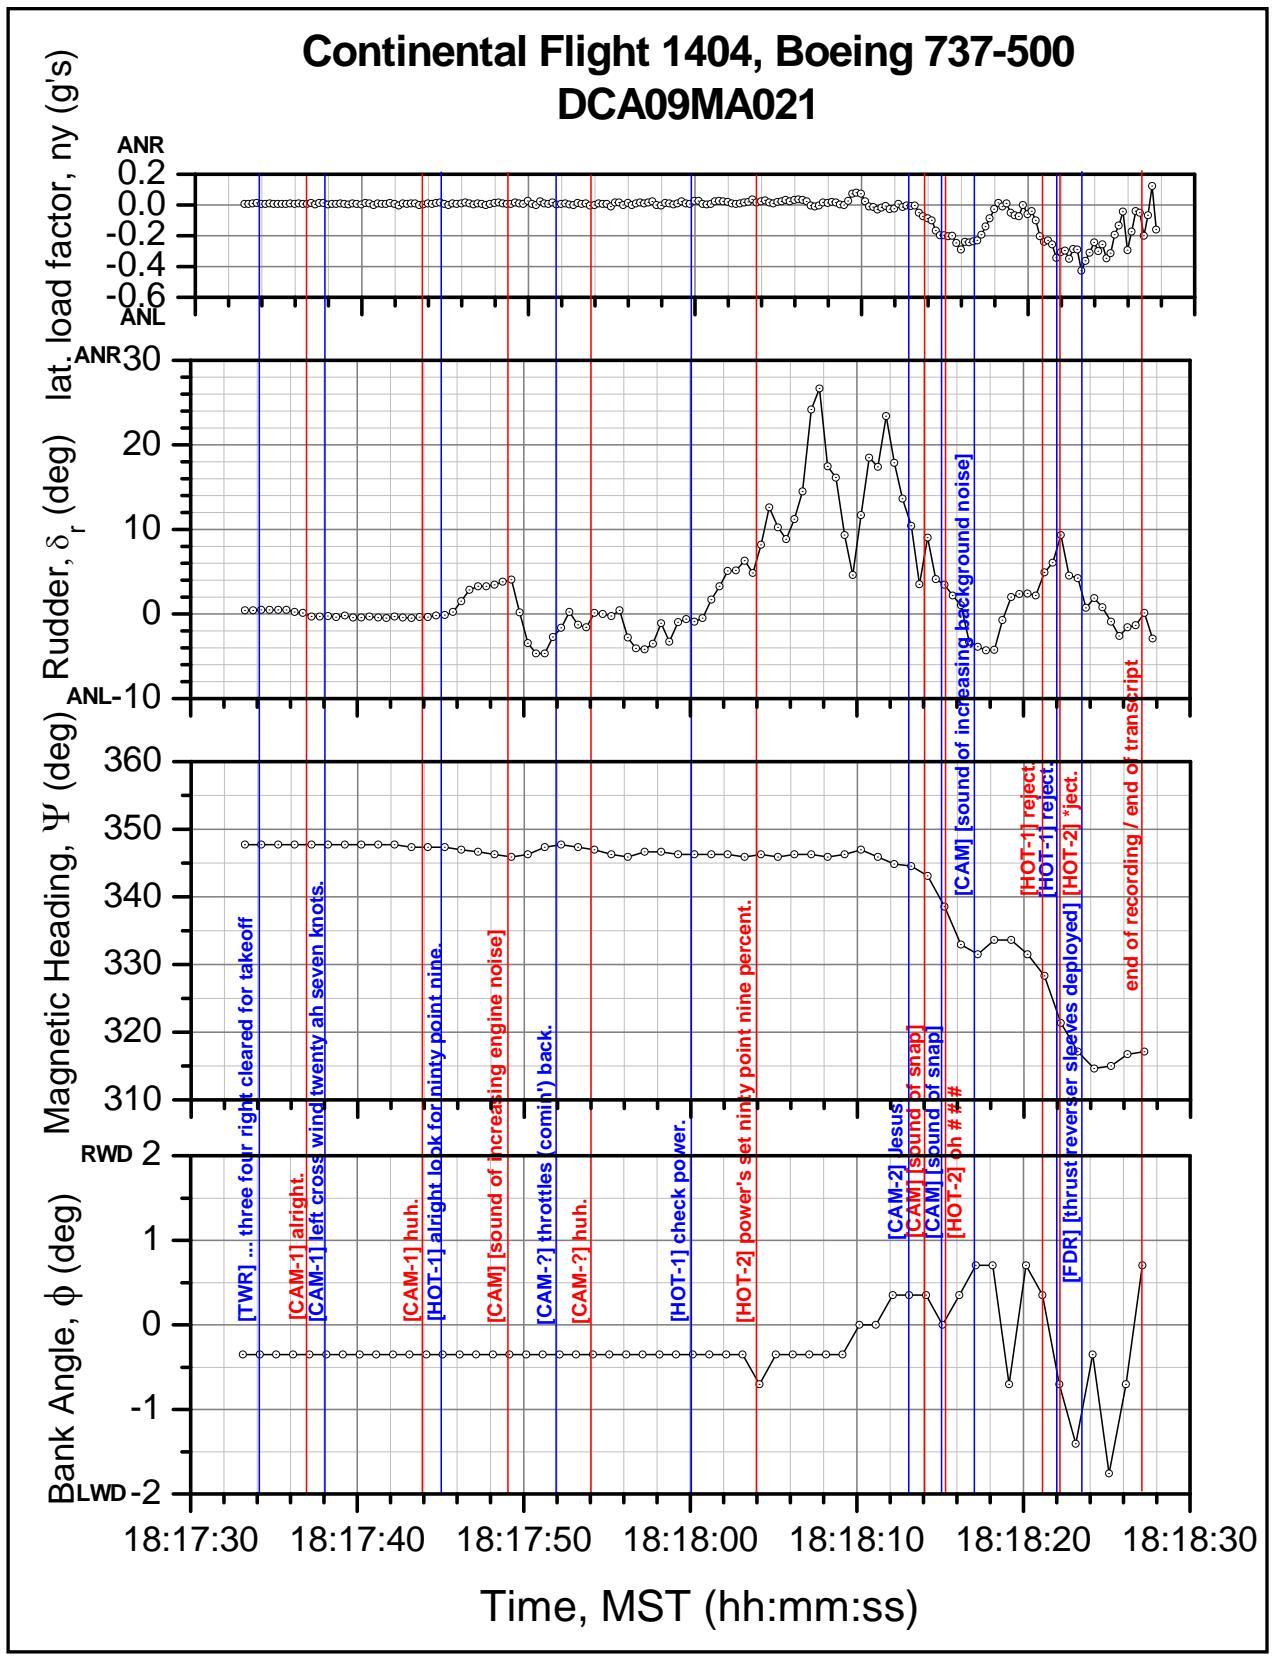
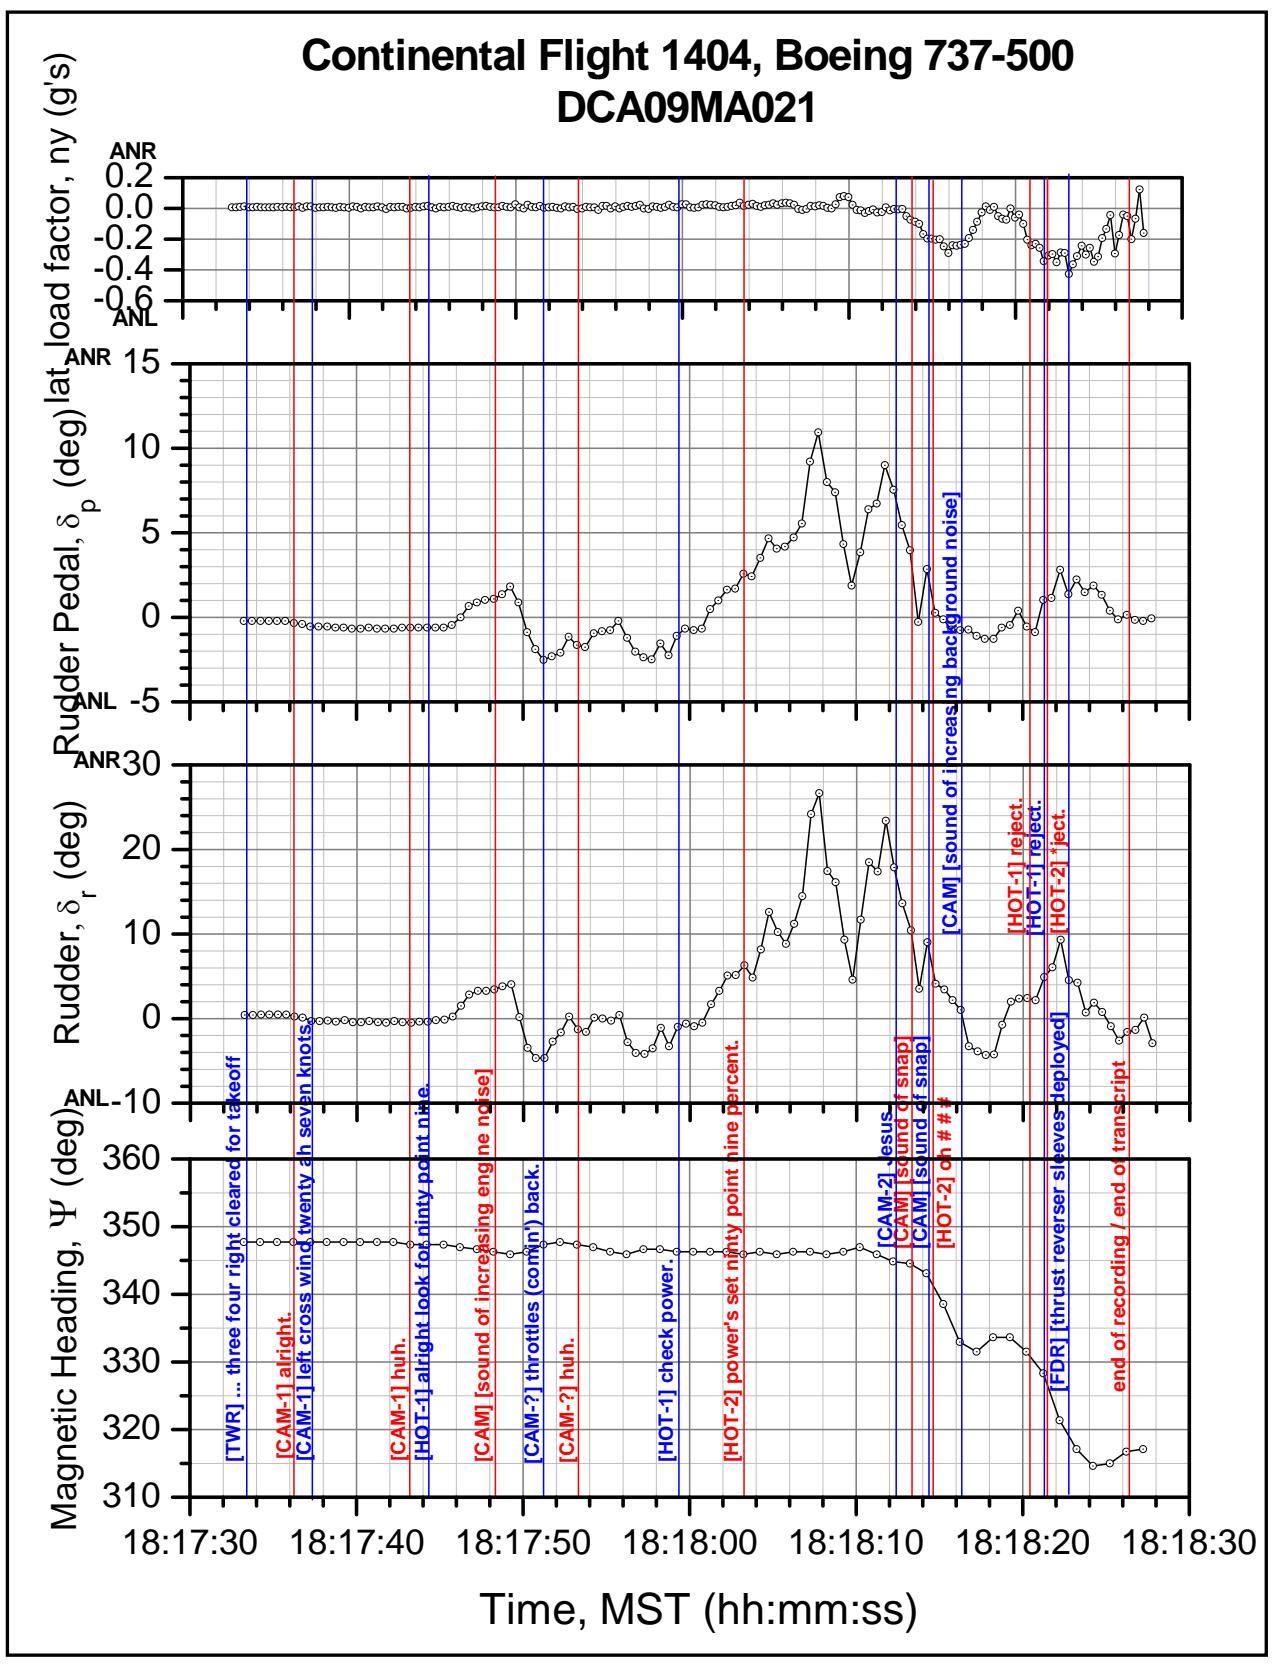
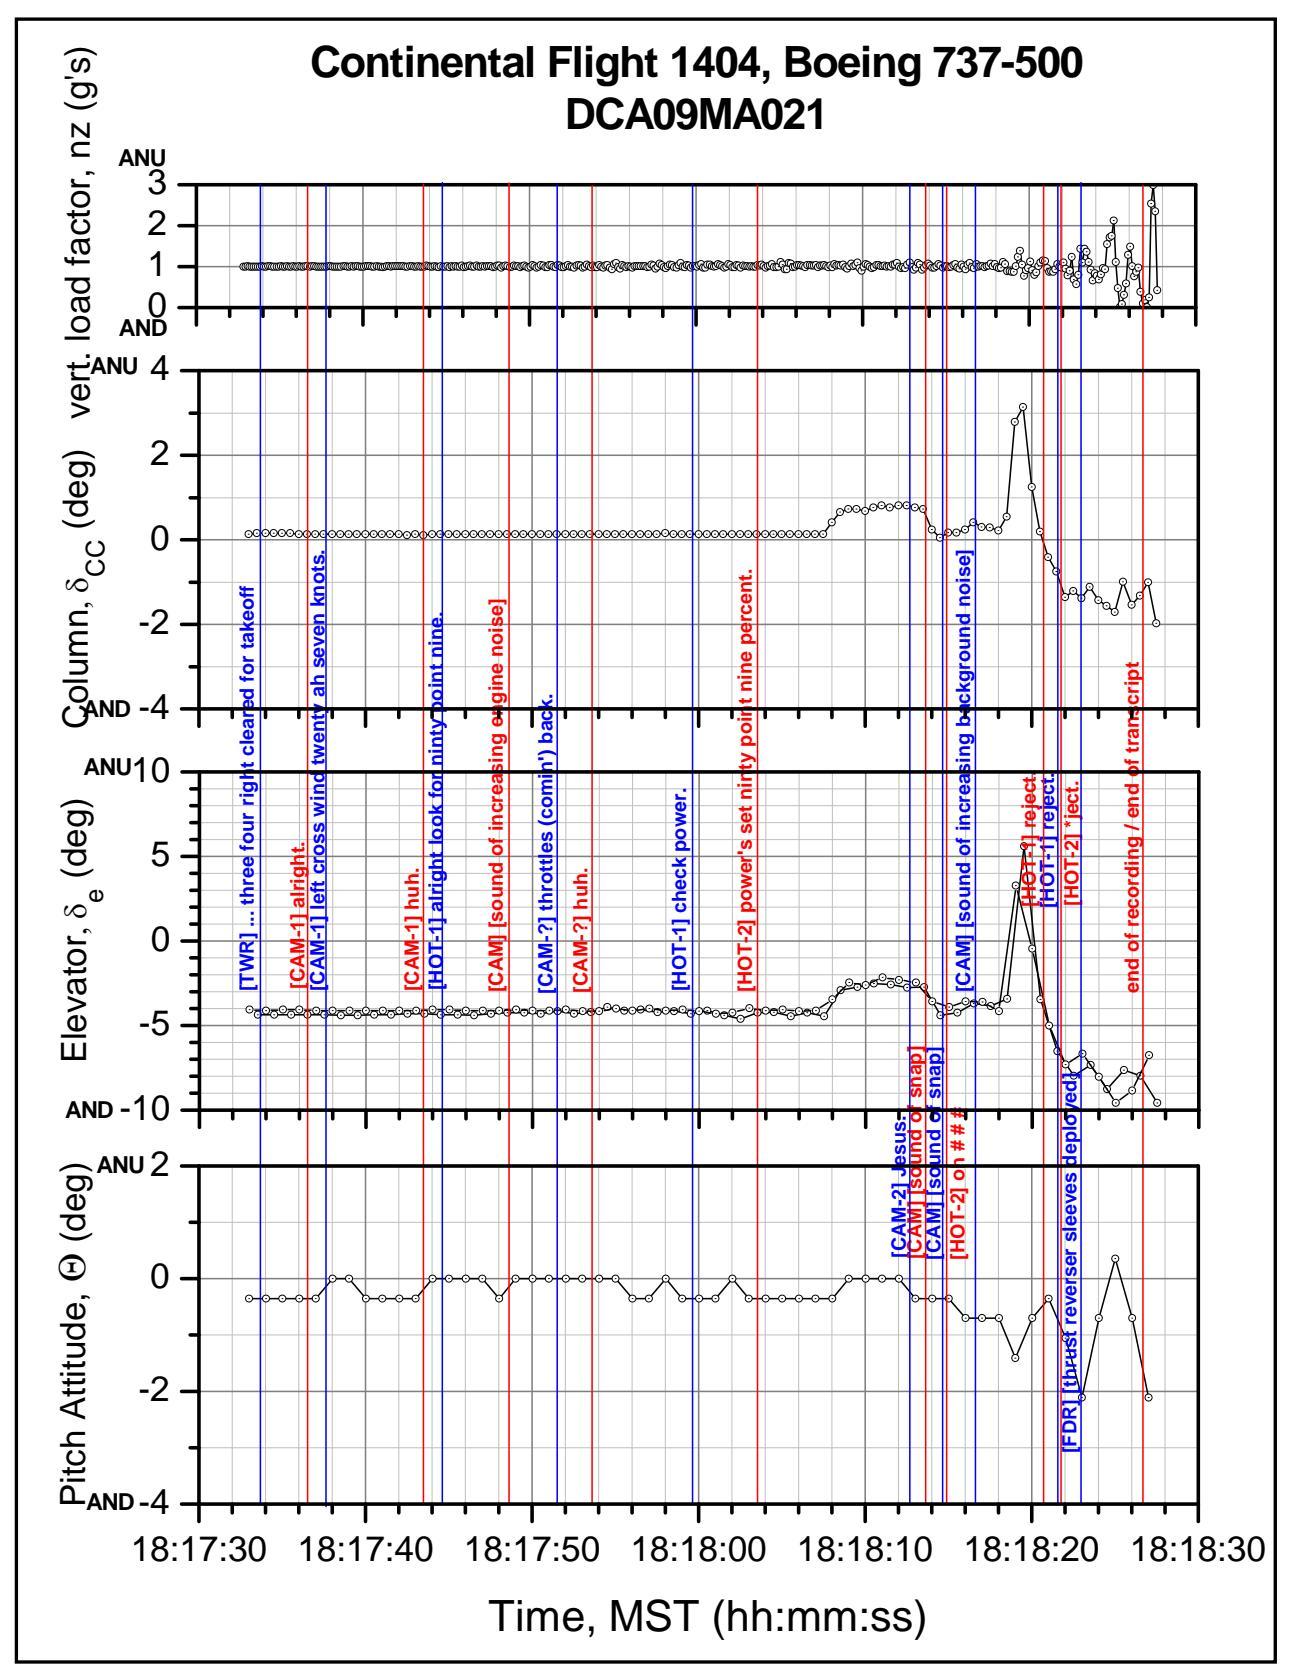
Figures 5 through 9 indicate that control continuity existed in both the yaw and pitch axes. The data also show that the control surfaces responded to the pilot's commands as expected and that the airplane responded to the control inputs as predicted. Little or no time delay could be detected between the pilot's rudder pedal commands and rudder movement. The same is true of column position and elevator.

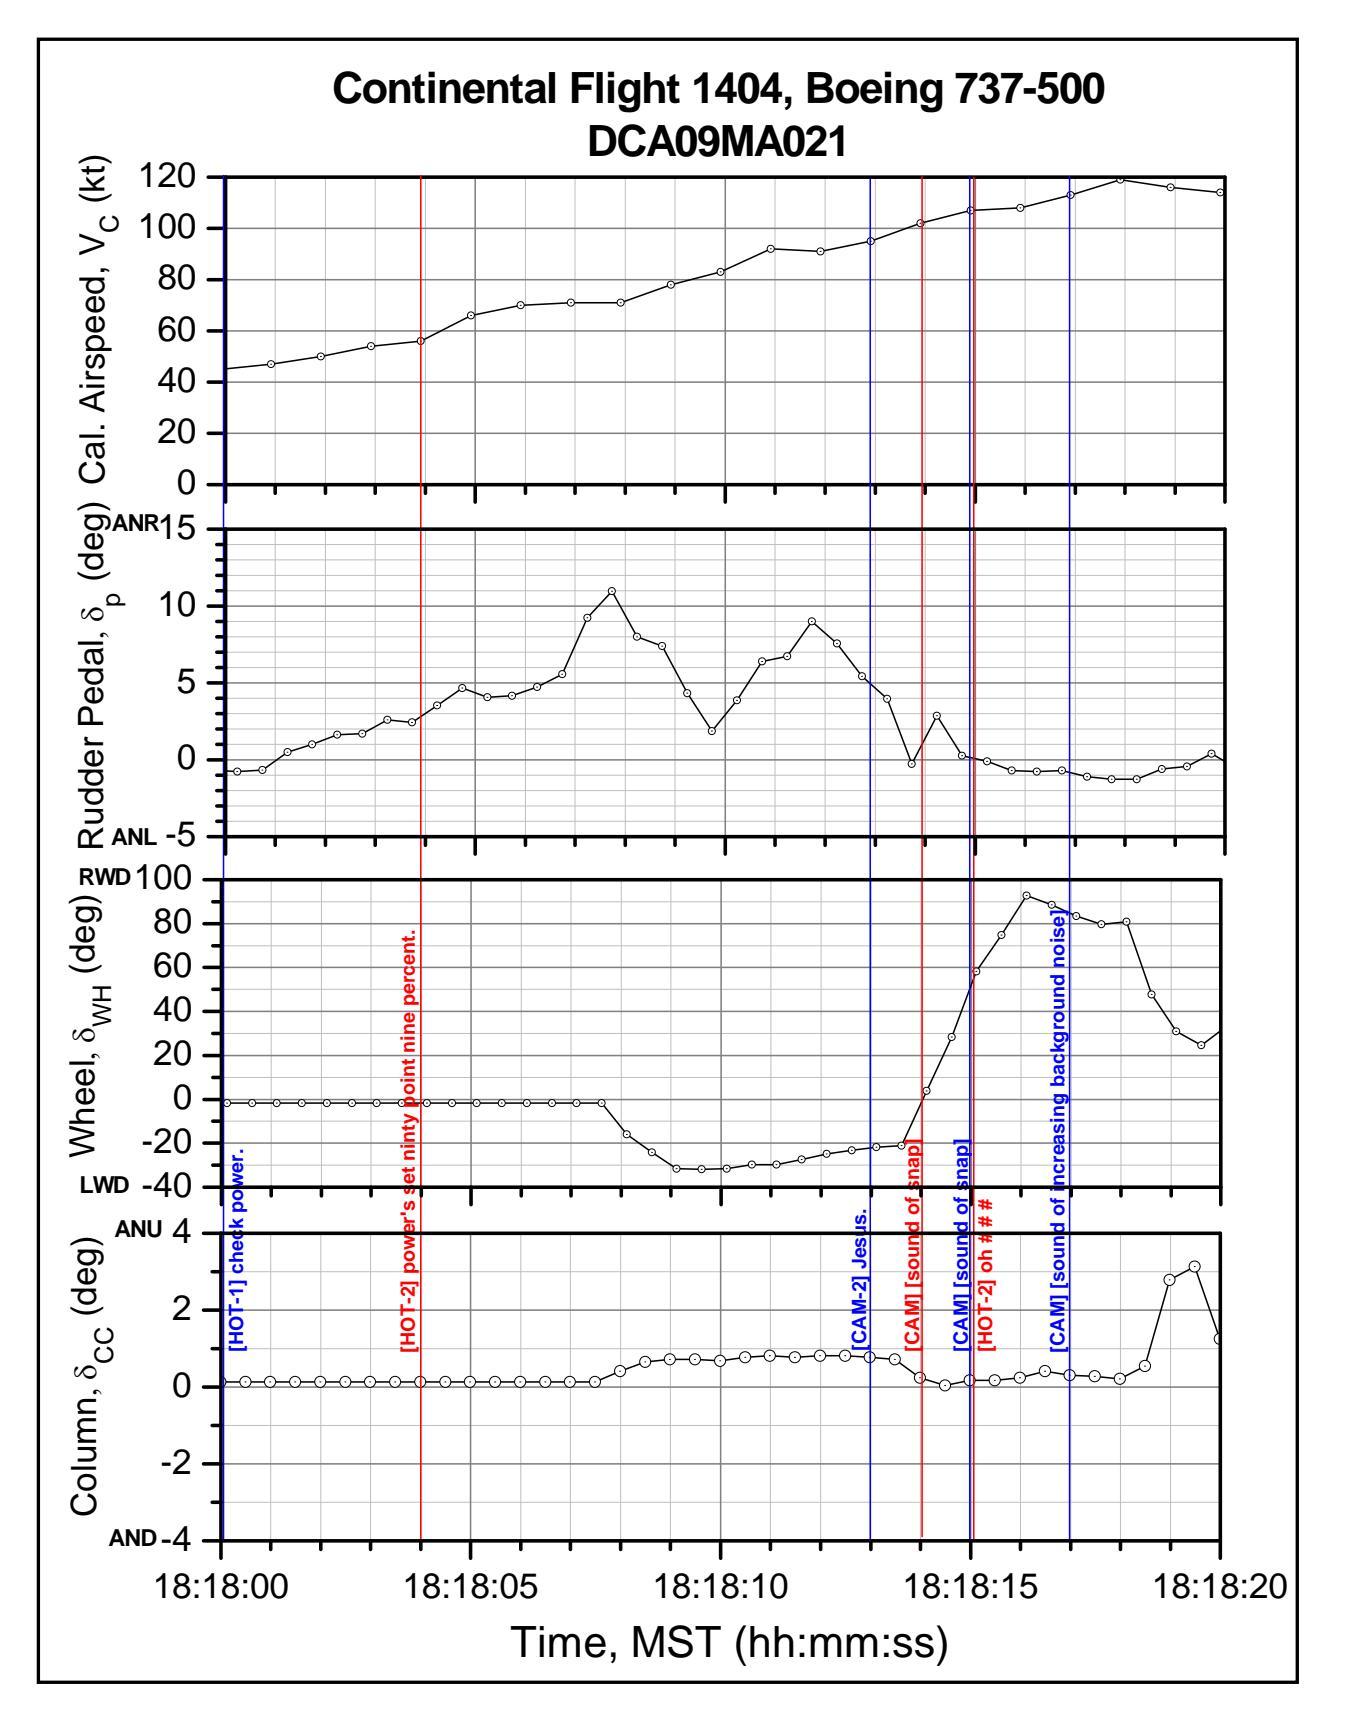
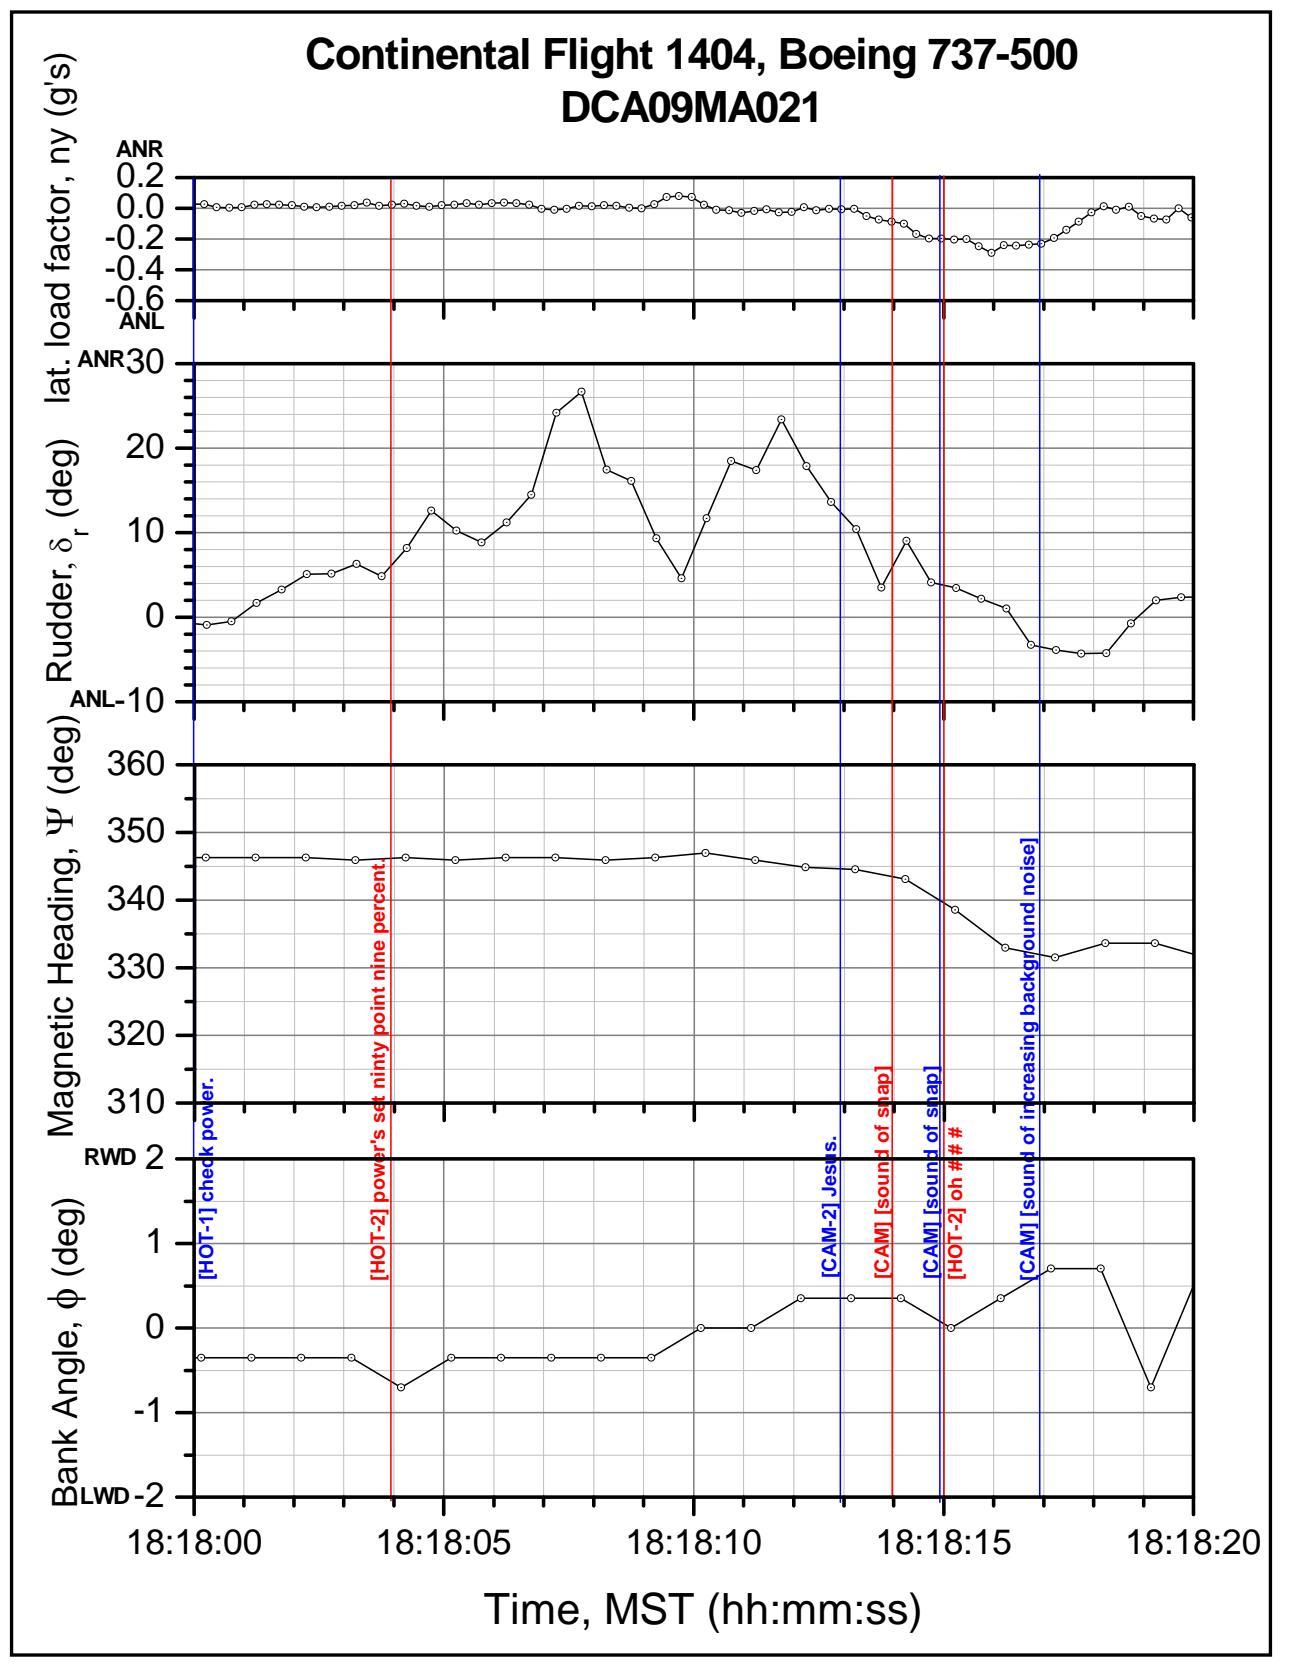
Figures 8 and 9 show an expanded scale of the pilot's inputs and the resulting airplane response for the time around the airplane's excursion off of the runway. Figure 8 shows that the proper airplane control wheel for a left crosswind was input just after 18:18:07. At this time, approximately 30° of left-wing-down (LWD) wheel and about 0.75° of airplane-nose-up (ANU) column were input. Five to ten degrees of airplane-nose-right (ANR) rudder had already been input by this point. While not recorded, the performance study assumed that no nose wheel tiller

Irrespective of the winds that were present during Continental flight 1404's take-off attempt, select FDR data shown that the airplane was capable of tracking the runway centerline. The airplane largely tracked the centerline until approximately 18:18:13 when the FDR rudder deflection went from 24° ANR to a near neutral position and the wheel transitioned from 20° LWD to over 80° of right-wing-down wheel (RWD).³

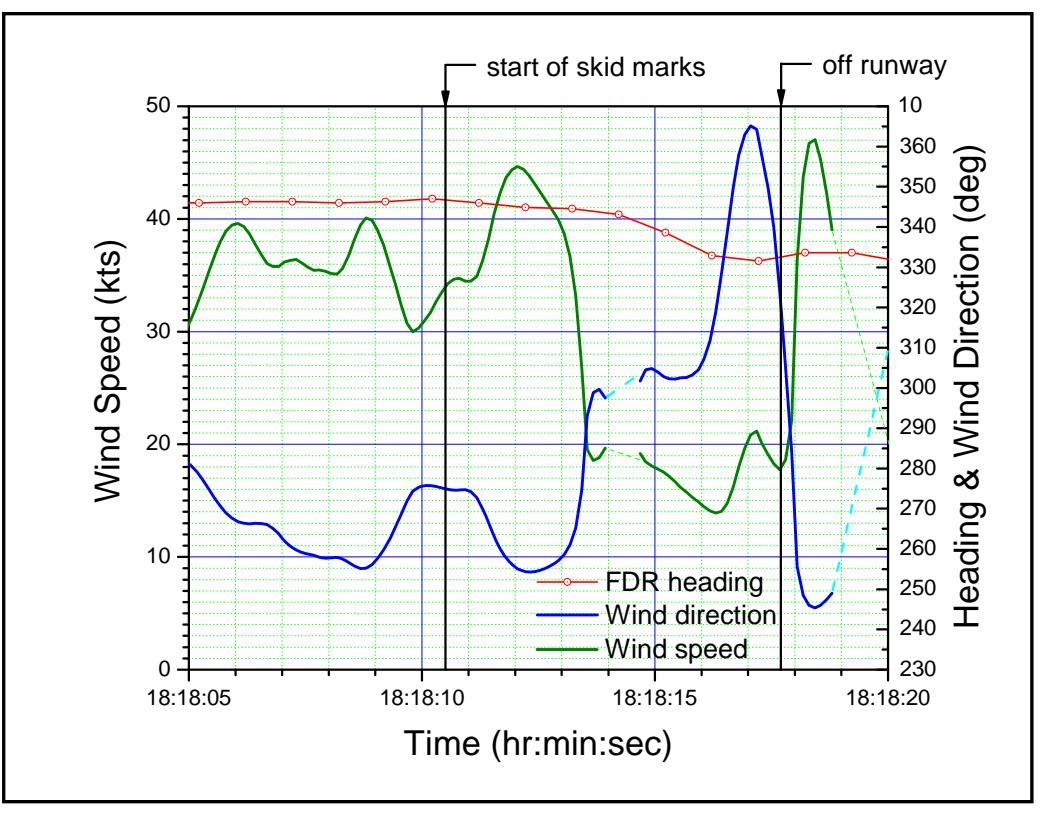
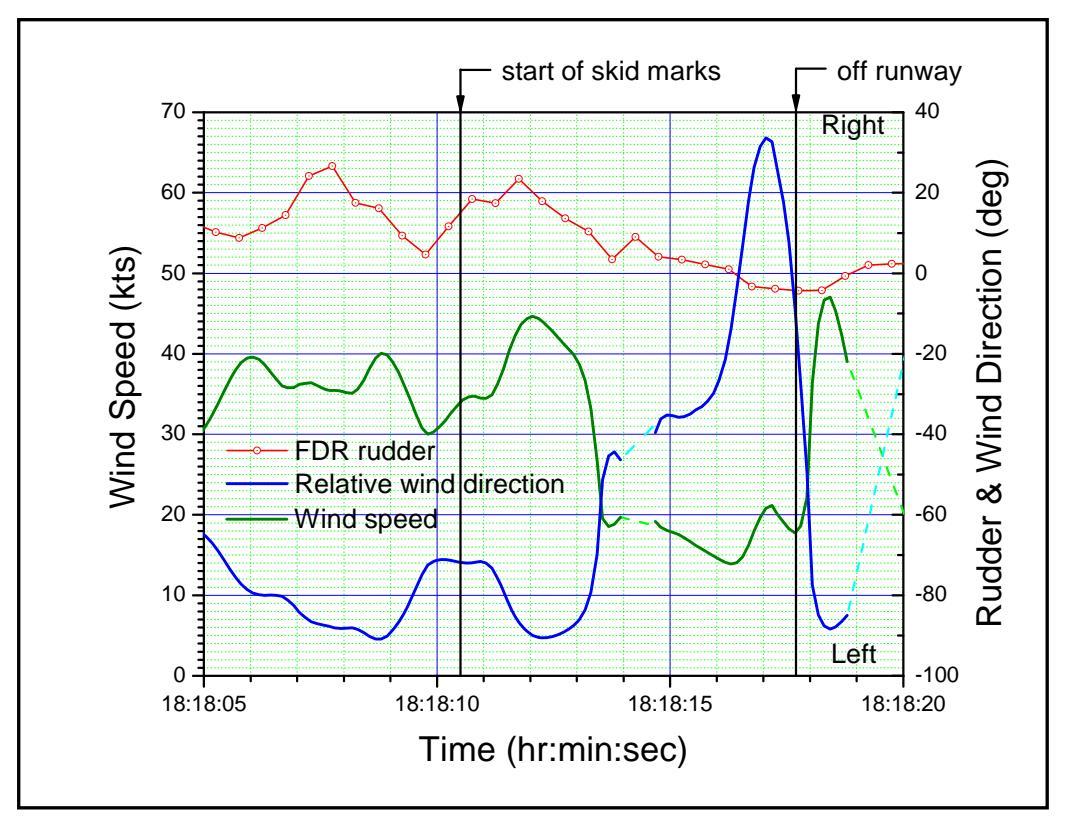
The NTSB's wind extraction results for the accident are shown with FDR magnetic heading in Figure 10 as a speed and absolute direction. The same winds are shown with the FDR recorded rudder in Figure 11 as a speed and a relative direction off of the airplane nose. The short dashed portions in the figures represent intervals where a wind extraction solution could not be mathematically determined.

The NTSB estimated that winds for the accident varied between 30 kt and 45 kt out of the west, almost a straight crosswind for Denver's runway 34R. A peak gust of 45 kt was extracted at about the same time the 24°ANR rudder input was returning to a near neutral position and about 1.5 seconds after the first recorded skid marks. This is in comparison to the Low Level Wind shear Alert System (LLWAS) at the Denver airport which recorded a ten-second average wind of 40 kt approximately two minutes prior to the accident and 34 kt around the time of the accident. (This was for LLWAS sensor #2 located closest to the departure end of runway 34R. A detailed discussion of the LLWAS data can be found in the Meteorological Factual Report and

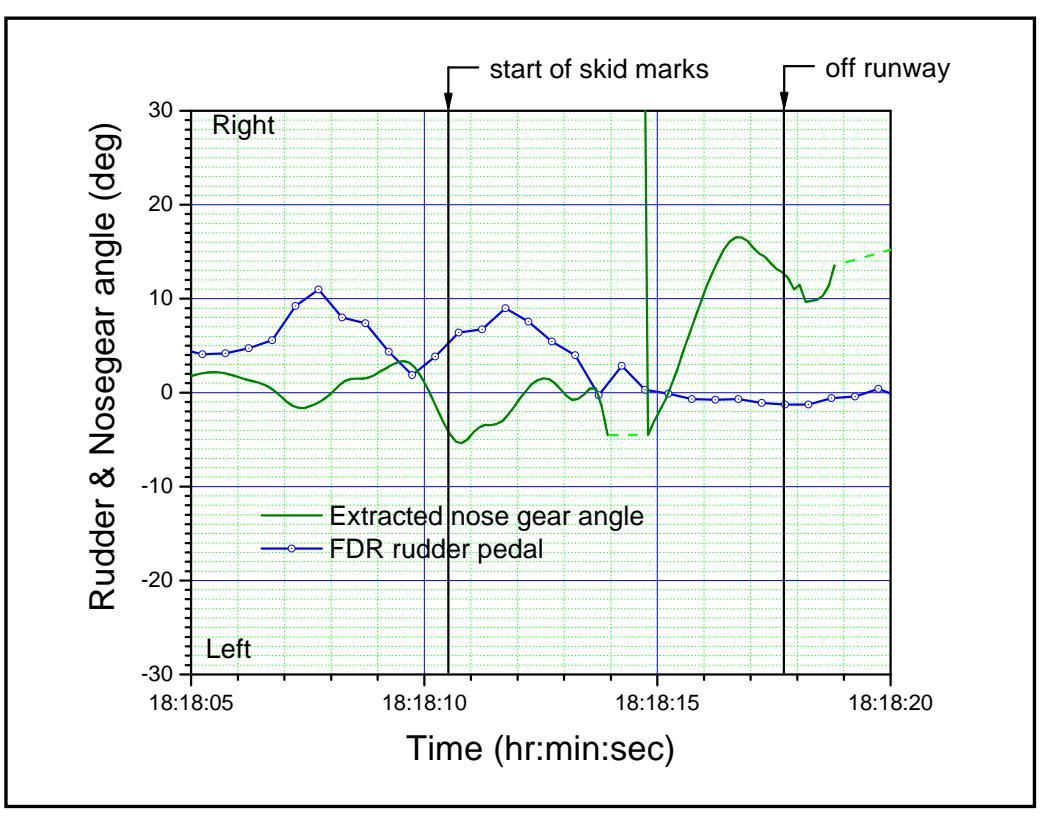
Figure 12: NTSB Extracted Nose Wheel Steering Angle

In addition to the accident winds, the nose wheel steering angle was also estimated using the FDR measurements and the NTSB B-737-500 simulation. The extracted steering angle is shown with FDR rudder in Figure 12. The nose wheel angle is commanded by either rudder pedal or tiller on the B-737. Assuming the crew of Continental flight 1404 did not input tiller around 18:18:12, the extracted steering angle would be expected to more closely mirror the rudder (as it did at time 18:18:07). This discrepancy is likely due to limits in the accuracy and availability of FDR data (e.g., drift sensitivity discussed below), skidding, and other limits in the ground and aerodynamic models used in the extraction. Despite this discrepancy, the large right nose wheel steering angle in the last three seconds of the extraction suggests that significant right tiller was input by the pilot as the airplane diverged from the runway centerline. While the tiller input may have slowed Continental flight 1404's departure from the runway, the final tiller input had little effect on the airplane's track, likely due to the high airspeed at this point in the take-off.
