National Transportation Safety Board

Airplane Performance Study

Specialist's Report of Investigation Timothy Burtch

Location:	Denver, CO
Date:	December 20, 2008
Time:	0018 GMT (6:18 pm MST)
Airplane:	Boeing B-737-500, N18611
NTSB Number:	DCA09MA021

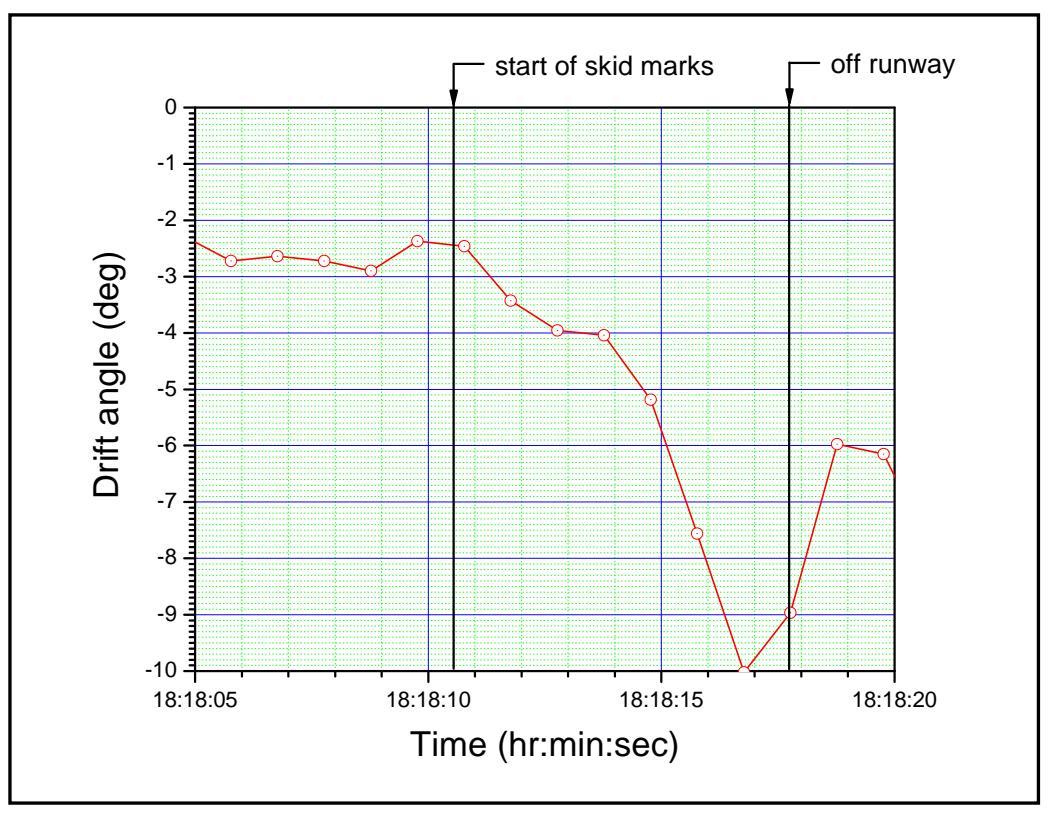
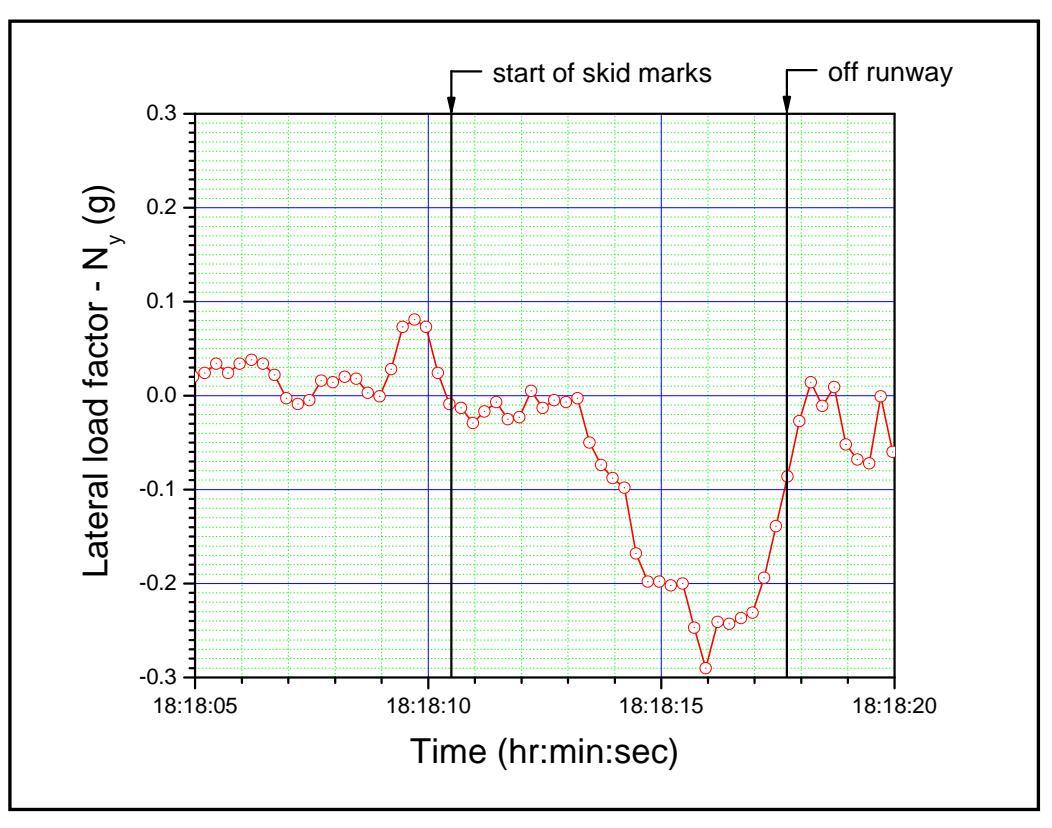
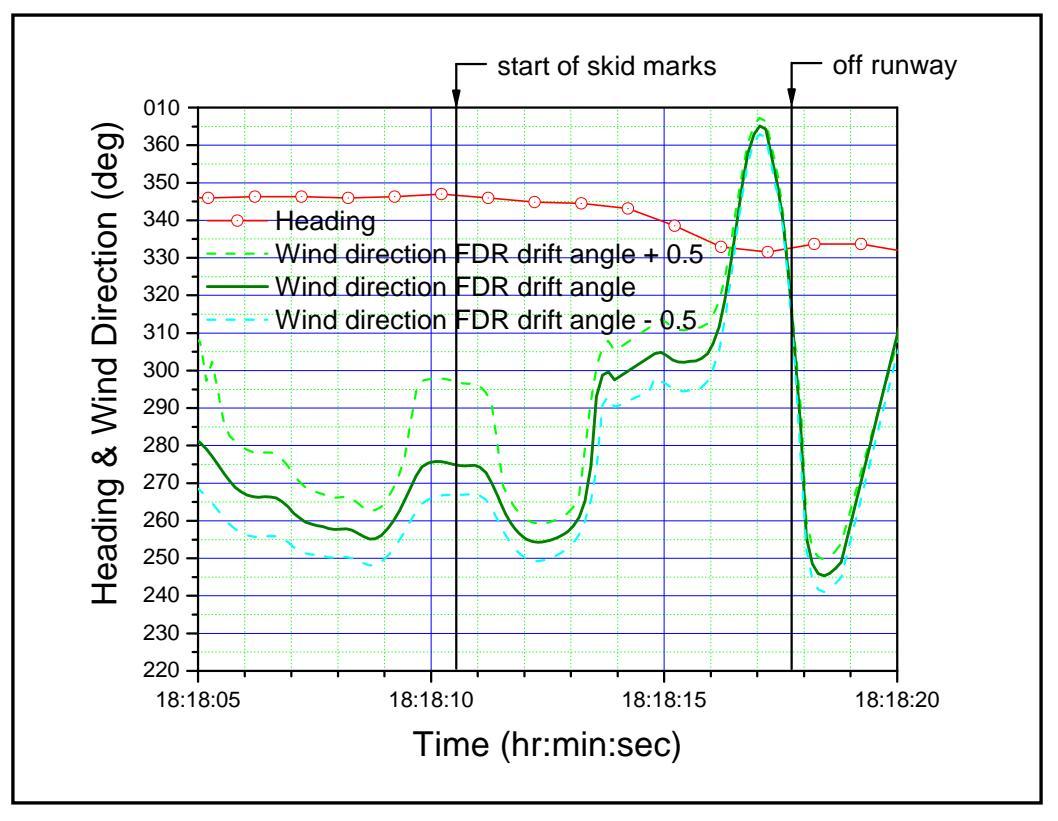
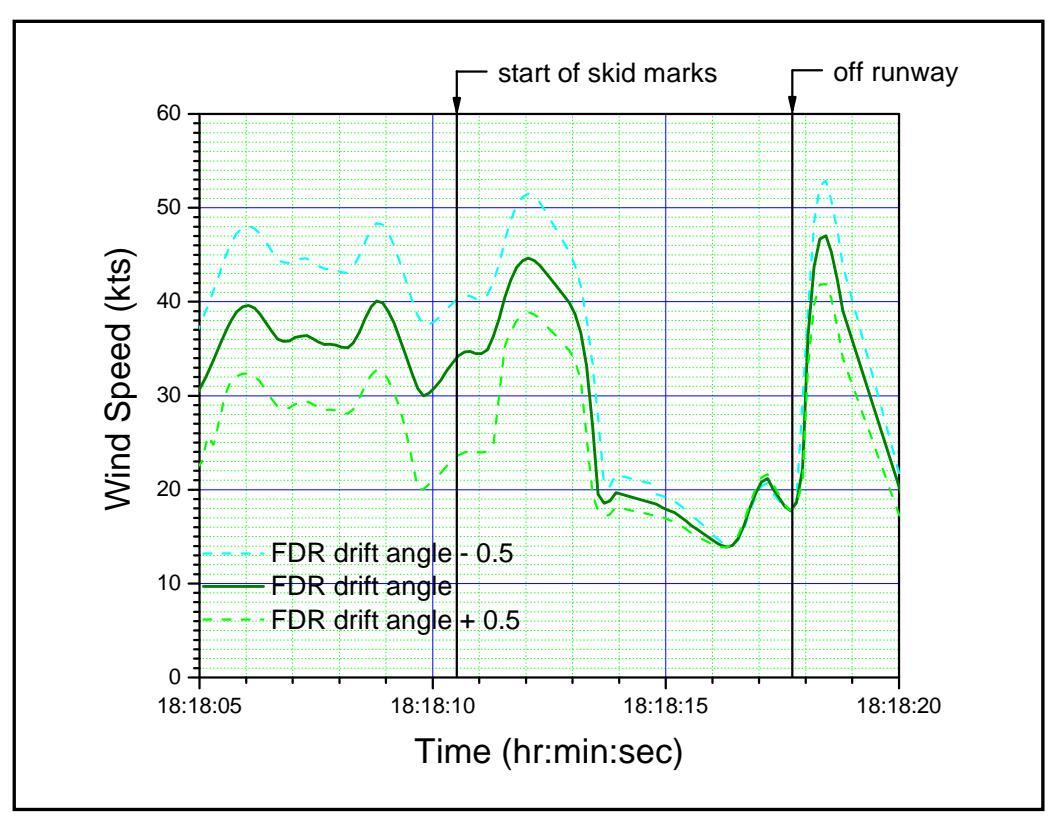
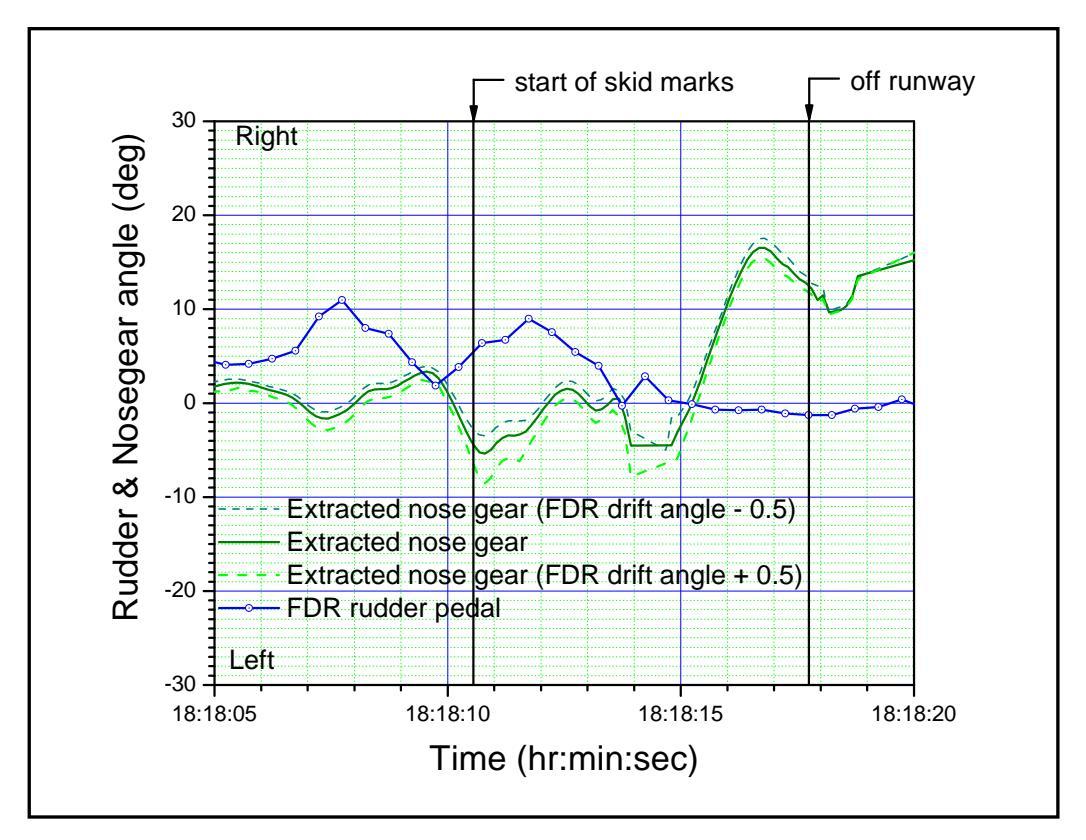
Finally, the NTSB considered a sensitivity study to determine the effect of small errors in FDR drift and lateral load factor on the extracted wind solution. FDR drift and lateral load factor are shown in Figures 13 and 14, respectively. Since the bias on n_y is known and accounted for as a result of the integration, only the sensitivity with respect to drift angle was considered further. The extraction sensitivity to drift angle was run with $a \pm 0.5^{\circ}$ tolerance-band on drift angle to determine the effect of small errors possibly present in the FDR data. The drift angle sensitivity is shown in Figures 15 through 17 for wind direction, wind speed, and nose wheel steering angle, respectively.

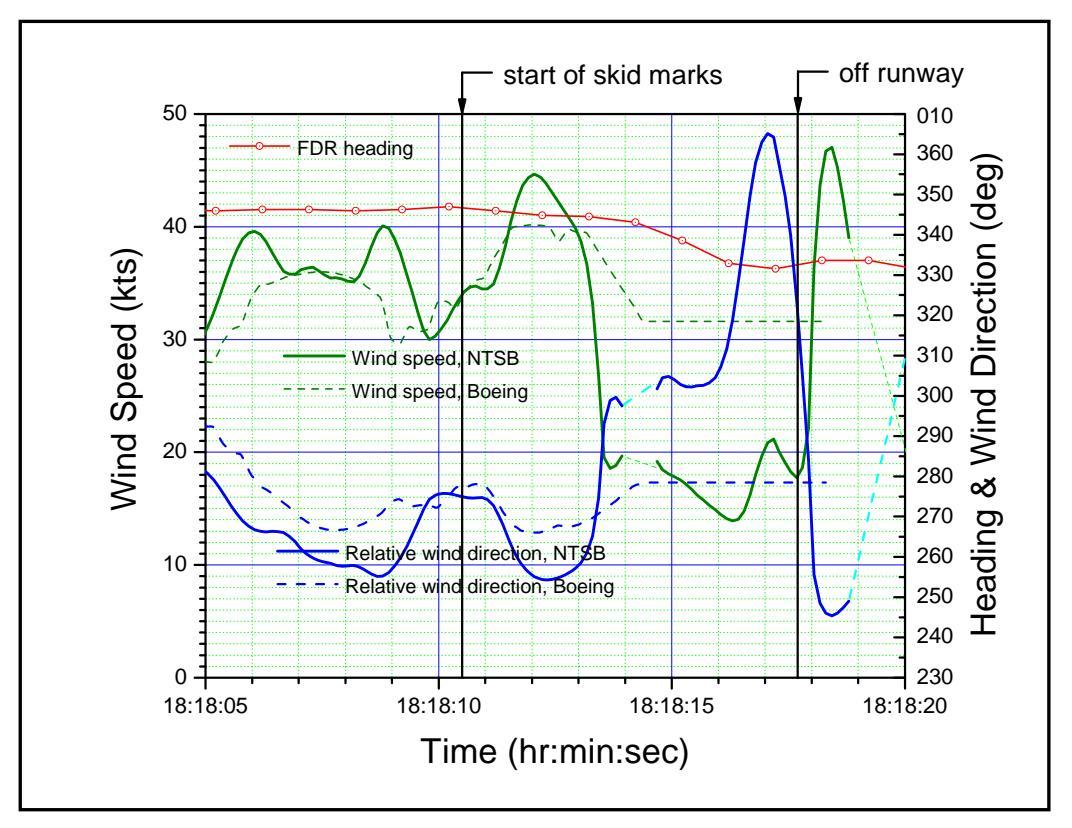
Figure 18: Boeing and NTSB Extracted Wind Speed and Magnetic Direction

All of Boeing's methods produced similar results above an airspeed of approximately 60 kt. The final winds extracted by Boeing for the accident are shown with the NTSB results in Figure 18 as a speed and magnetic direction. Boeing reported the accident winds as gusting out of the west at 25 kt to 40 kt, and the results aligned well with the LLWAS sensor data⁸. The final Boeing wind solution produced a very good match with the FDR recorded heading and resulted in small differences in other parameters – namely drift, lateral load factor, and rudder deflection. Bank angle differed from the FDR recorded value by one to two degrees because bank angle was an output in Boeing's forward⁹ time history simulation. However, Boeing used FDR bank angle in the "point-by-point" methods discussed previously, and Boeing's final wind solution is largely based on these methods. The time history simulation was used only to refine the point-by-point results.

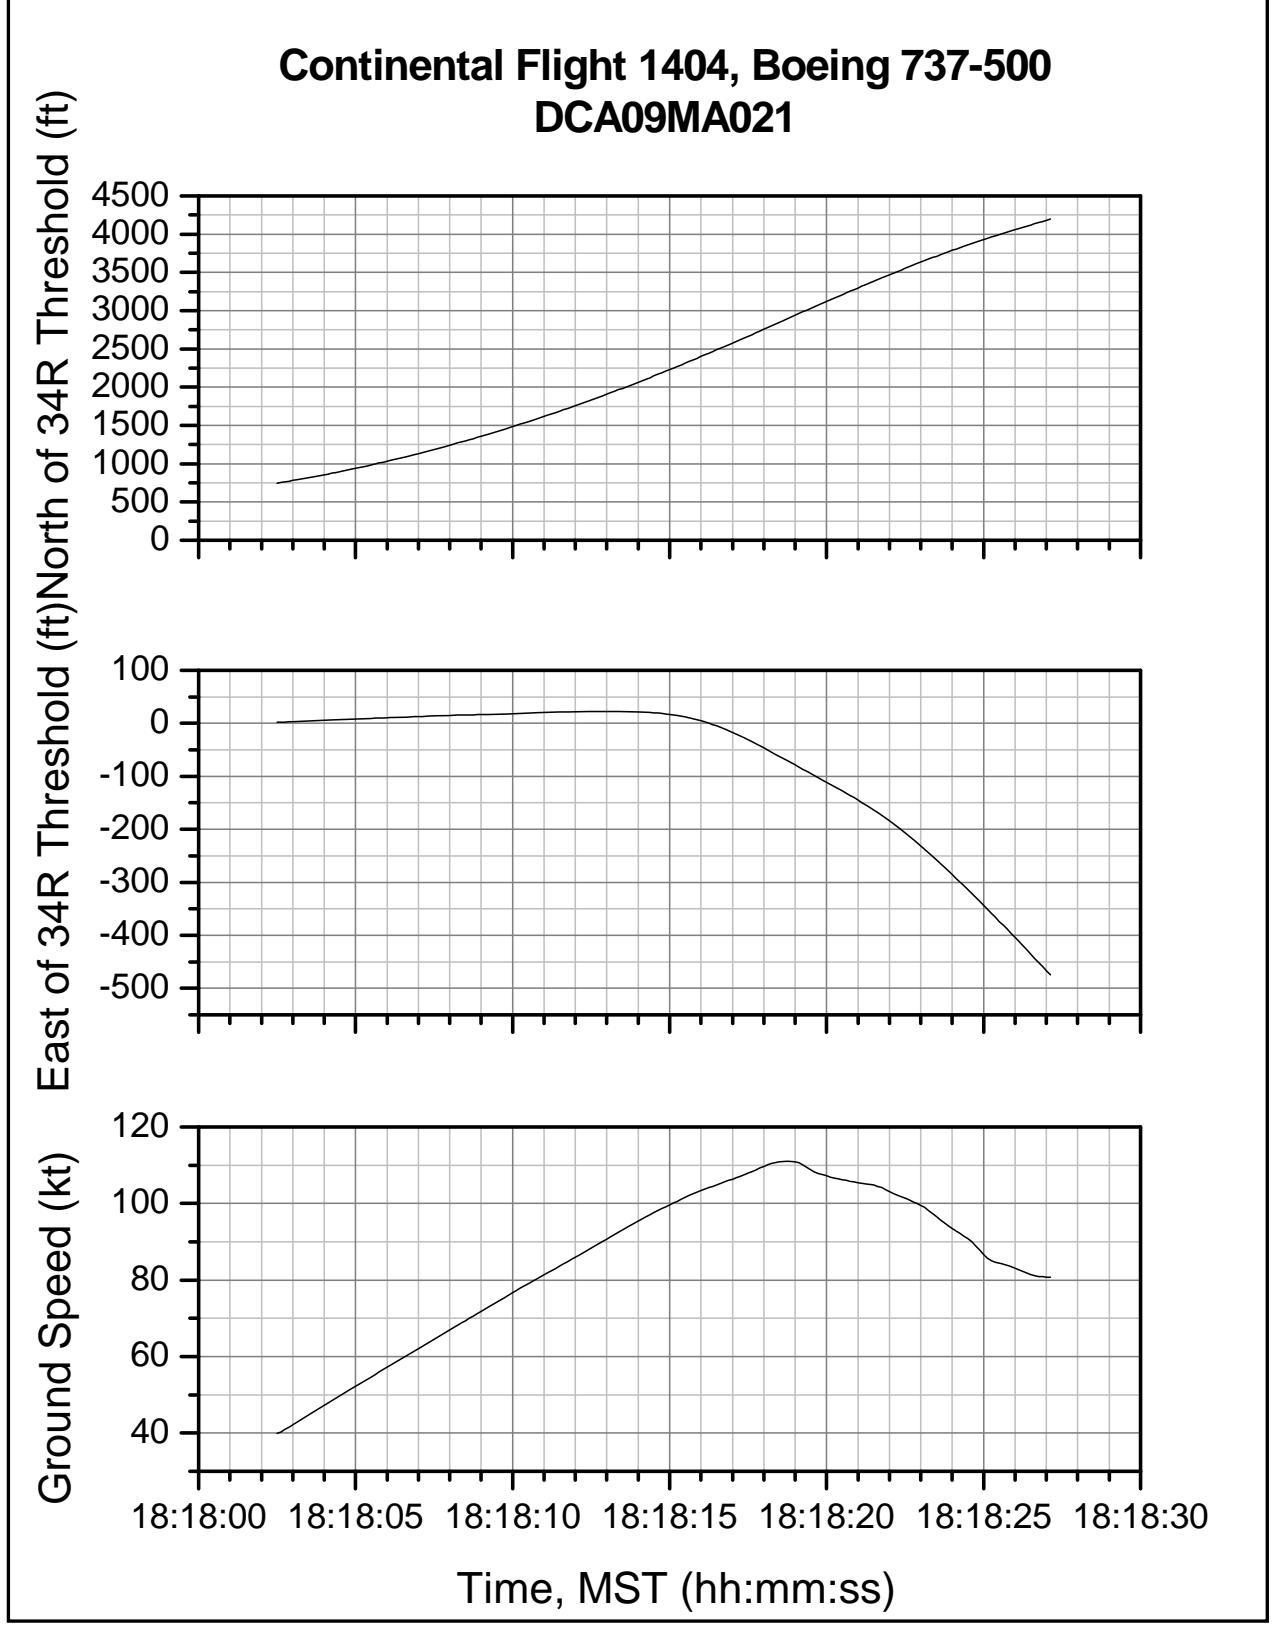
Figure 19: Final Integrated Position and Speed Relative to Runway 34R Threshold

The final integrated position and speed is shown in Figure 19 as a function of time, and the integrated altitude never varied more than ± 10 ft from the recorded airport elevation.
