## NATIONAL TRANSPORTATION SAFETY BOARD

# AIRFRAME AND ENGINE EXAMINATION

WPR15LA177

Location:Dewey, AZDate:June 1. 2015Aircraft:Bell Helicopter Company 206-L4, N73AW, Serial #: 52115NTSB IIC:Albert Nixon

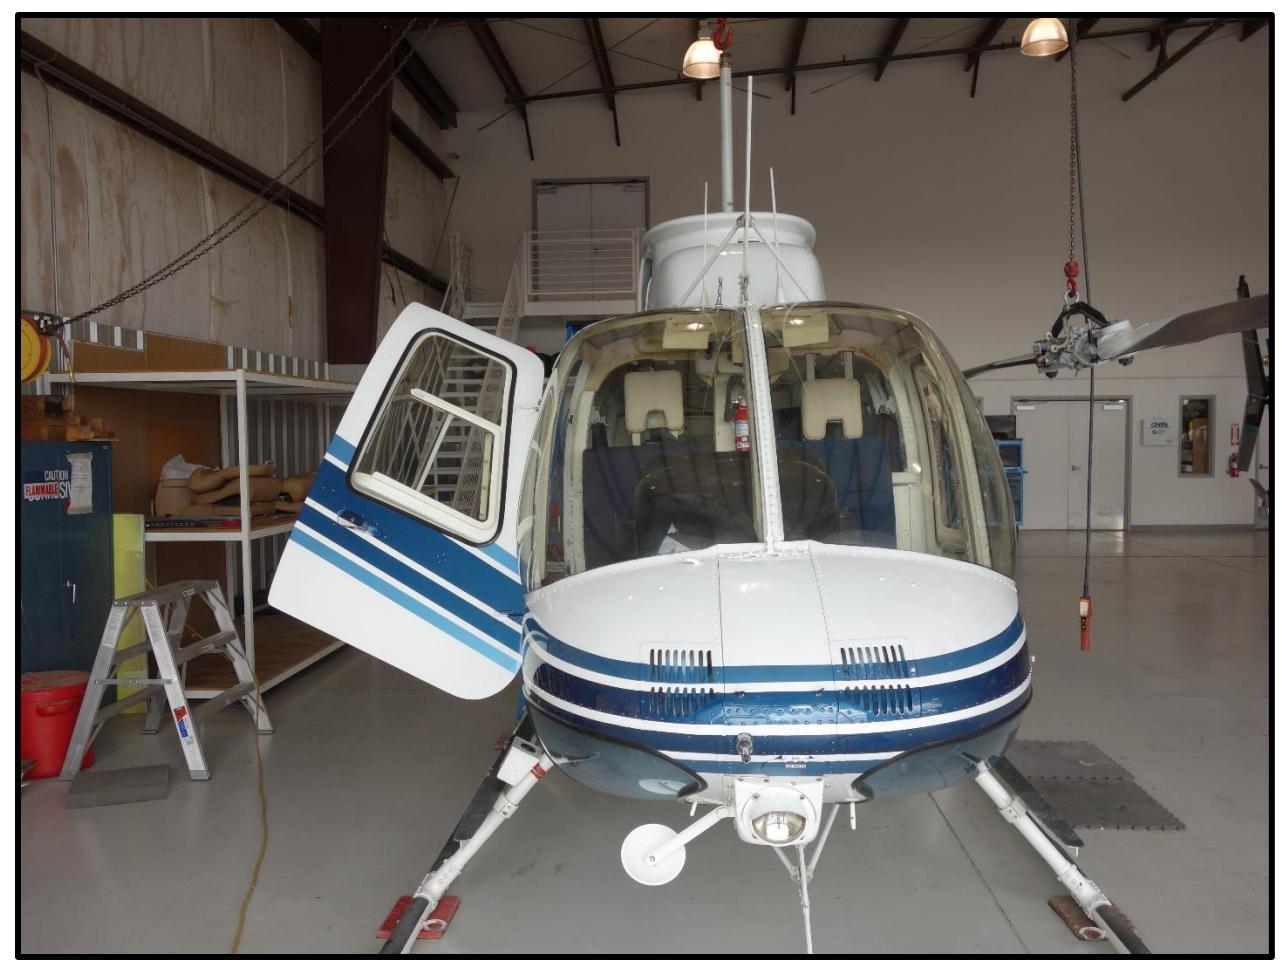
The main rotor blades had been removed for recovery. The helicopter's cabin and fuselage was intact, forward of where the tail boom attached. Flight control continuity was established with the cyclic and collective. Tail rotor continuity was established through the pilot pedals. The main drive continuity was established by turning the steel T/R driveshaft by hand and observing appropriate mast rotational movement.

Figure 1: Helicopter as view from the front.

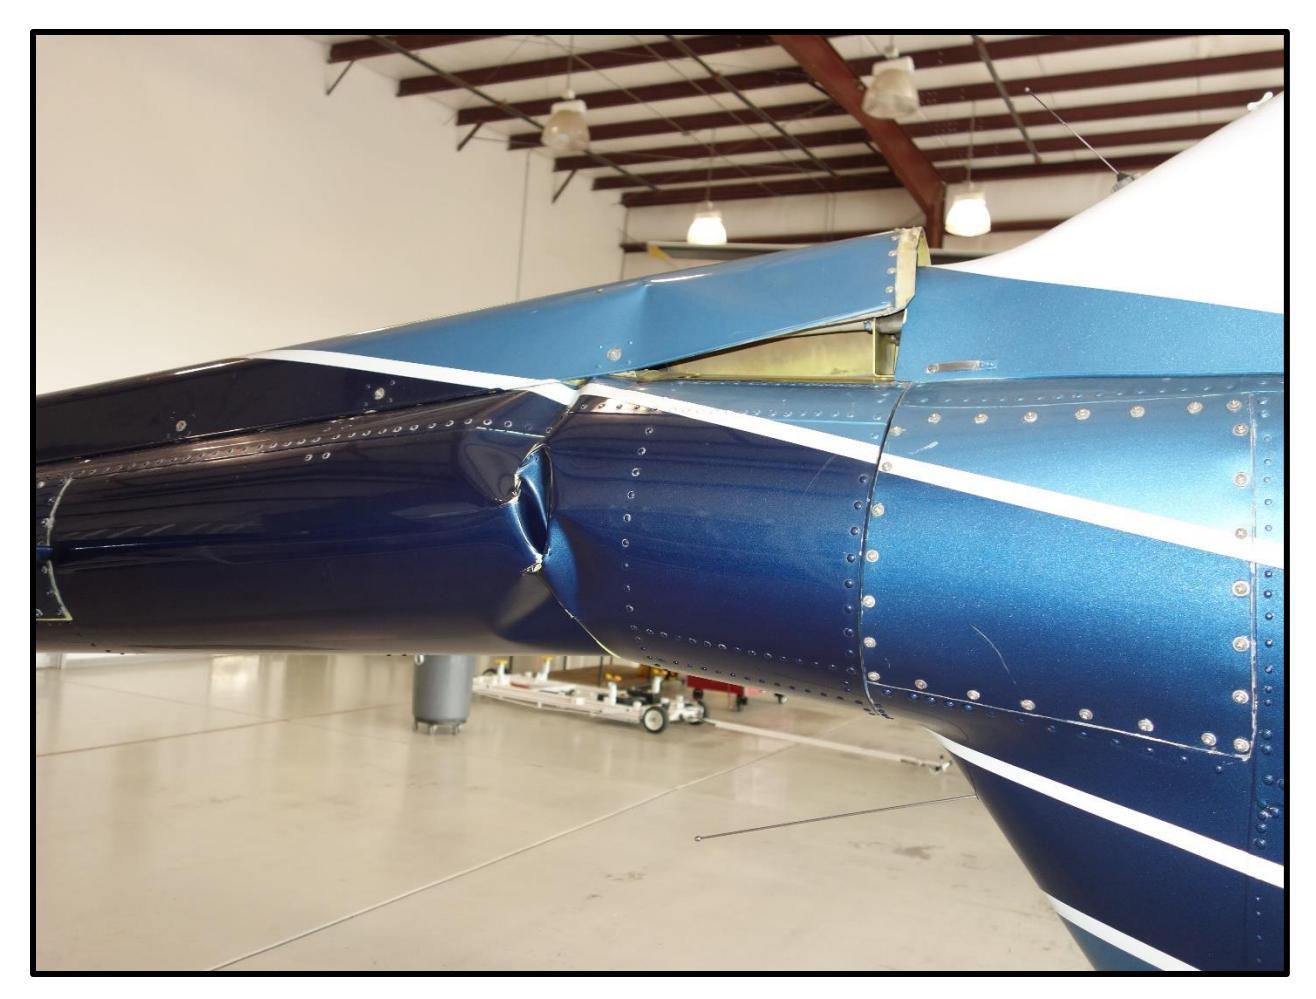
The tail boom was observed to be bent down aft of the intercostal support. Both horizontal stabilizer end plates were struck on the top and bent to the right. Additionally, the main rotor blades had dents and markings on the bottom of both blades. All the damage was consistent with a main rotor blade strike.

Figure 2: Right side view of tail boom damage.

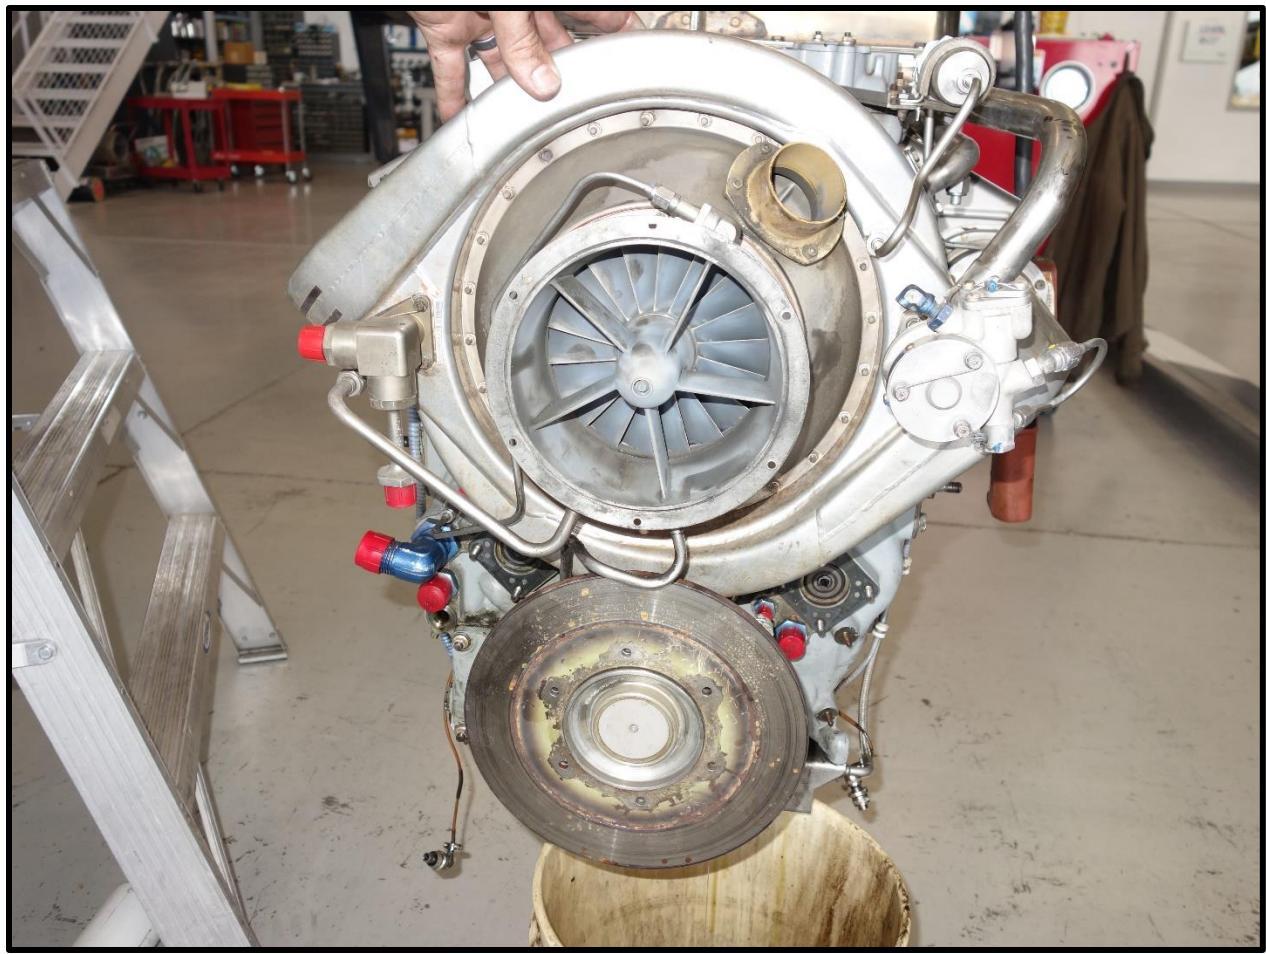
The engine's N1 was locked and the N2 rotated by hand, with some resistance. On the engine chip plugs, a lot of debris was observed. A determination was made to ship the engine to Rolls Royce, for a teardown examination. The engine was removed from the airframe and packed and sealed in a shipping container.

Figure 3: Front view of engine that has been removed from airframe.
