NATIONAL TRANSPORTATION SAFETY BOARD

AIRFRAME AND ENGINE EXAMINATION

WPR17LA084

Location:Brinnon, WADate:April 2, 2017Aircraft:Cirrus Design Corp., SR22, Registration Number: N167CBNTSB IIC:Albert Nixon

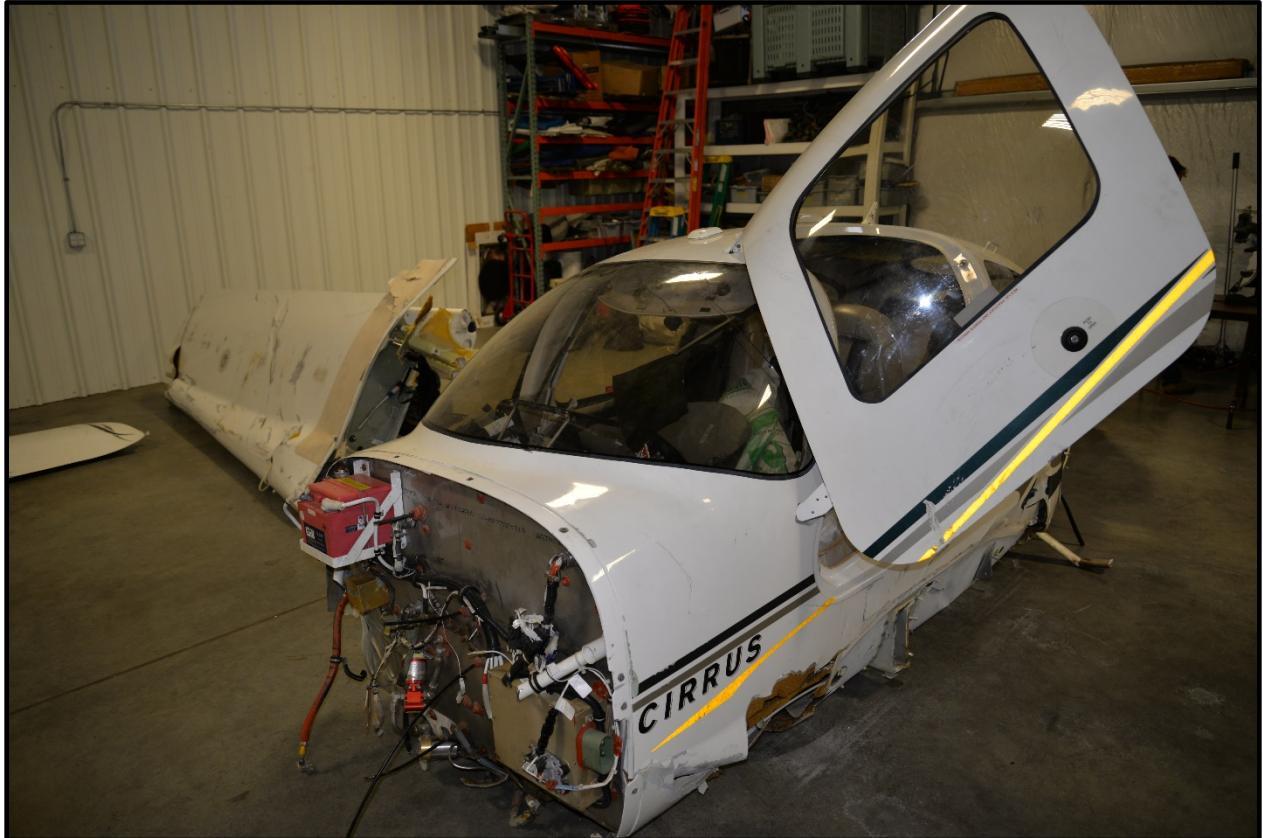
Examination of the airplane revealed that the engine and wings were removed for recovery. Leading edge damage was sustained on the left wing from the wing root to the left cuff and on the right wing for the entire span. Both flaps and ailerons were attached and sustained impact damage. The flap actuator indicated a flaps up position. The fuselage remained intact, but the empennage was separated from the fuselage about aft of the CAPS enclosure compartment. According to recovery personnel, the empennage broke loose during recovery and dropped into the mountains and was unable to be recovered. Both cabin doors remained attached to the fuselage. The baggage door was separated from the fuselage.

Figure 1: Right fuselage and wing as viewed from the left side.

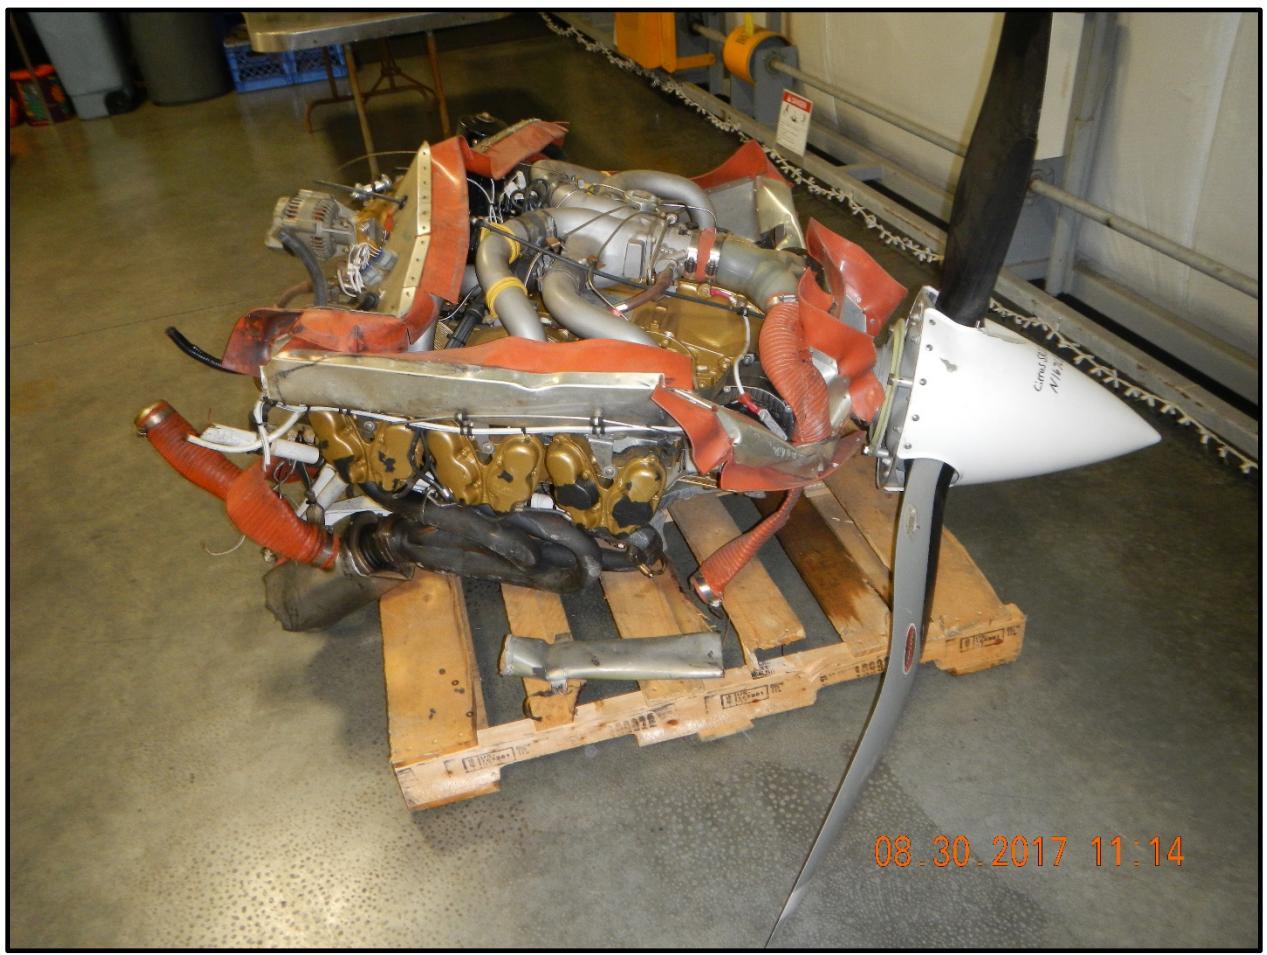
Examination of the Continental IO-550-N (27B) engine, revealed that it had been removed at the accident site by cutting the engine mount and control cables. Additionally, the airframe cooling baffles sustained impact damage. The three-blade constant speed propeller and spinner remained attached. All three propeller blades sustained slight bending to the aft.

The rocker covers were intact. The crankshaft was rotated by hand, utilizing the propeller, and rotational continuity was established throughout the engine, accessory section, and the valve train. During crankshaft rotation, thumb compression and suction were attained on all cylinders. A borescope inspection of the cylinders revealed evidence of normal operational conditions.

Figure 2: Airplane engine viewed from the right side.
